REACTOR PRIMARY SYSTEM INVESTIGATION

AT NINE MILE POINT NUCLEAR STATION

May 1, 1970

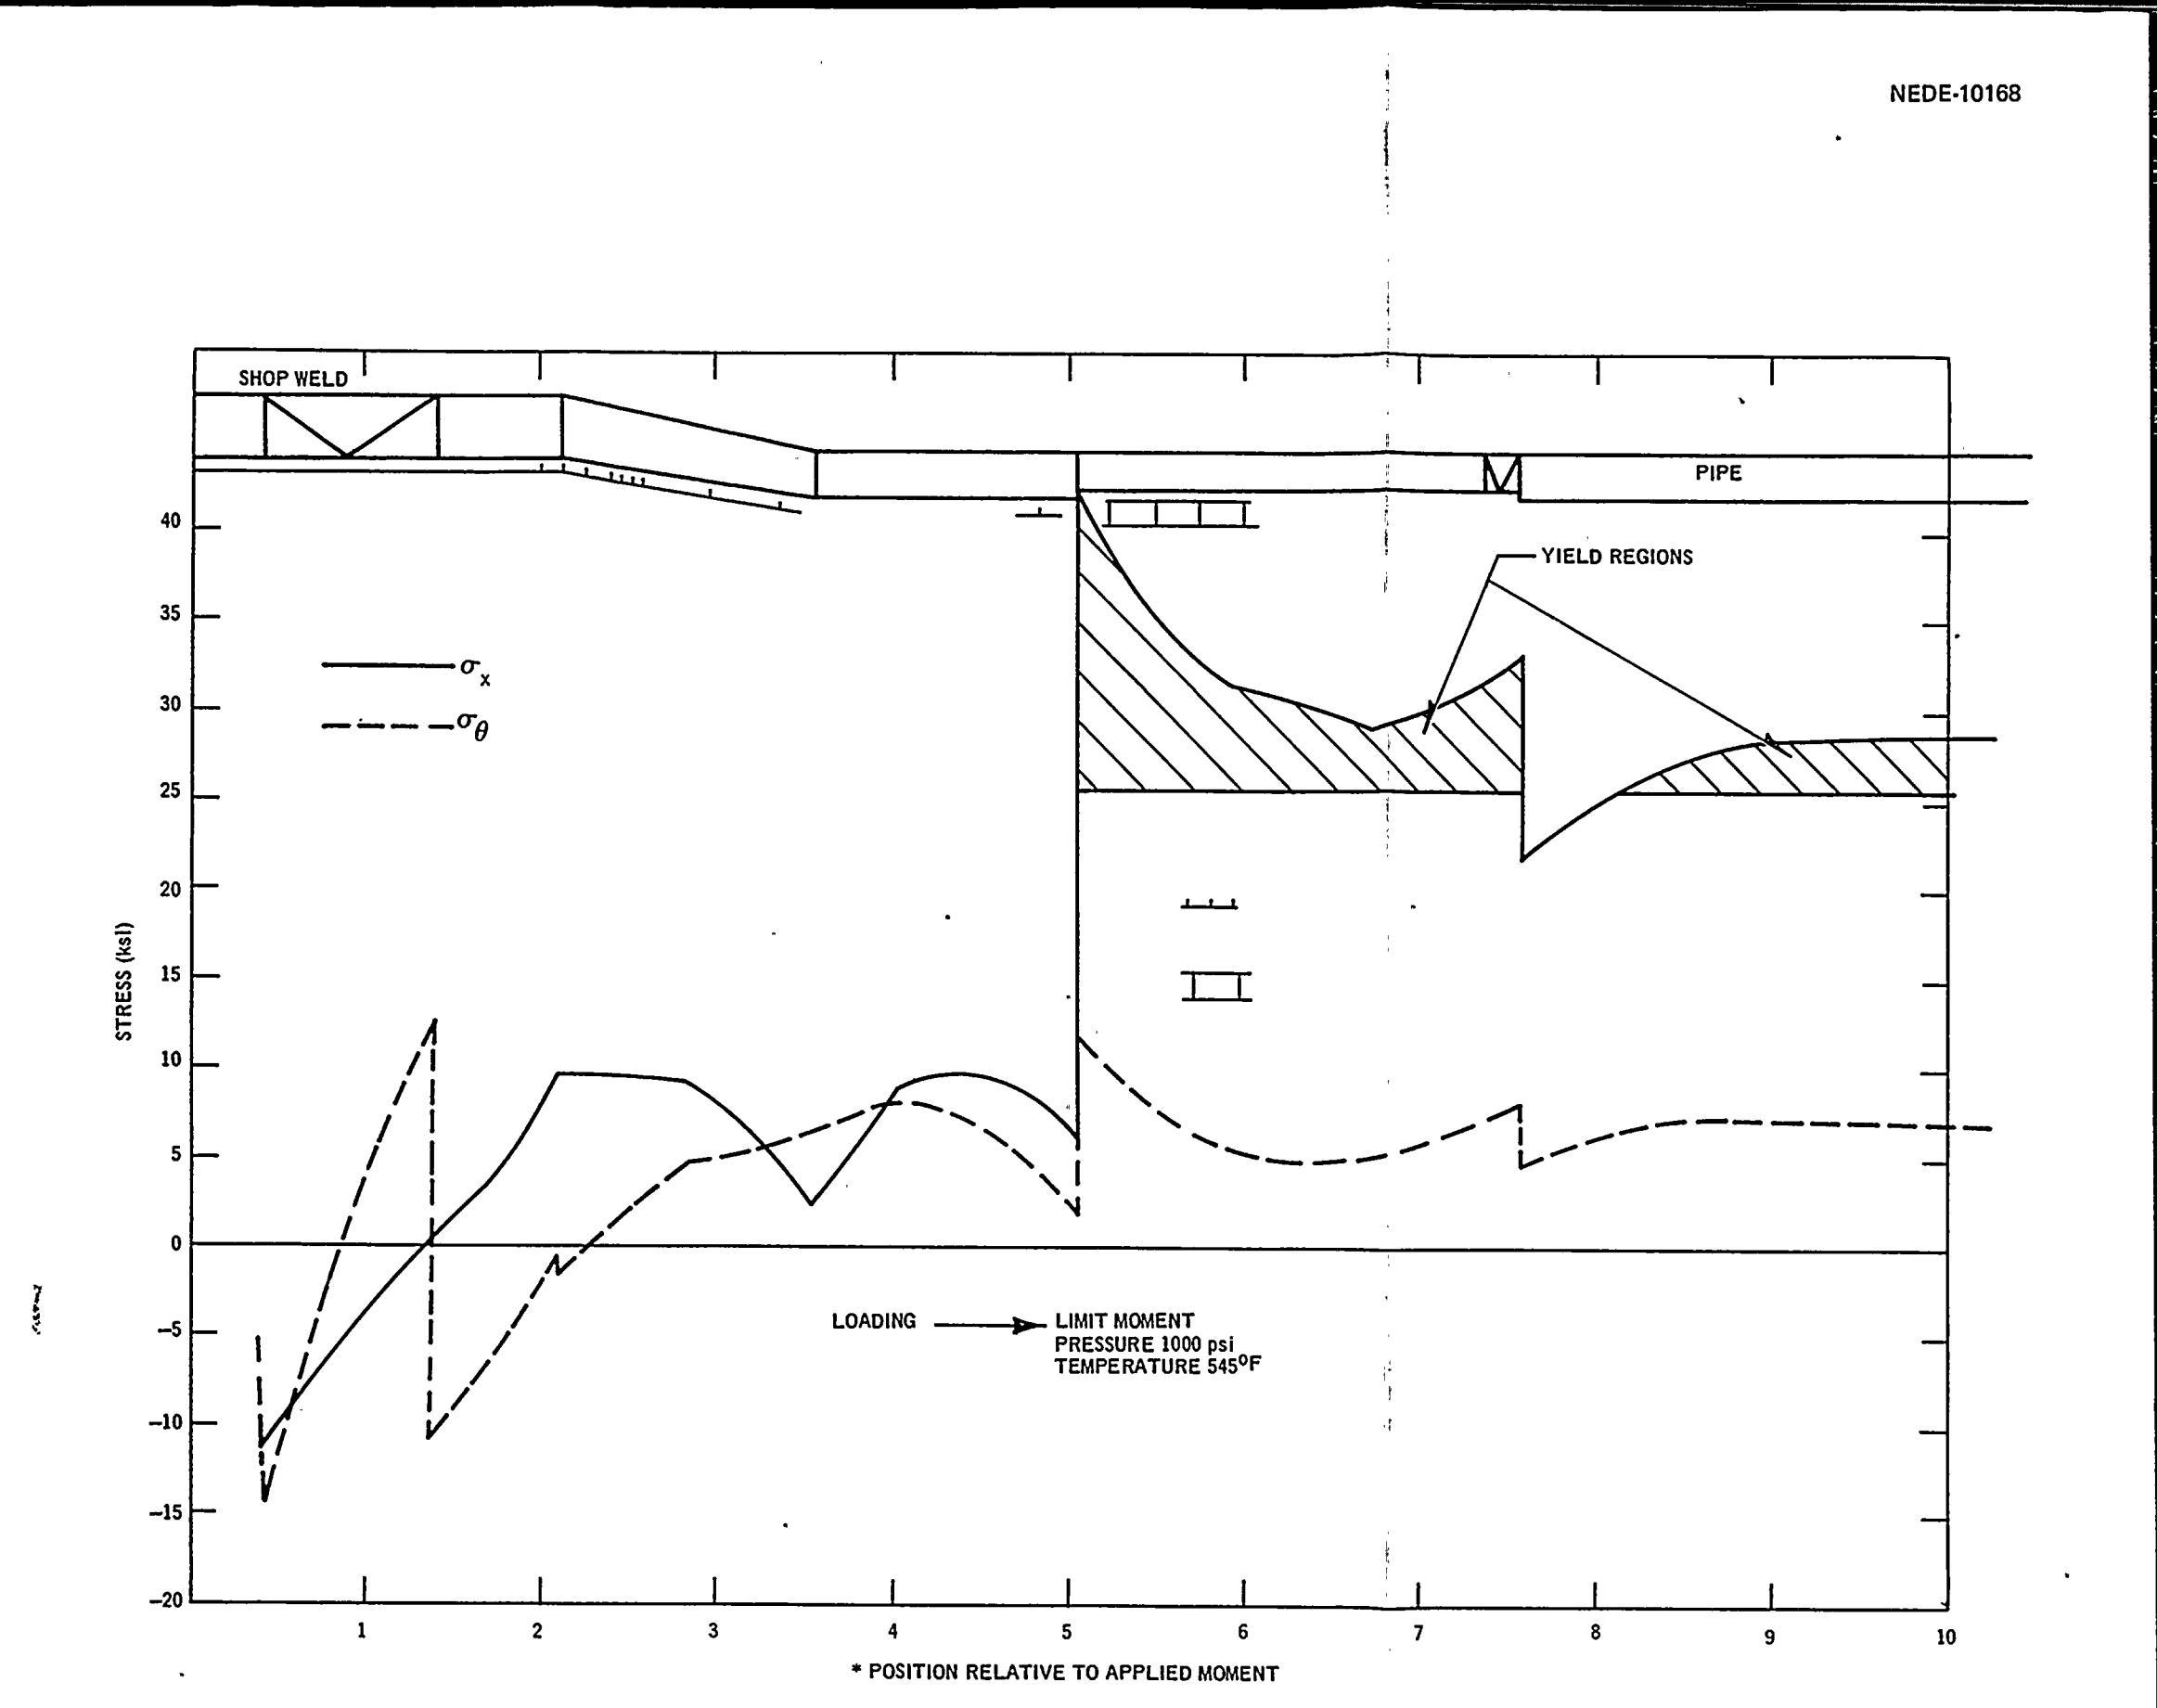
FIGURE 3-8. NINE MILE POINT N6B WEST CORE SPRAY NOZZLE-INSIDE SURFACE STRESSES 12 O'CLOCK POSITION

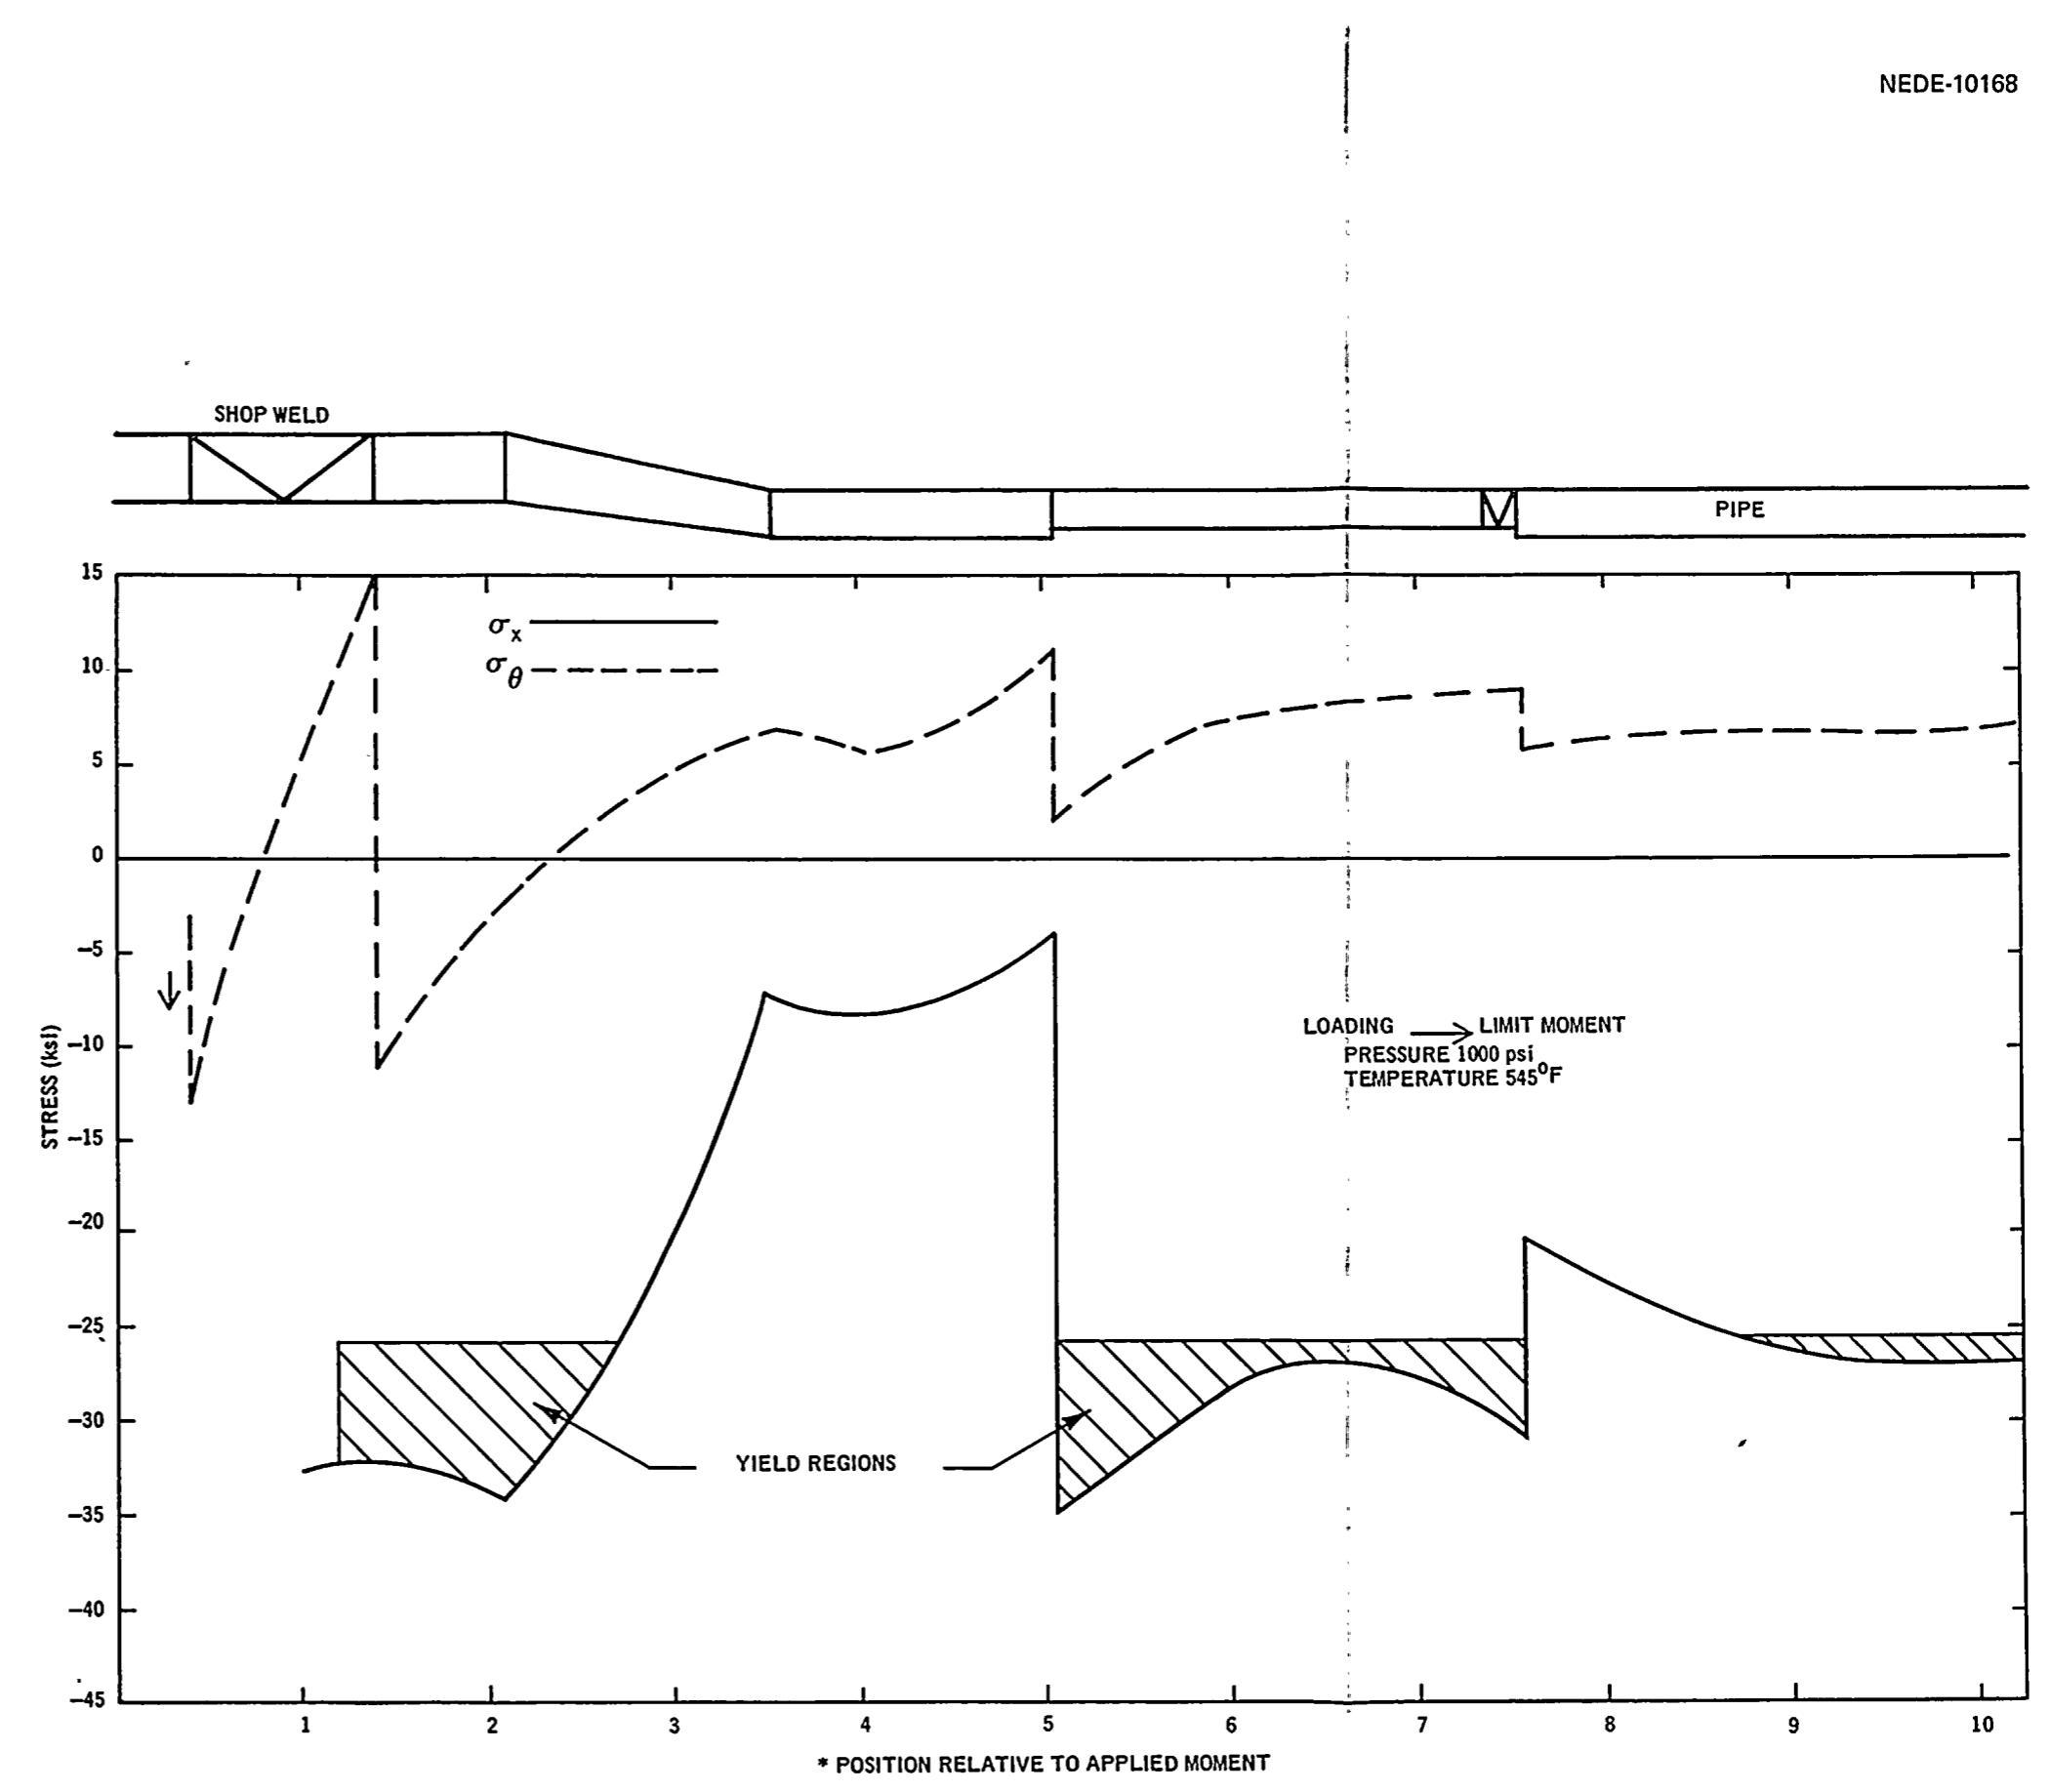
FIGURE 3-10. NINE MILE POINT N6B WEST CORE SPRAY NOZZLE-INSIDE SURFACE STRESSES 6 O'CLOCK POSITION

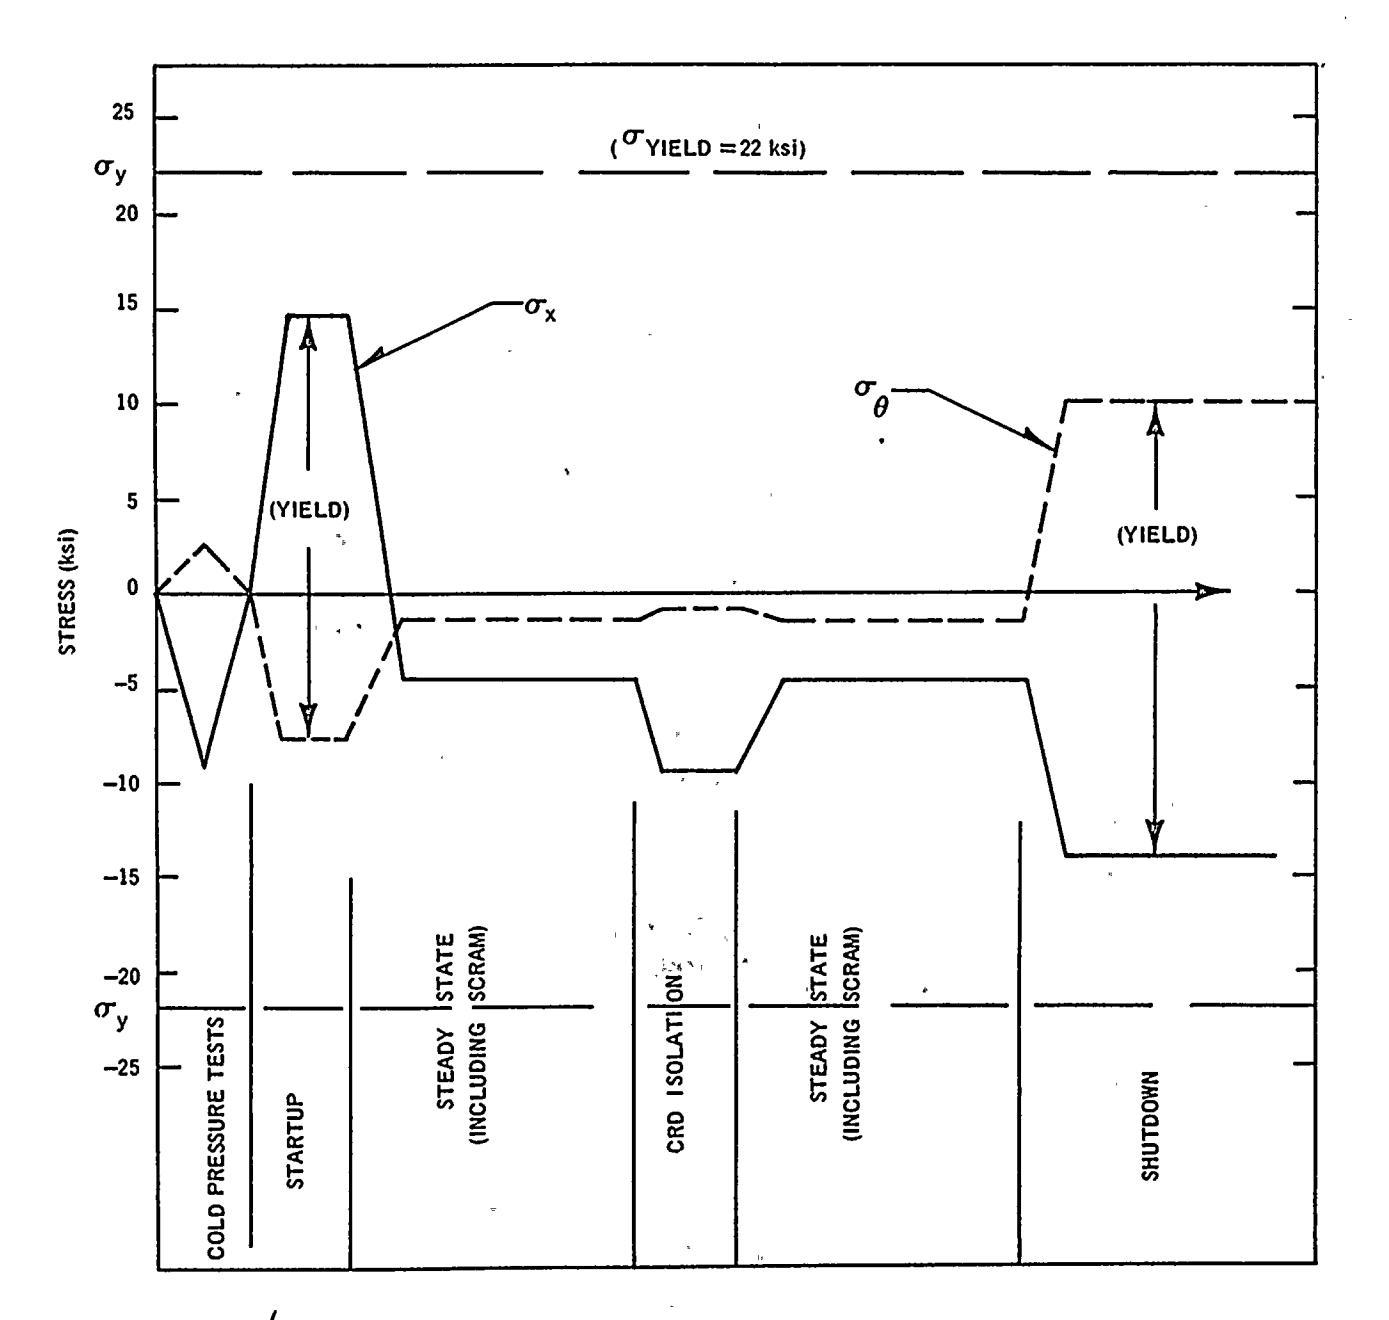
STRESS VALUE OF σ_x, σ_θ WILL CHANGE WITH CONTINUING CYCLES DUE TO COMBINED YIELD FAILURE

FIGURE 4-9. BOTTOM OF STUB TUBE (I.D. SURFACE) PEAK STRESS VERSUS TIME

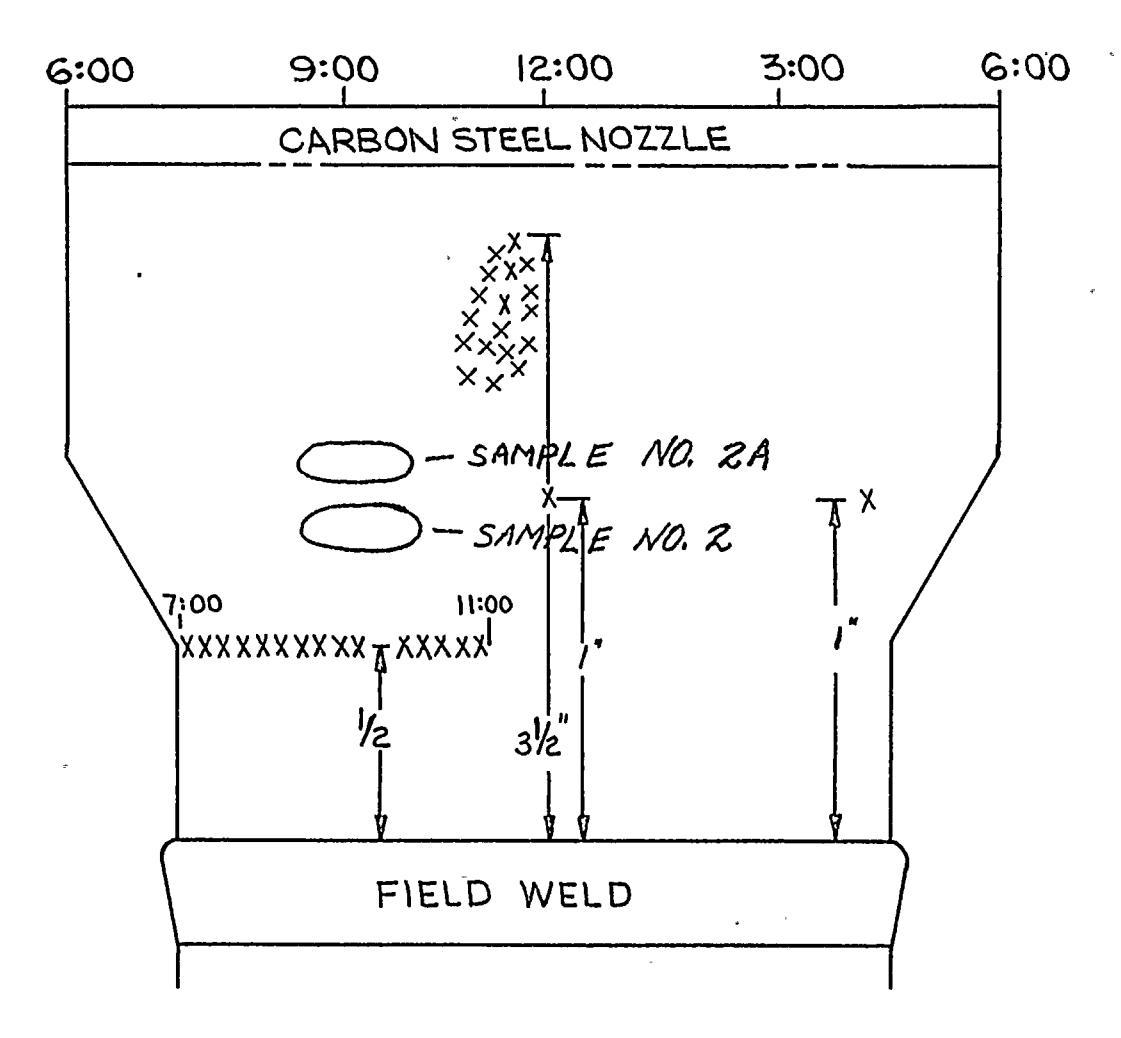
A sample was cut from the west emergency condenser nozzle safe end N5A after indications were disclosed on dye-penetrant examination. Photo microscopy indicated intergranular attack to a maximum depth of 40 mils on the outside surface. TMR reported total longitudinal stress on the east and west emergency cooling steam line near the nozzle as 15,600 and 14,200 psi respectively. Double wall radiographs and ultrasonic probes disclosed no indication of internal cracking.

IDENTIFICATION: N5A-ISOLATION COND. SAFE END O.D. INSPECTION DATE: 3-11-70 BY: Original Ligned Ly M. Johnson Mar.

REMARKS: PHOTO 1-5 SHOWS LARGE AREA AS FOUND. 1-7.SHOWS LARGE AREA AFTER 15 GRIND 2-8 SHOWS LARGE AREA AFTER 30 MILL GRIND 2-9 SHOWS LARGE AREA WITHOUT DYE CHECK MAT'L PT PROCEDURE USED: 21A8570

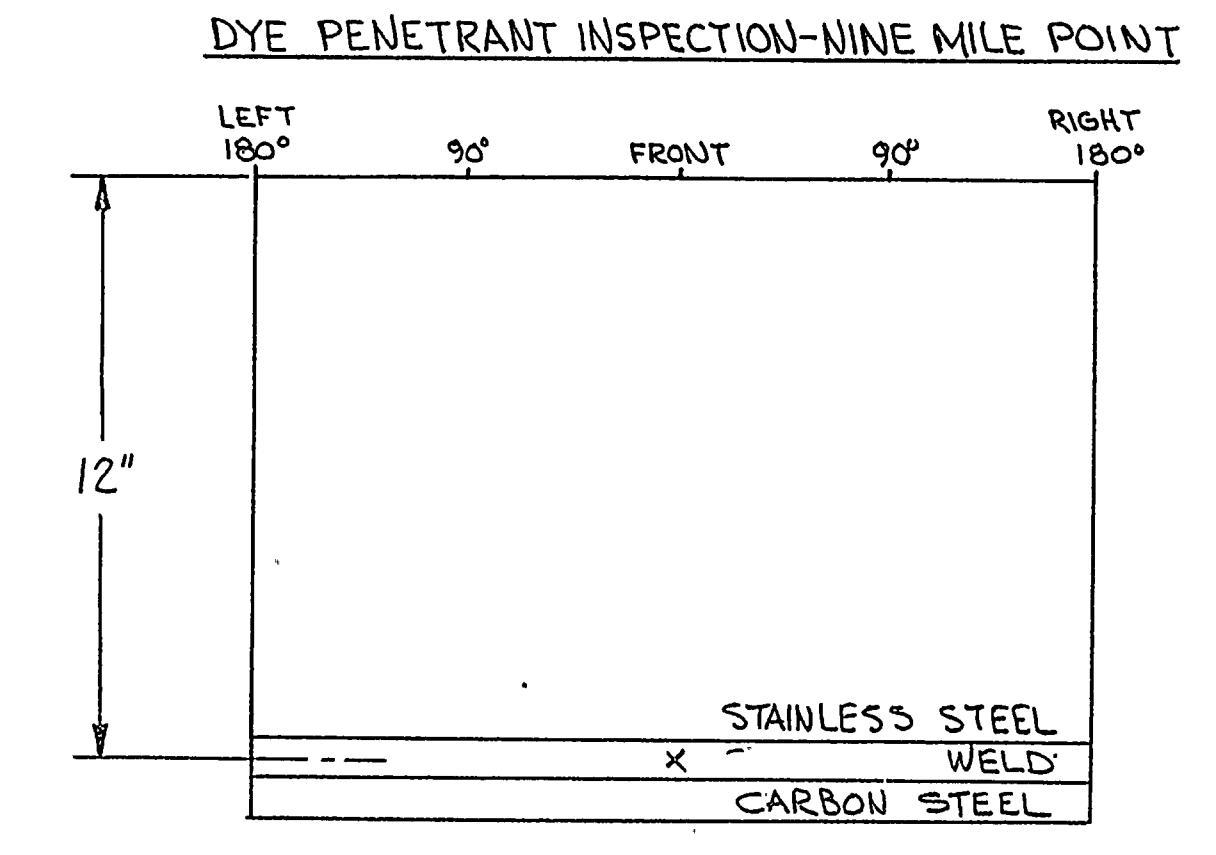
IDENTIFICATION: N7P-VESSEL HEAD SAFE END I.D. INSPECTION DATE: 3-29-70 BY: B.2. Lindeman

REMARKS: PHOTO 4-5 SHOWS FRONT INDICATION AFTER .020 GRIND INDICATION GETTING SMALLER

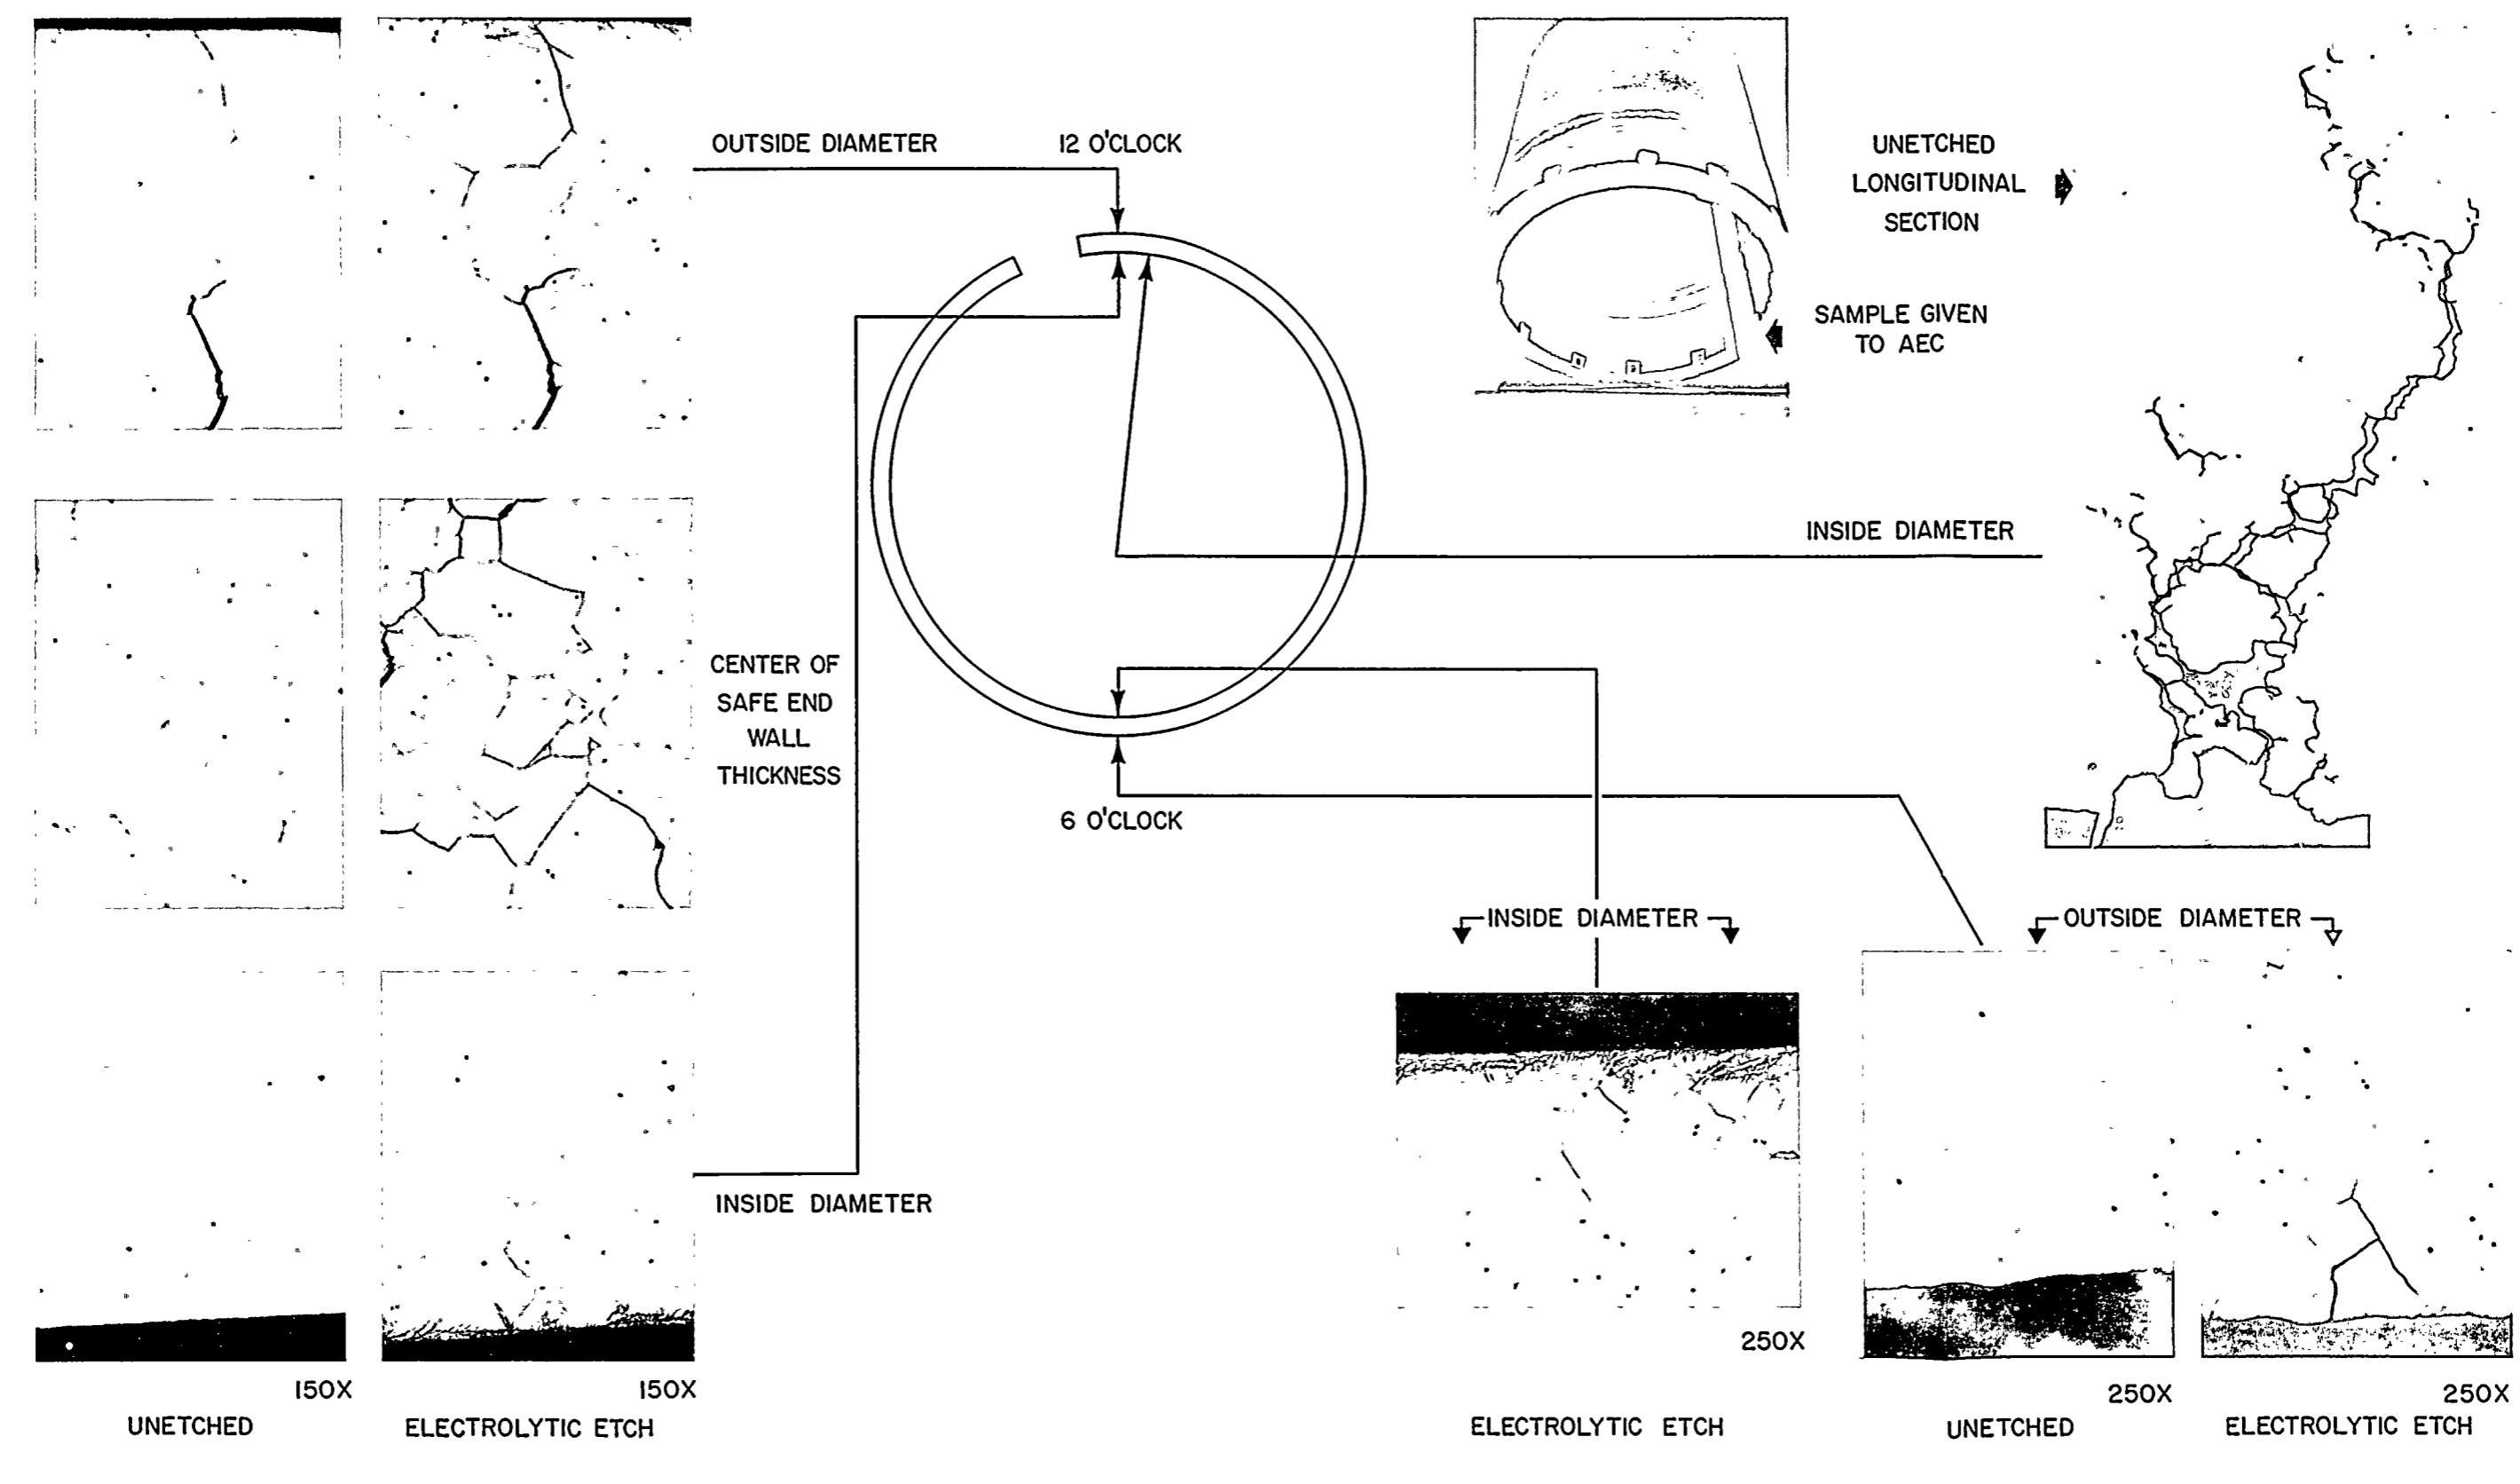
METALLOGRAPHY OF SAMPLE NO. 1, CORE FIGURE C-1 SPRAY NOZZLE SAFE END N6B (PIPE END)

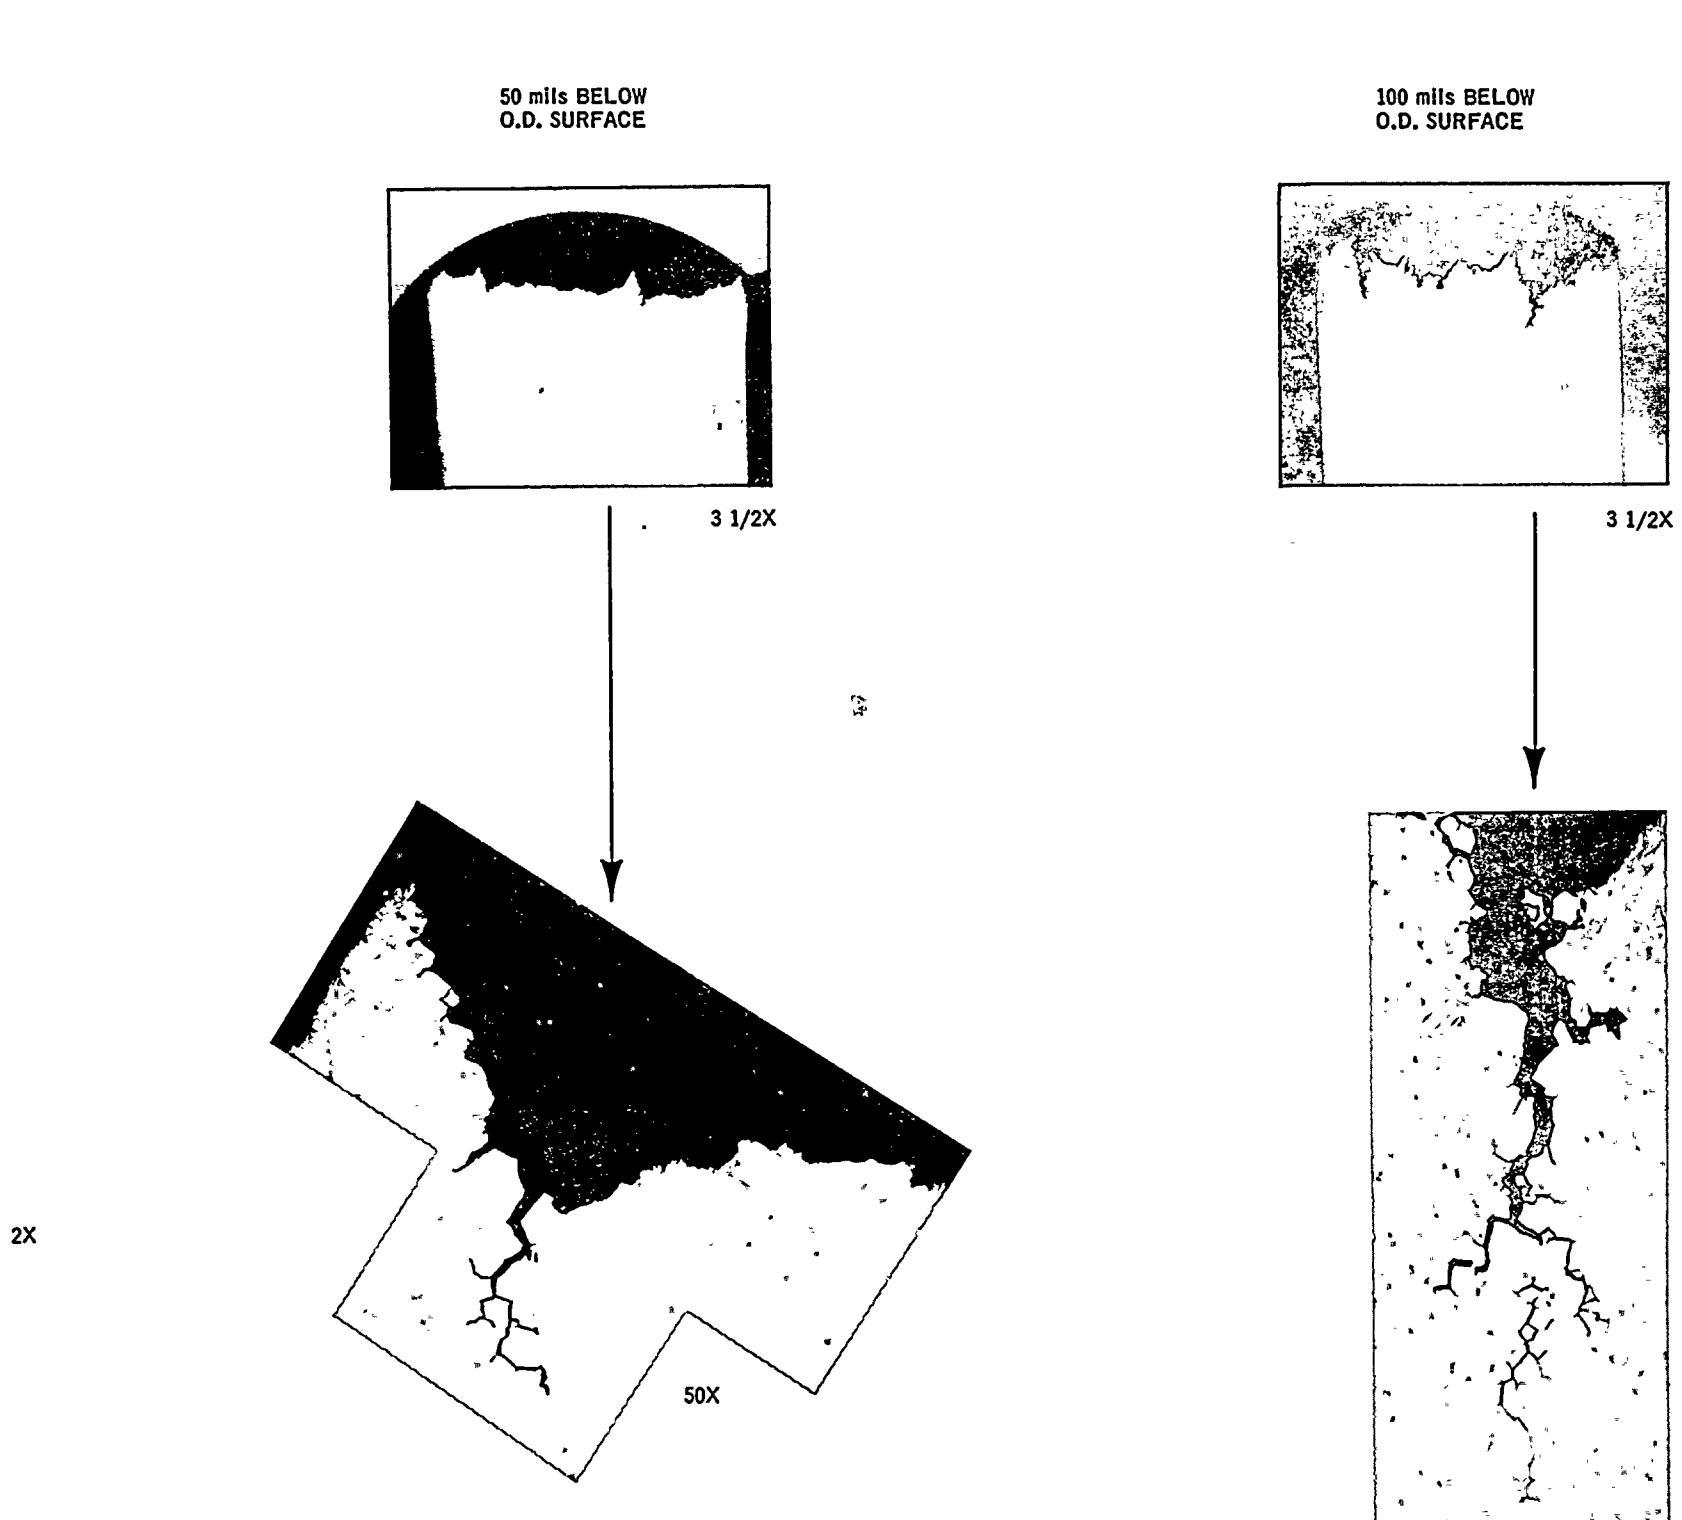
MORPHOLOGY OF AXIAL CRACKS IN FAILED FIGURE C-3. SAFE END - SAMPLE NO. 1

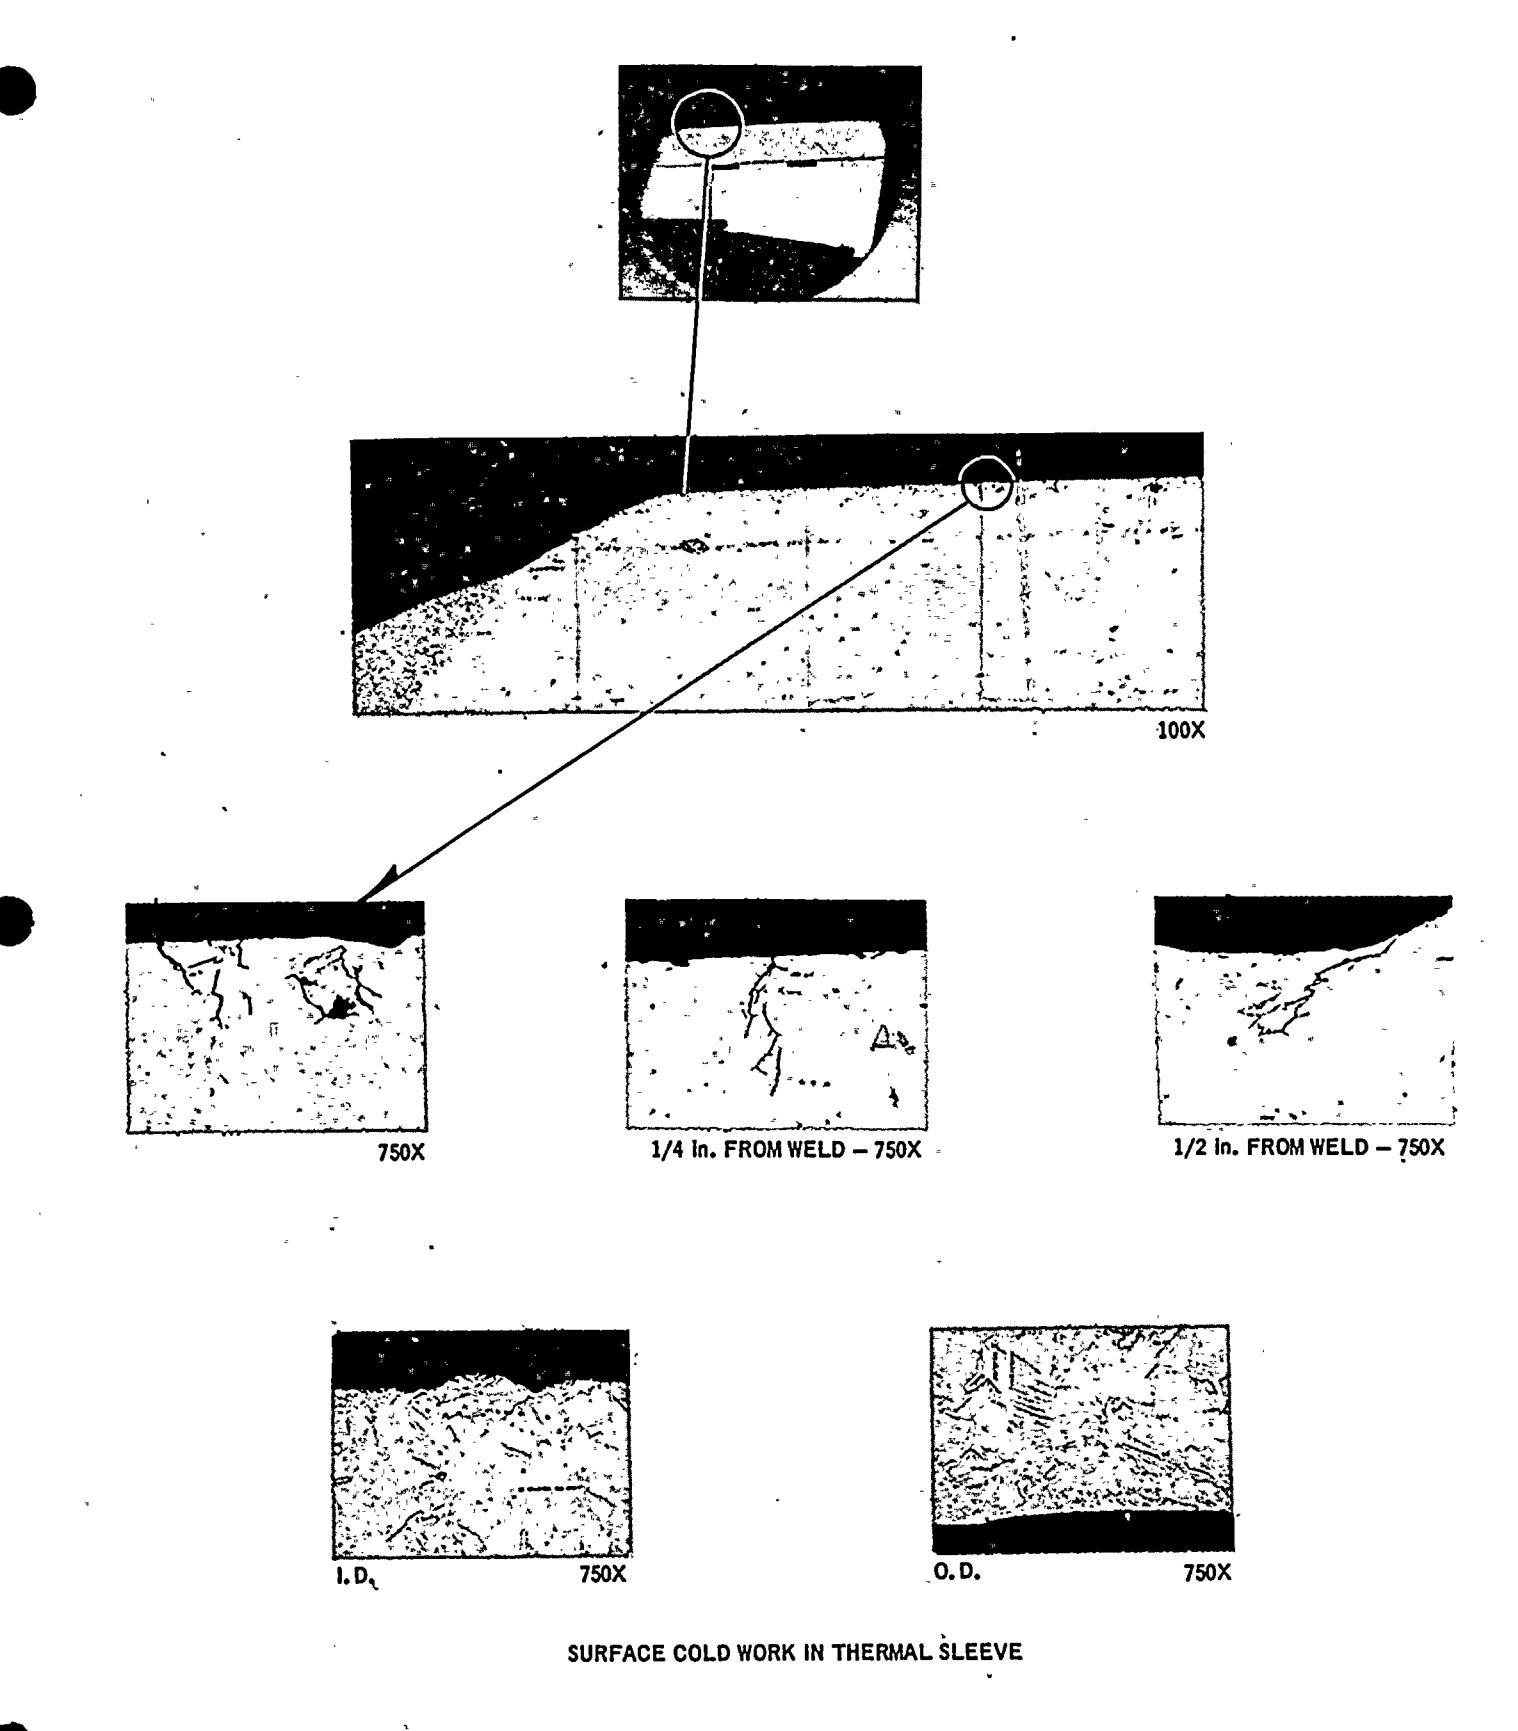
FIGURE C-6. METALLOGRAPHY OF SAMPLE NO.4 THERMAL SLEEVE CORE SPRAY LOCATION N6B . .
