REACTOR PRIMARY SYSTEM INVESTIGATION

AT NINE MILE POINT NUCLEAR STATION

May 1, 1970

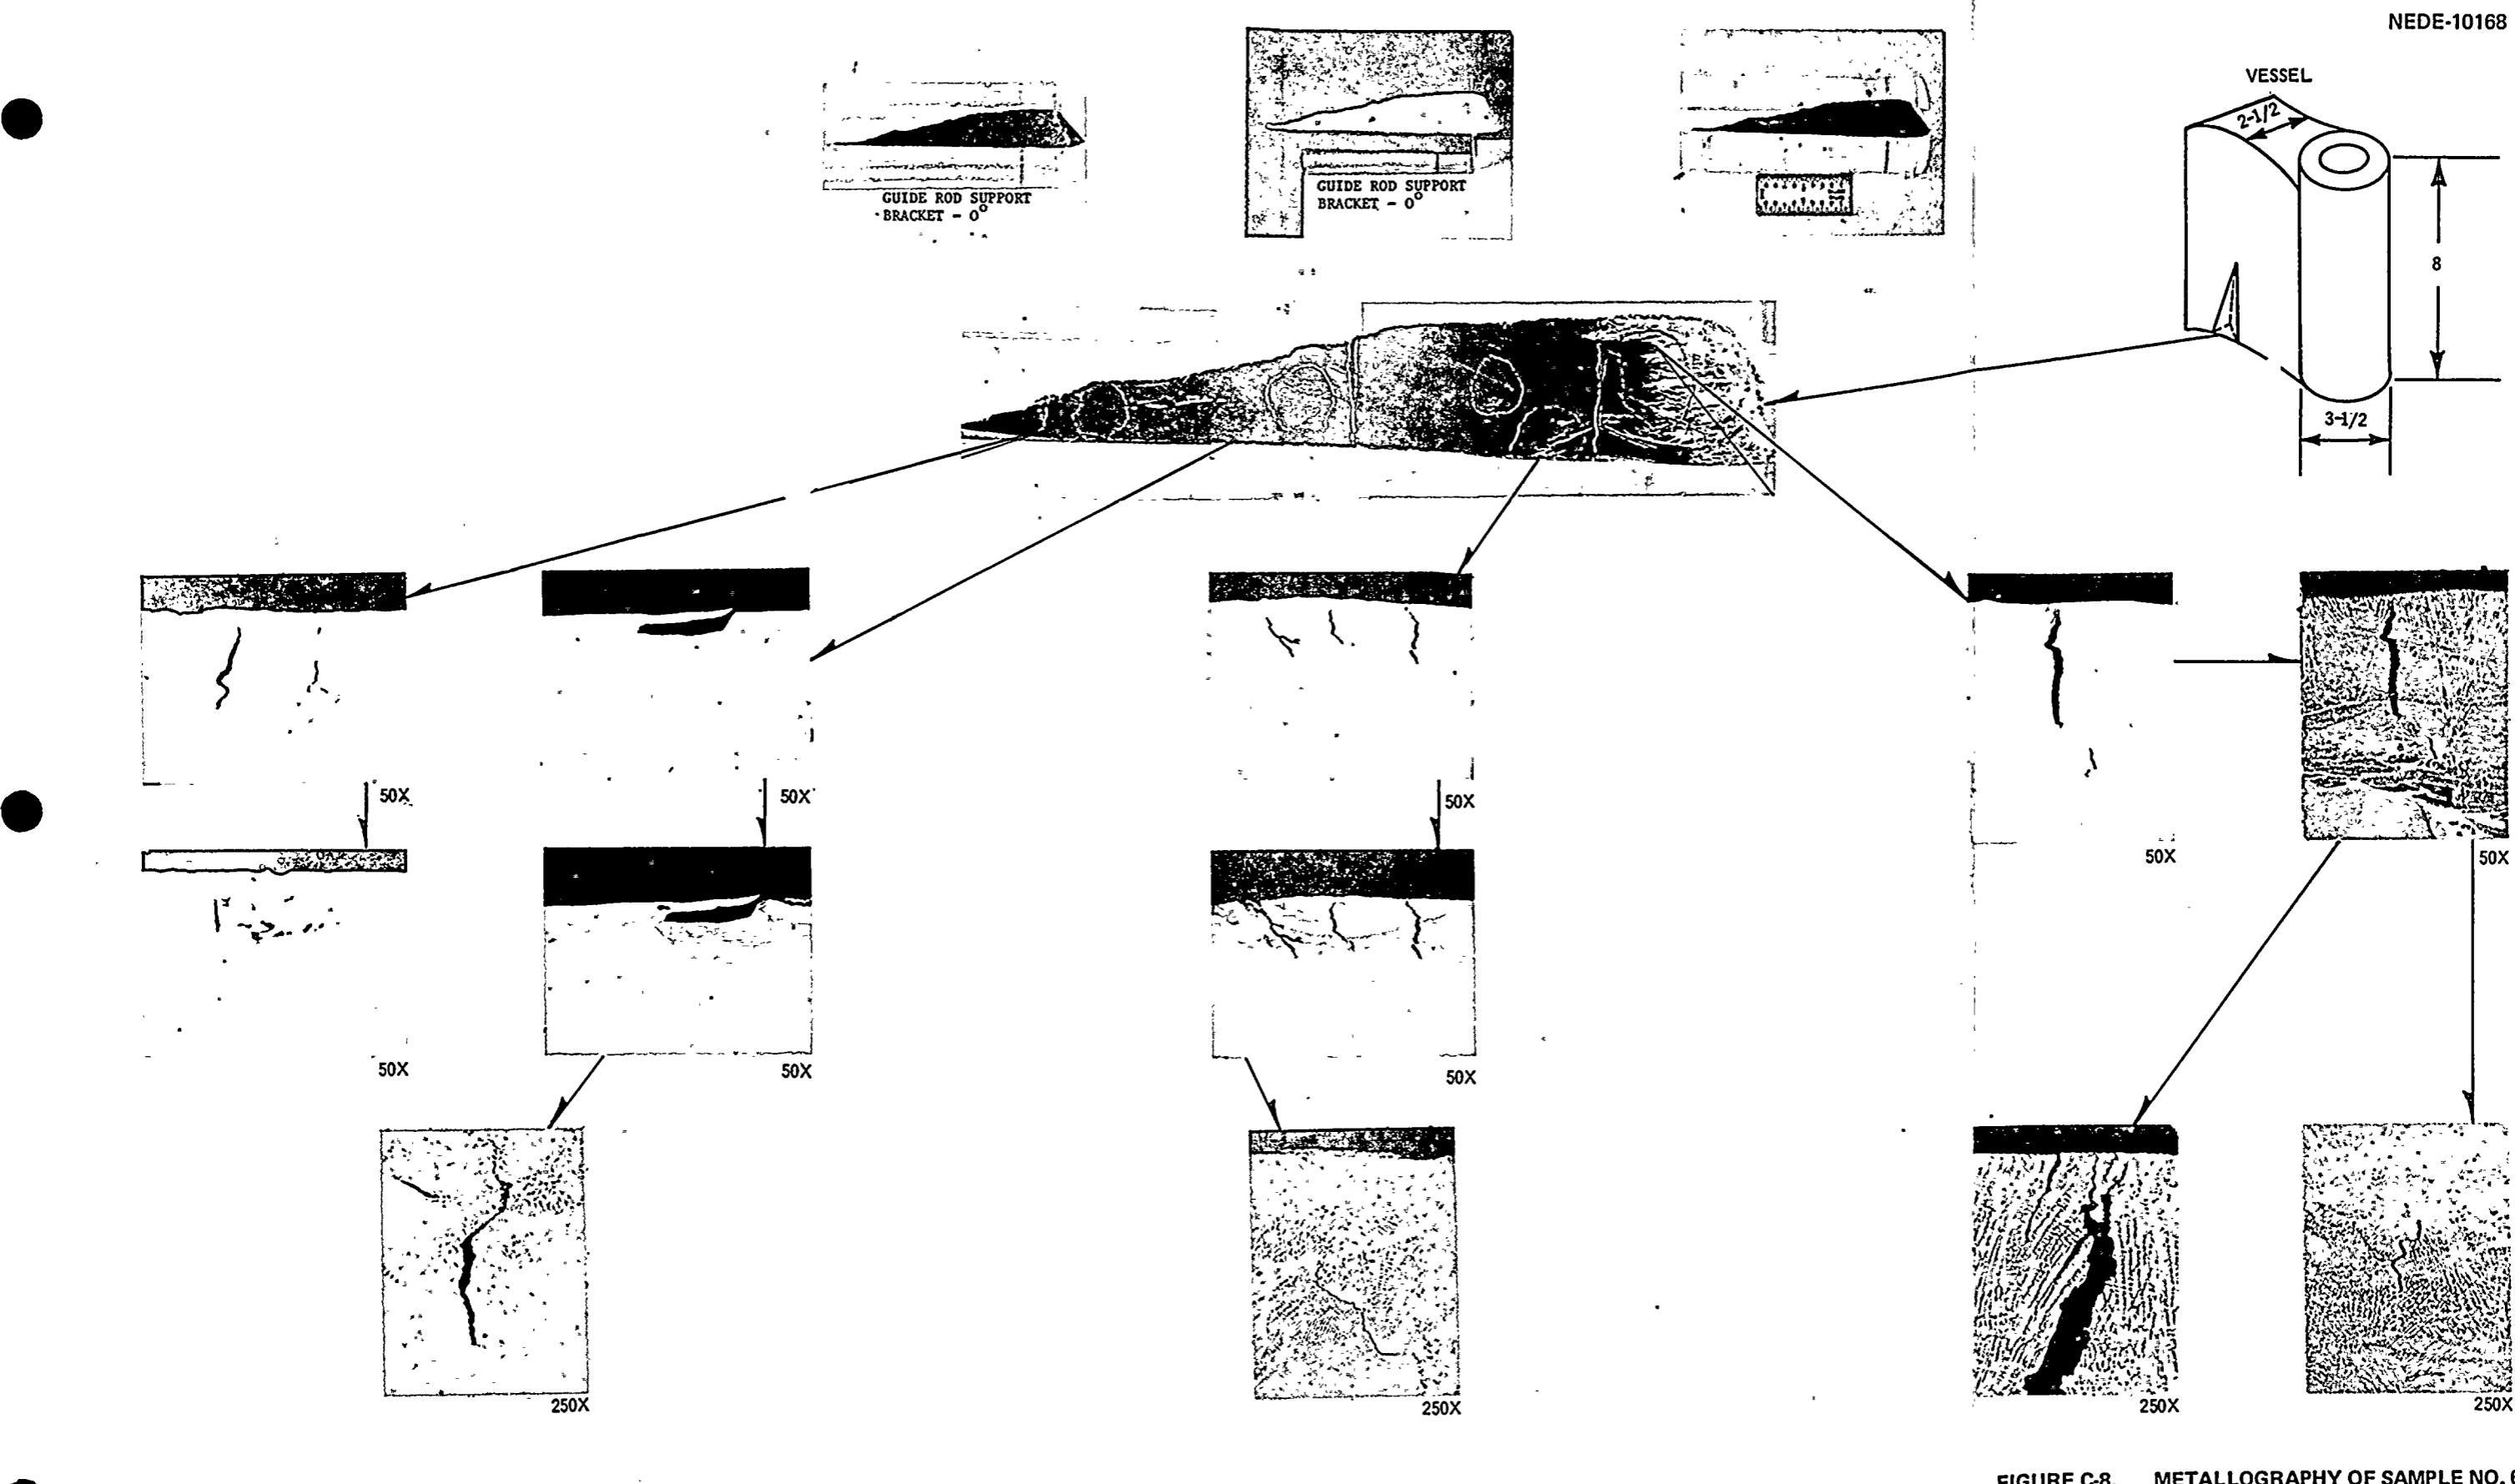
A sample removed from the guide rod support bracket consisted of weld metal which contained interdendritic fissuring. This appears to have been caused by hot tearing during the welding process.

FIGURE C-8. METALLOGRAPHY OF SAMPLE NO. 6 GUIDE ROD SUPPORT BRACKET-0° WEDGE SAMPLE

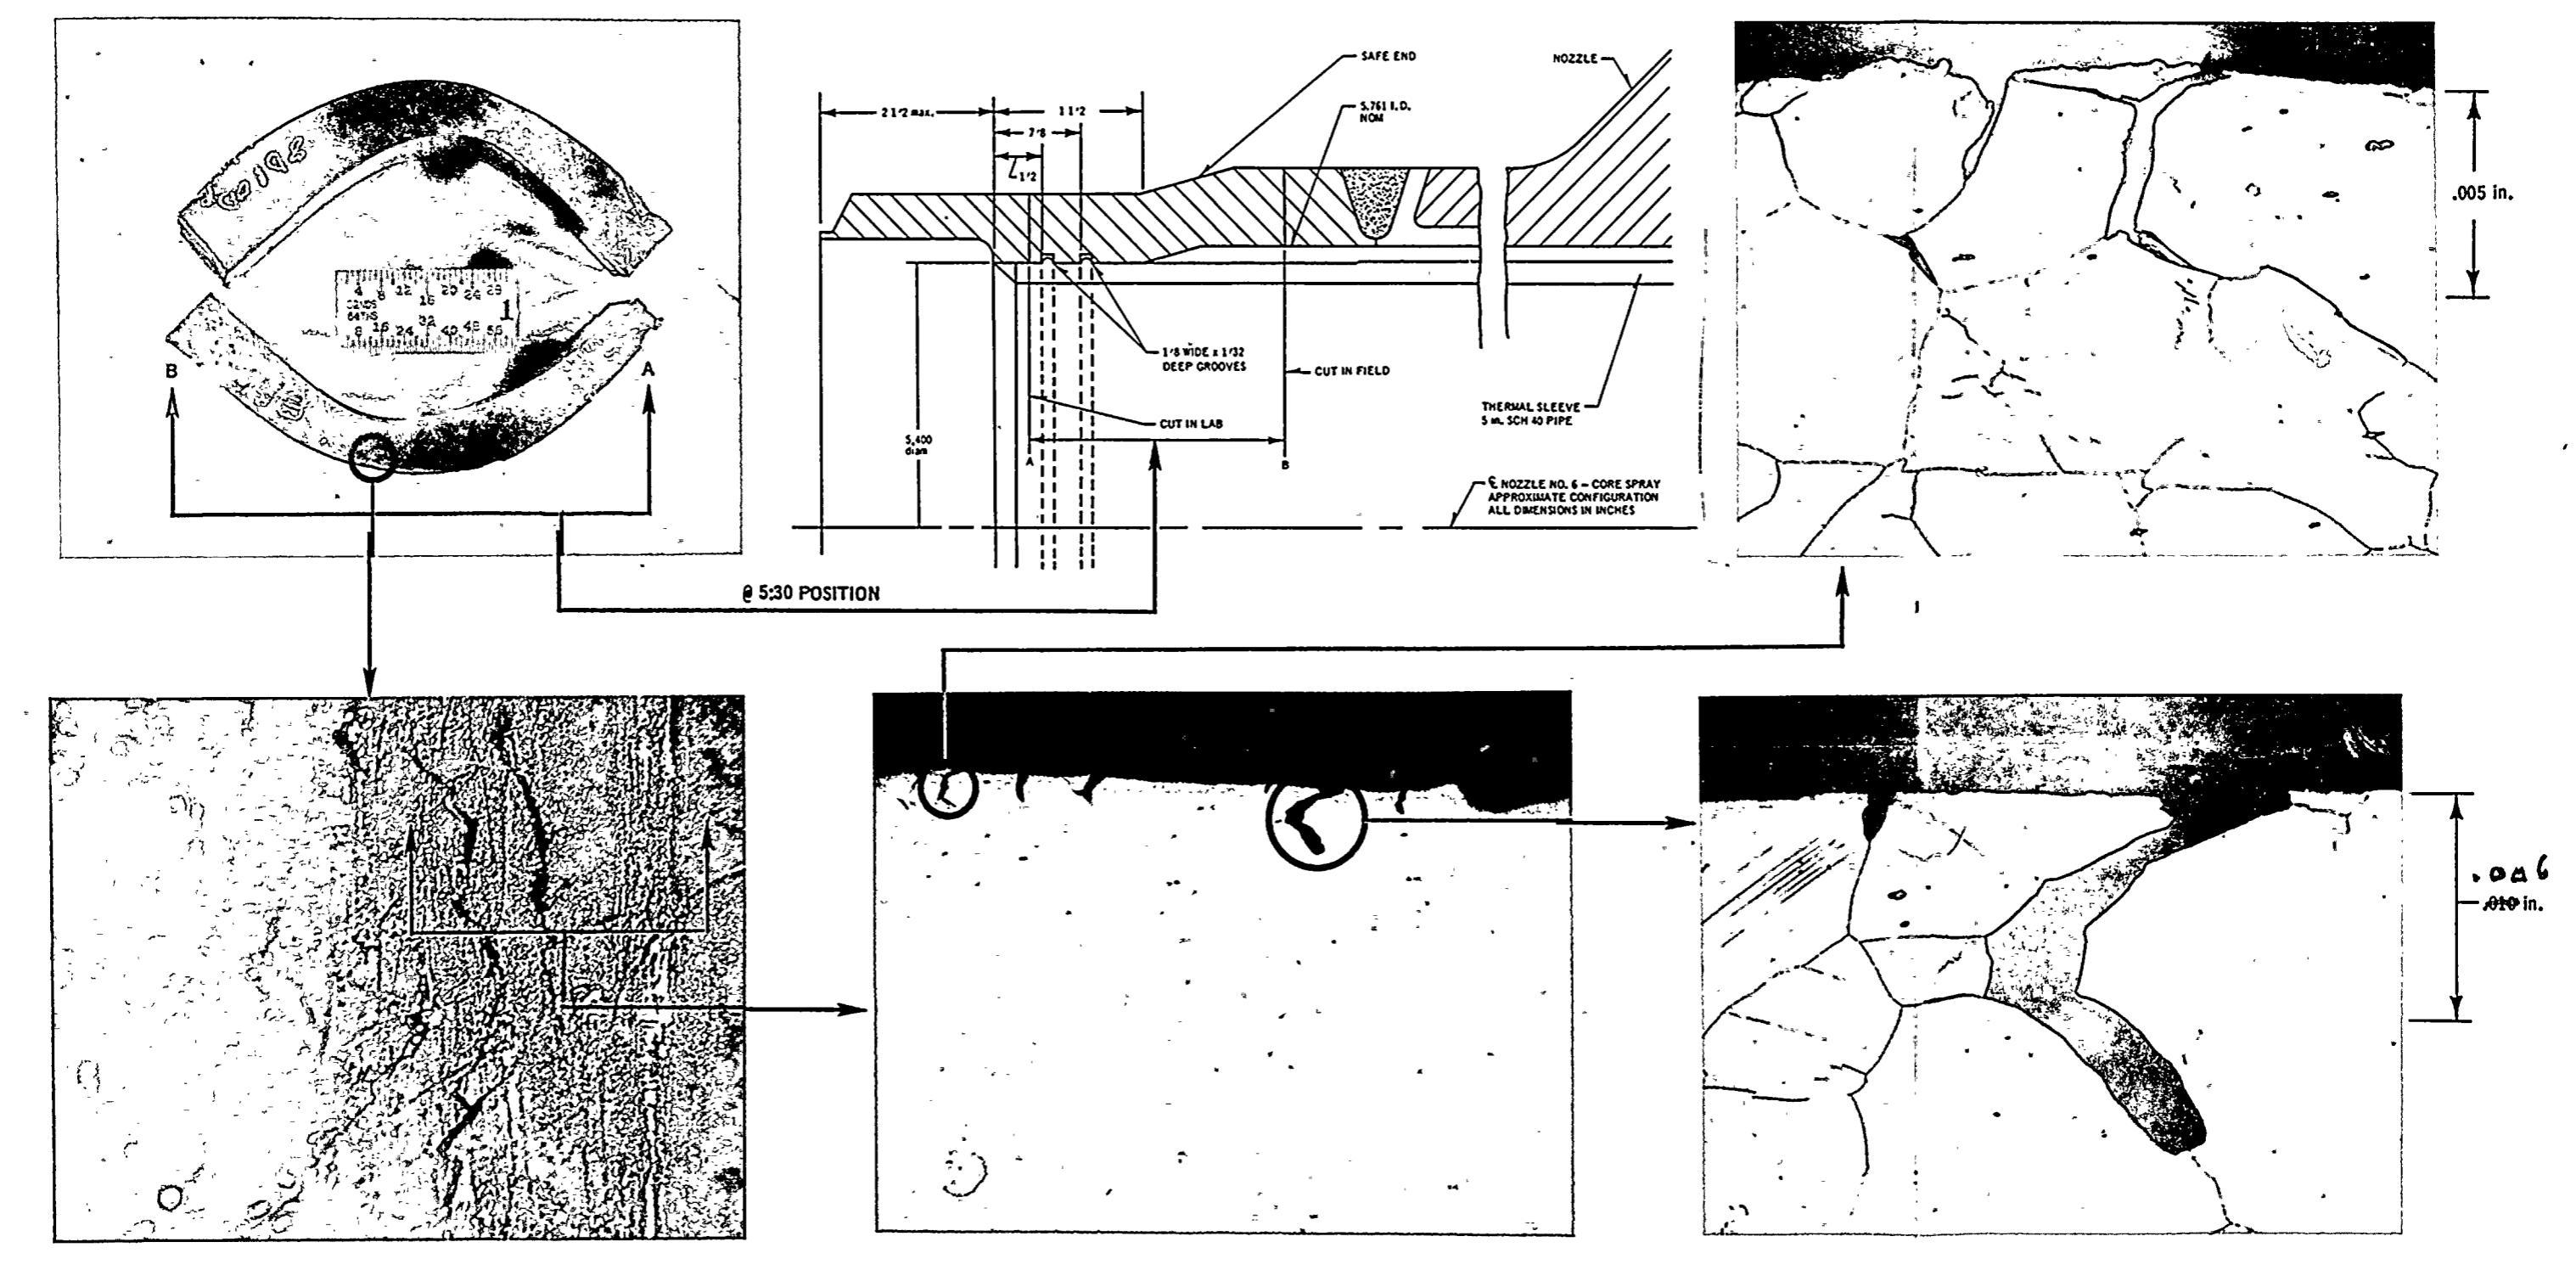
Fig 6

METALLOGRAPHY OF SAMPLE #7 INSIDE SURFACE OF CORE SPRAY SAFE END NGA - BEND SAMPLE OF THICK END.

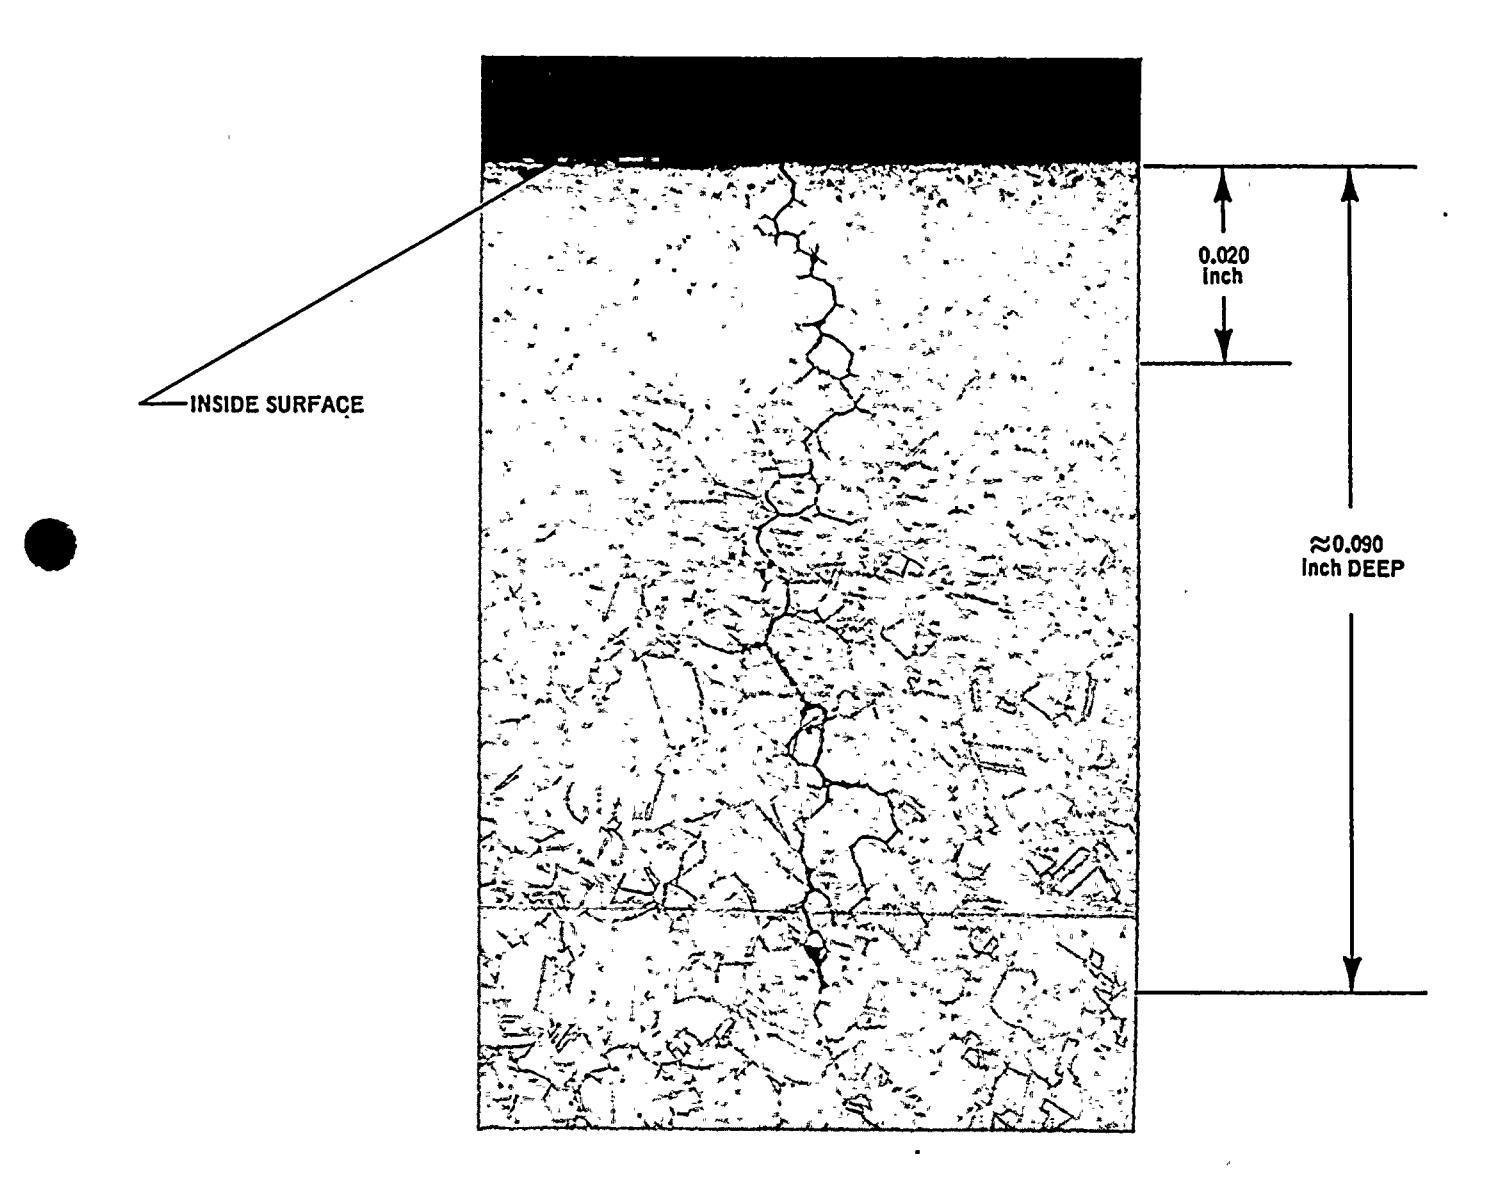
Fig 8

INTERGRANULAR CRACK IN PIPE MATERIAL LOCATED 1/4 inch FROM FIELD WELD ATTACHING PIPE TO CORE SPRAY SAFE END N6A - 5 O'CLOCK POSITION

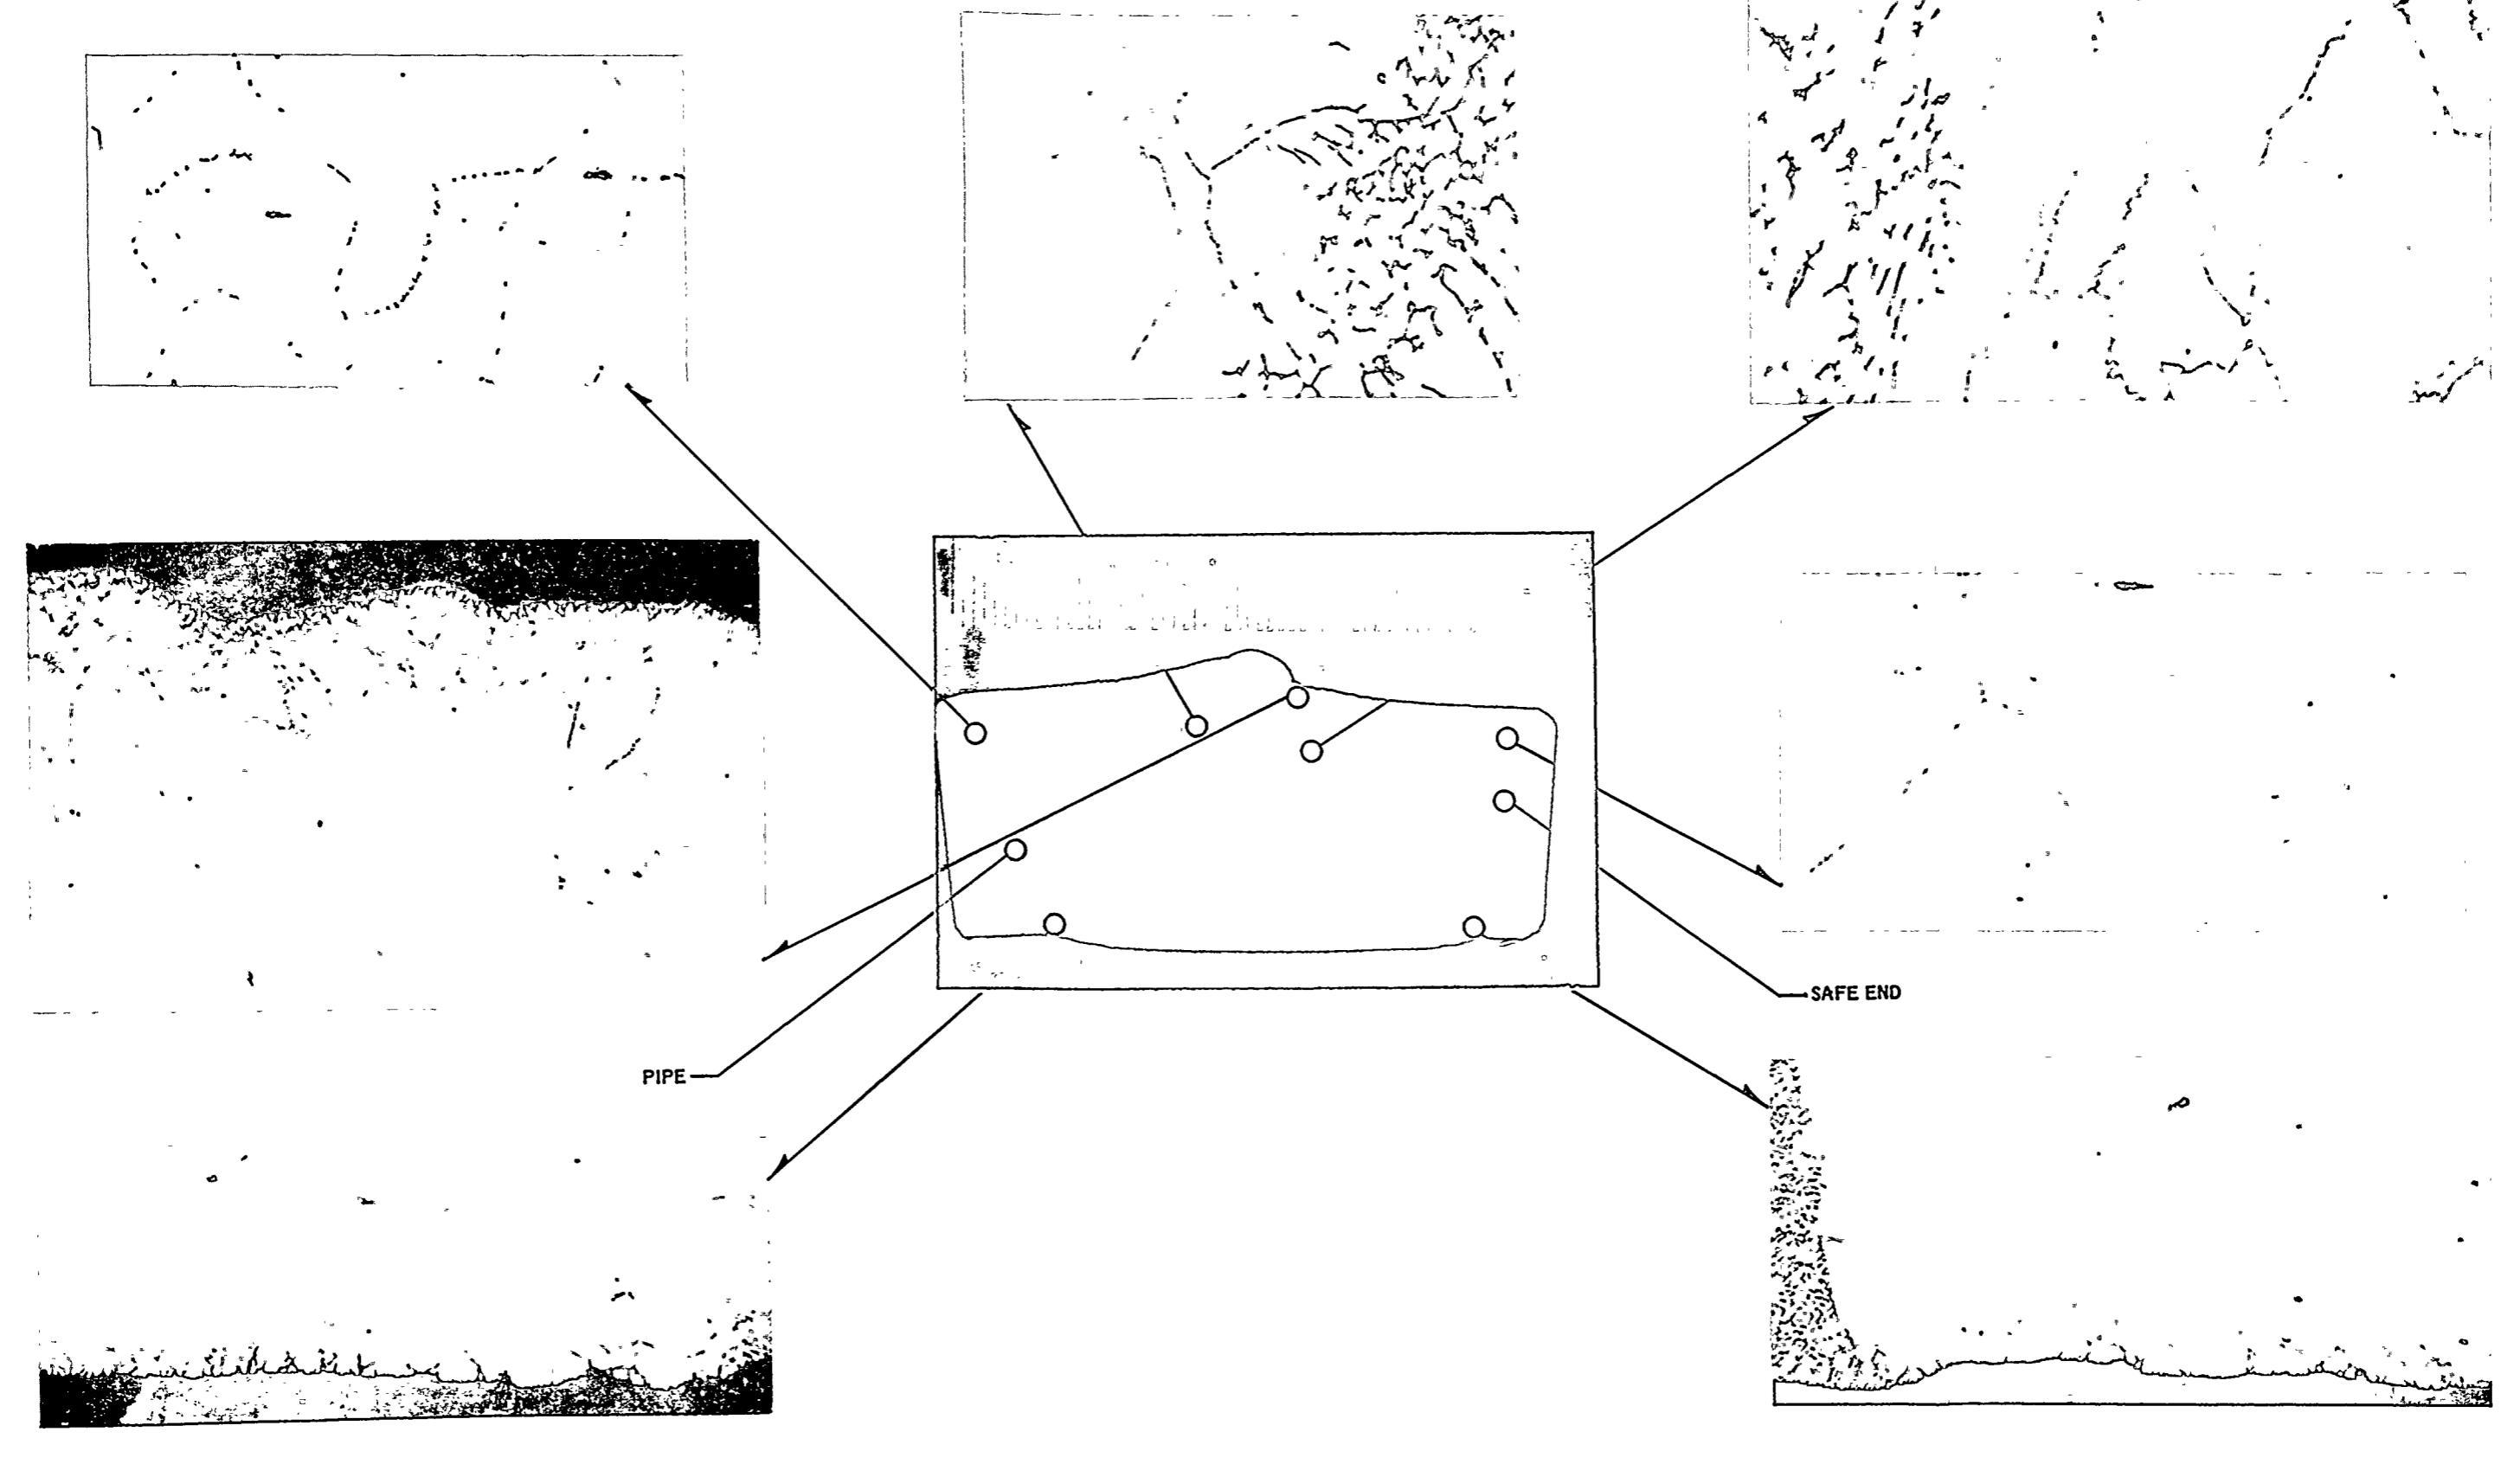
9 Fig

# METALLOGRAPHY OF FIELD WELD BETWEEN SAFE END AND PIPE ON CORE SPRAY N6A -2:15 O'CLOCK POSITION

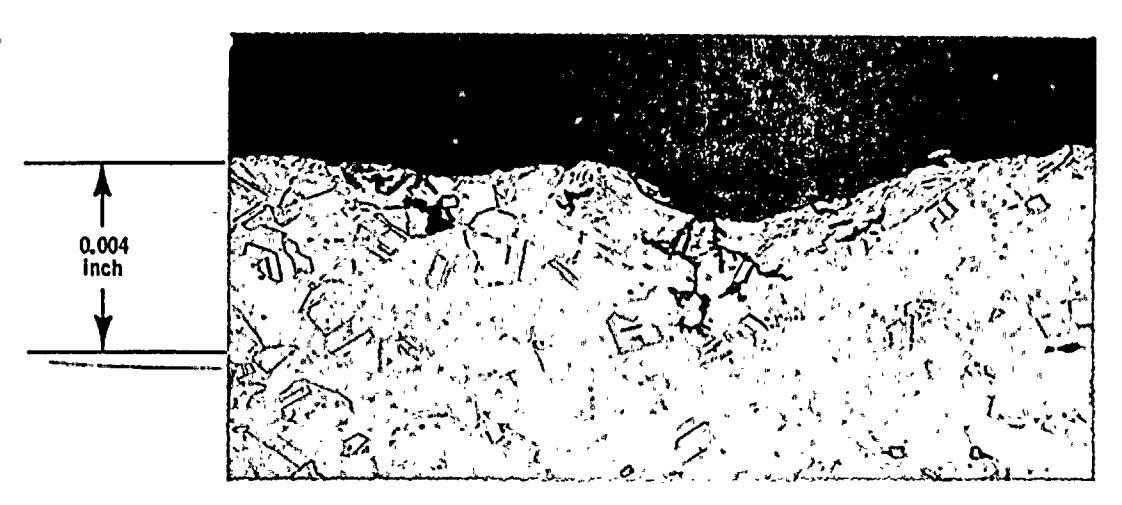
# TYPICAL EXAMPLES OF MIXED MODE CRACKING ON INSIDE DIAMETER OF THERMAL SLEEVE ATTACHED TO CORE SPRAY SAFE END N6A
