SUBJECT: LER 87-074-01: on 871219, unsatisfactory floor plug installation discovered in fire rated floor. Caused by const deficiency & personnel error. Fire watch patrols established in affected areas. W/880430 ltr.

RE: Docket No. 50-410 LER 87-74 Supplement 1

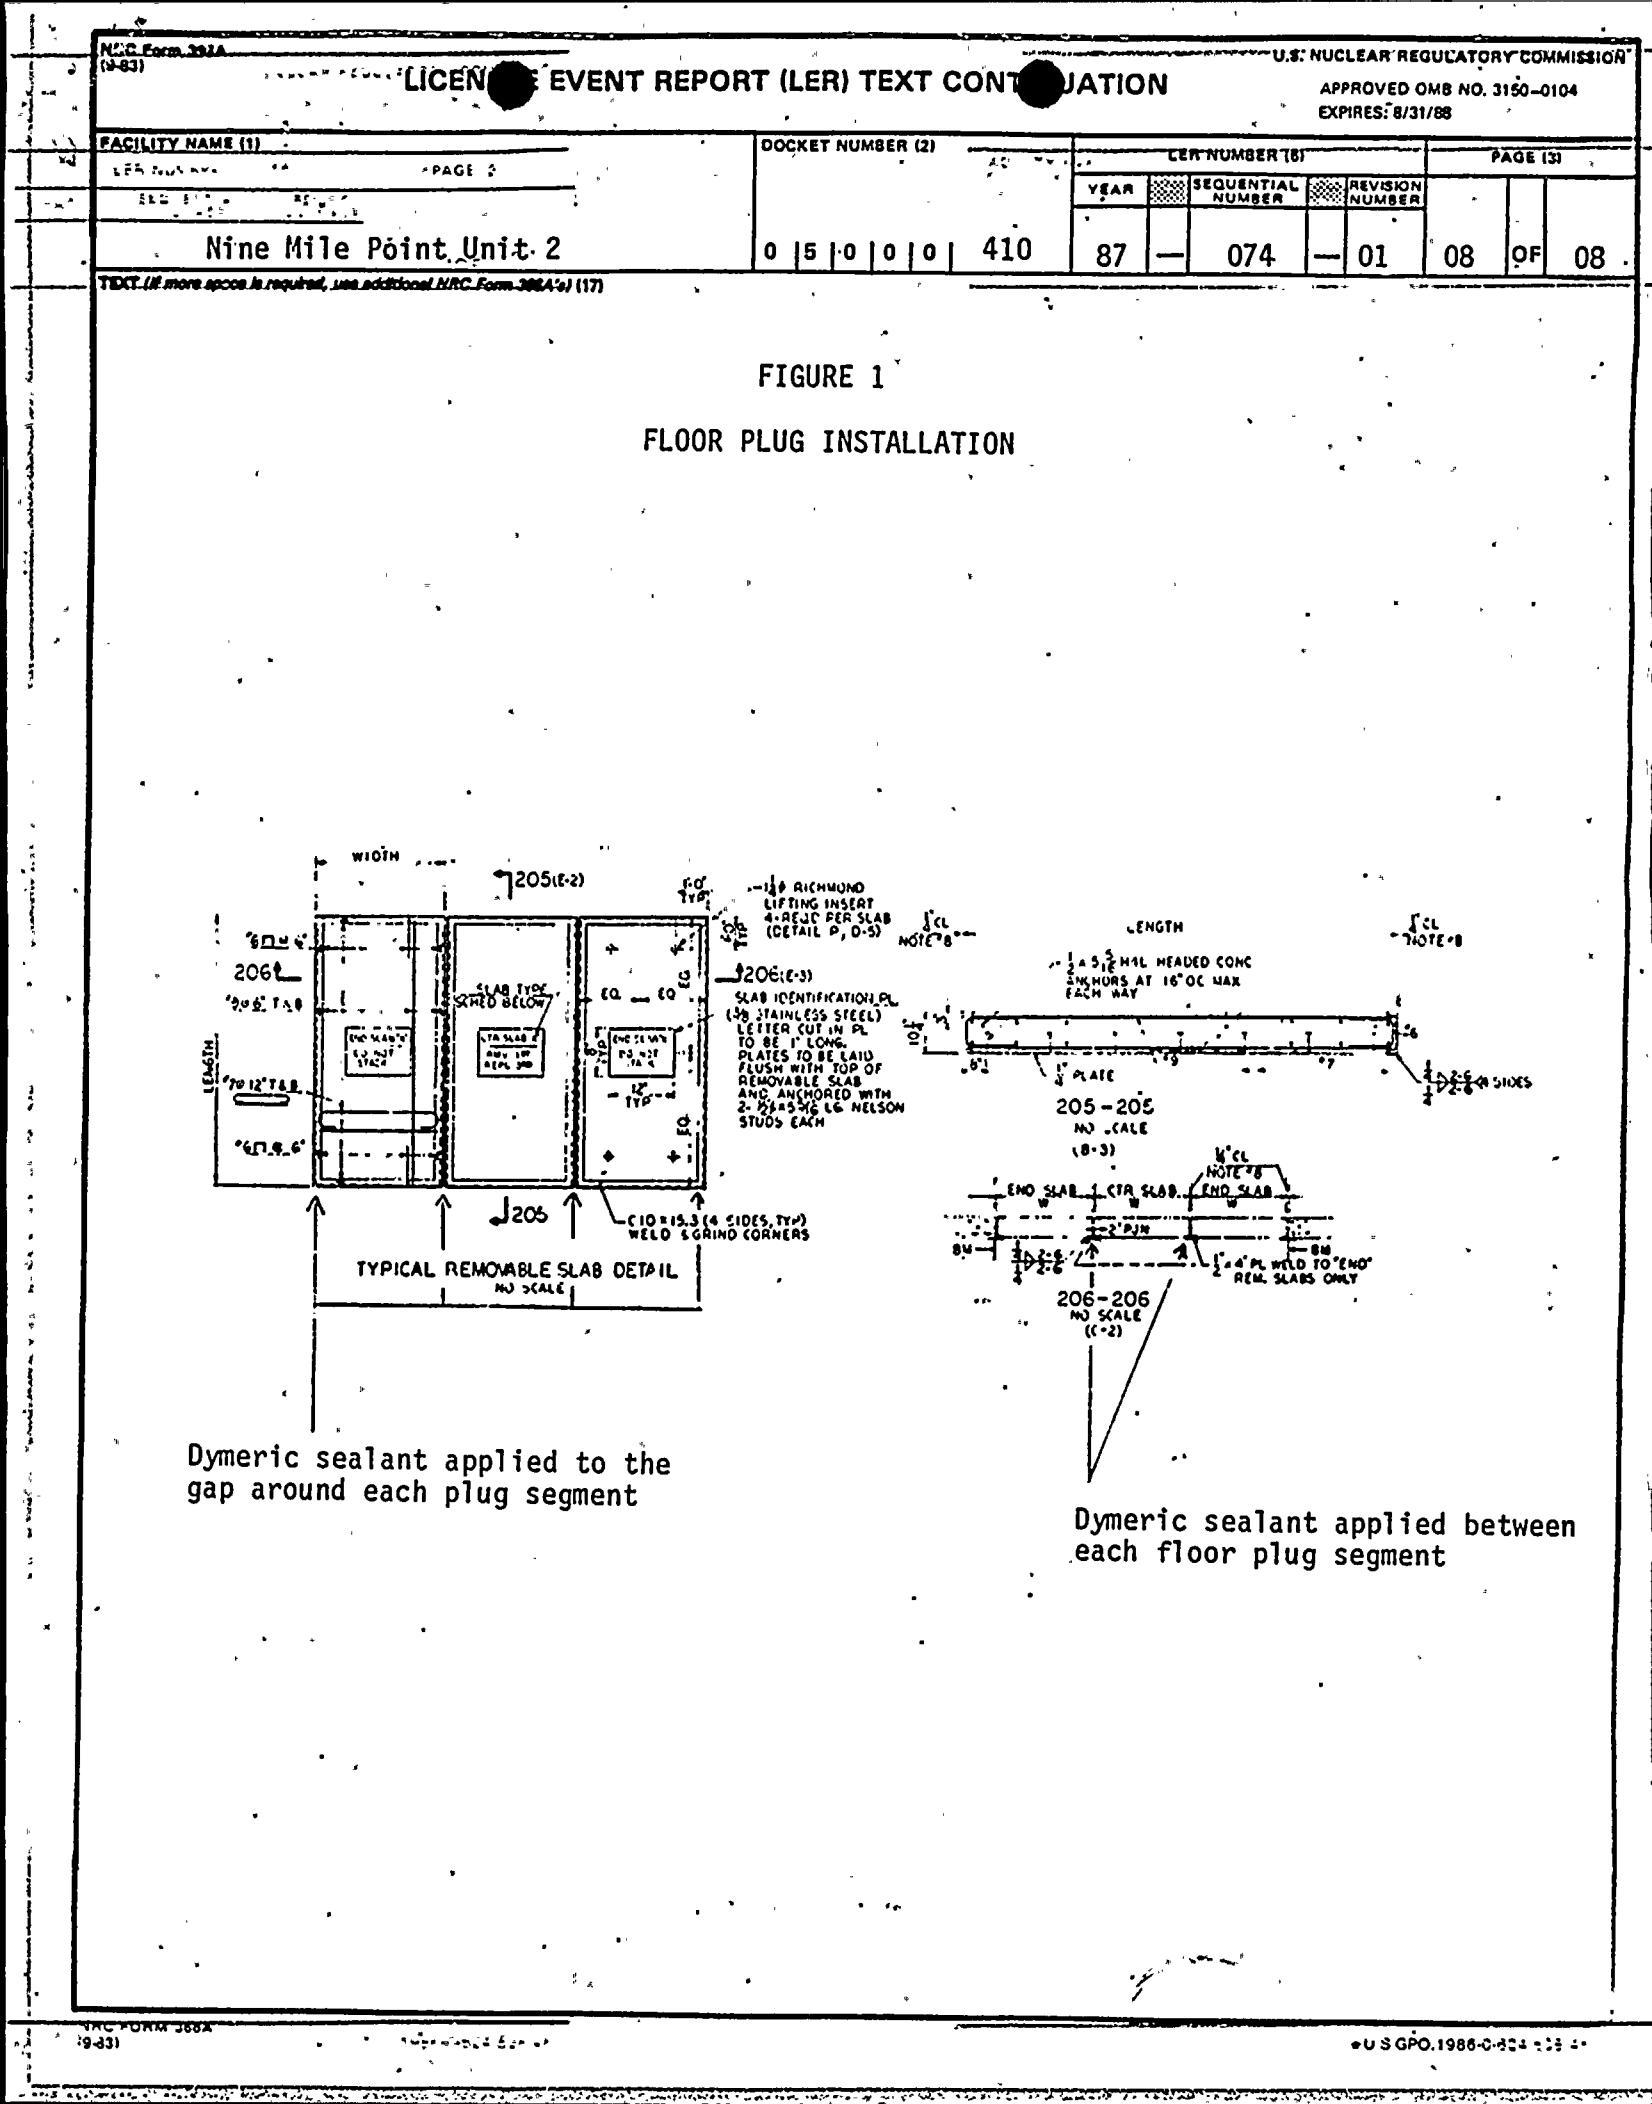
The floor plug installation (refer to ) reasons:	Figure 1) was que	stion	.ed	for	-the	foi	lowin	ıg		•	
- 5 7	1. Portions of the sealant materia floor plug segments were missin fire barrier.	l used to seal th ug allowing air co	e gap: )mmuni	is a icat	irou tion	nd the	e t ugh	hree the		● • ■+ F~}	146 1 1214000	
	The sealant material (specifica fire rating and was not intende	lly a dymeric ela d for installatio	istome n in	<del>:r)-</del> a f	-did fire	-not- rate	hav d b	'é-a arri€	er.	• • ••••	• •	-

3. The construction of the floor p sealant to seal the space betwe	lug used steel pl en the plug segme	ate a ents.	lor	א, gr	ith t	he	dymer	ic		*	
	As a result of this floor plug install Division 1 HVAC Room—(on-CB Elevation declared inoperable as required by the Section 9A.3.5.1.1Therefore, had a it is possible that equipment in both adversely impacting the station's safe	ation, the fire r 288) and the Divi NMP2 Final Safet fire occurred in fire zones could shutdown capabil	ated sion y Ana eithe have ity.	flo 2 H ilys ir c bee	Jor IVAC sis Jne en a	betwee Room Repor of th ffect	en wa: t ( ese ;ed,	the s FSAR) room	) NS,	, -	•	
	In light of this event, the Niagara Mol review of the design (utilizing the de- installations. As a result of this re potentially unsatisfactory Appendix R CB elevation 288 and on CB elevation 2	hawk Engineering sign documents) o view, on January floor plug instal 37 in fire rated	depart f sim 14, 1 latio floor	tme iila 988 ins 'S.	int ir f 3 tw wer	perfor loor p o oth e ide	rme plu er nti	d a g fied	on

3.	The floor plug installat with the existing design plug on CB elevation 237 with corrective action i	ion on CB elevation details per Work Re will be resealed by tem #4.	306 was equest y June	s res (WR # 1, 19	eale 1302 88 f	ed in 233). in con	acco Tho ijuno	ordan e flo ction	ce or	•
