PACIFIC GAS AND ELECTRIC COMPANY
DEPARTMENT OF NUCLEAR POWER GENERATION
DIABLO CANYON POWER PLANT

TITLE: SURVEILLANCE TEST PROCEDURE
SURVEILLANCE OF DIABLO CANYON BREAKWATERS

1 AND 2

Attachment 2 to the Monthly Operating Report for May 1989

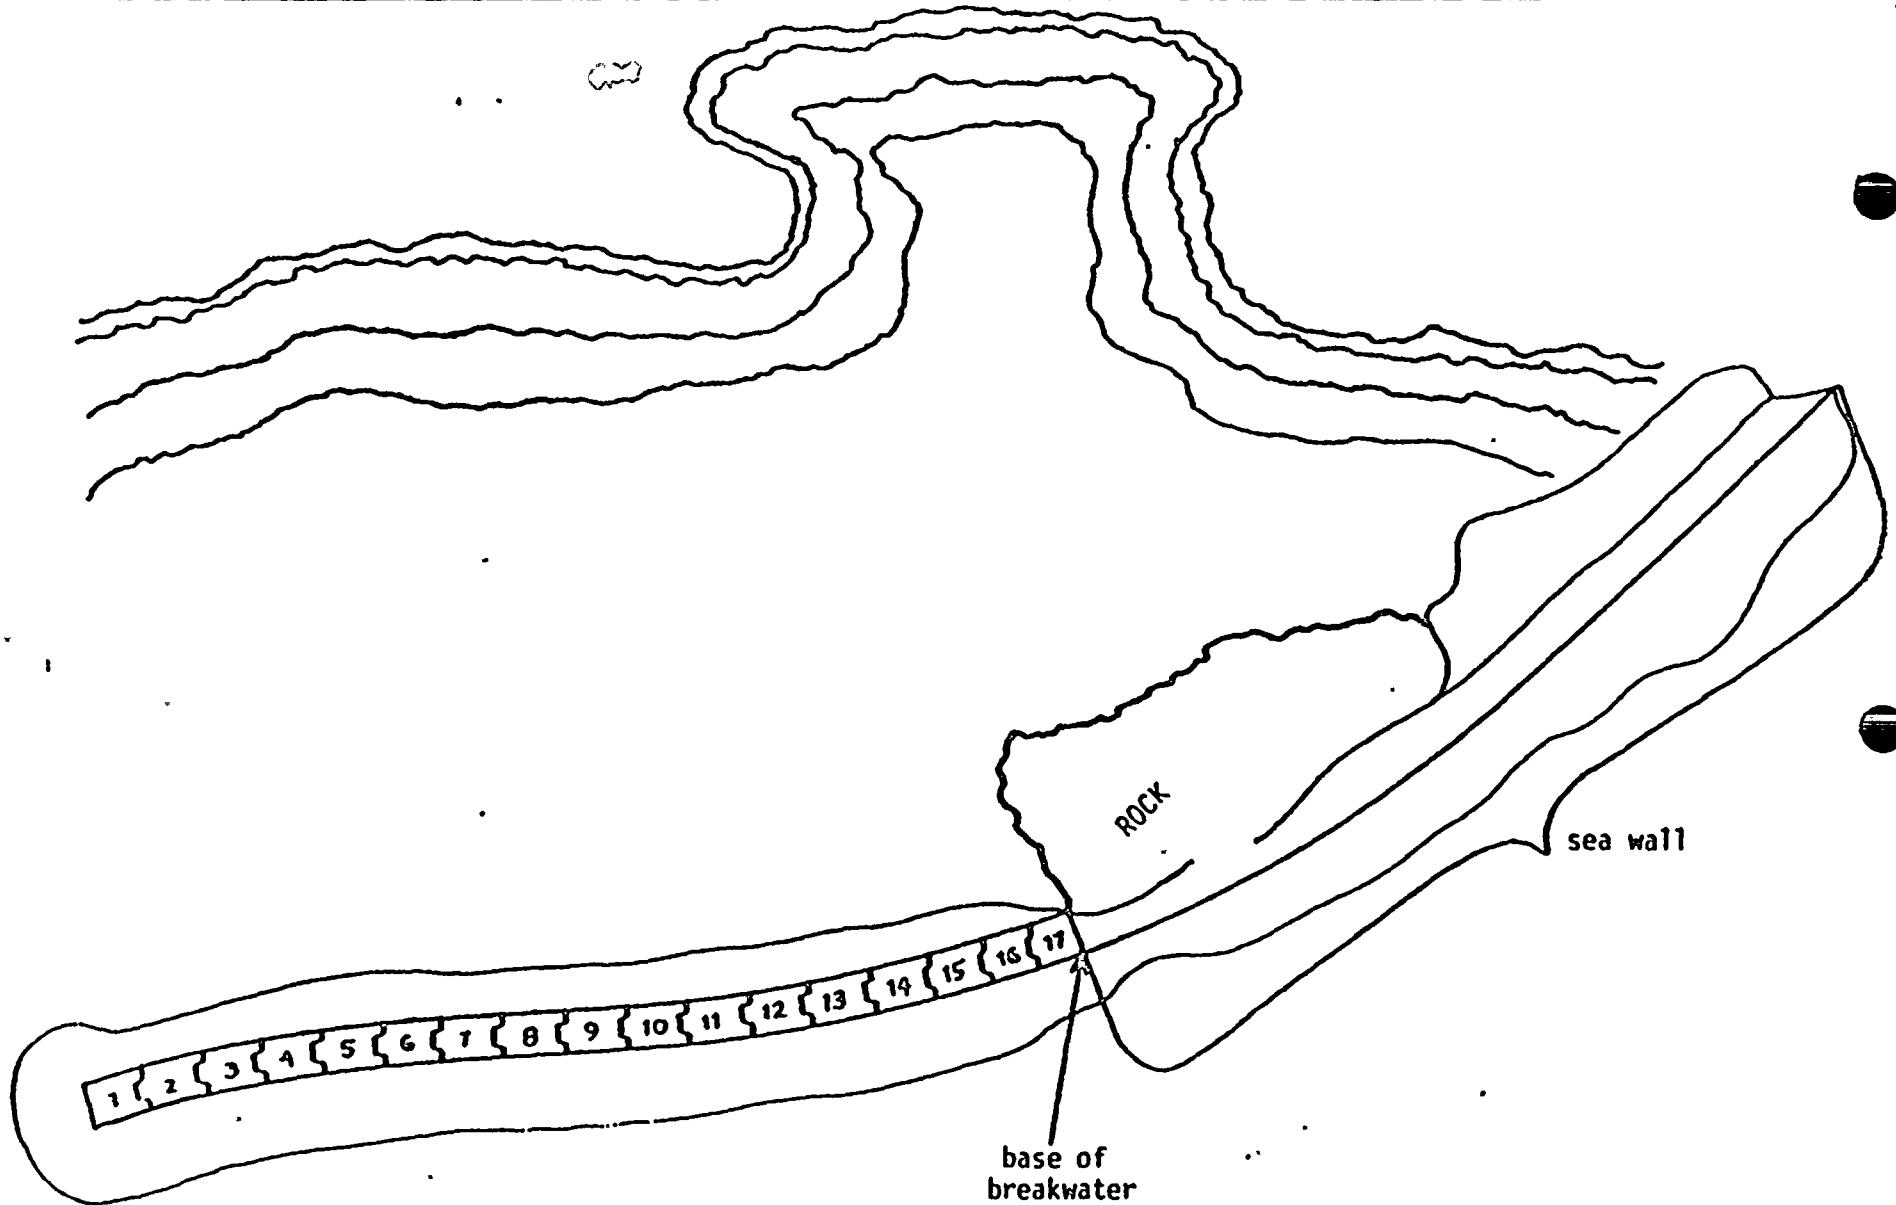
TITLE: EAST BREAKWATER (FIGURE 1) - STP M-90

<u>CAP SECTION NO.**</u>	<u>COMMENTS</u>	<u>N/A</u>
1	<i>no visible signs of deterioration</i>	[]
2		[]
3		[]
4		[]

5	<i>no visible signs of deterioration</i>	[]
6		[]
7		[]
8		[]
9		[]
10		[]
11		[]

<u>CAP SECTION NO.**</u>	<u>COMMENTS</u>	<u>N/A</u>
12	<i>no visible signs of deterioration</i>	[]
13		[]
14		[]
15		[]
16		[]
17		[]
SEA WALL		[]

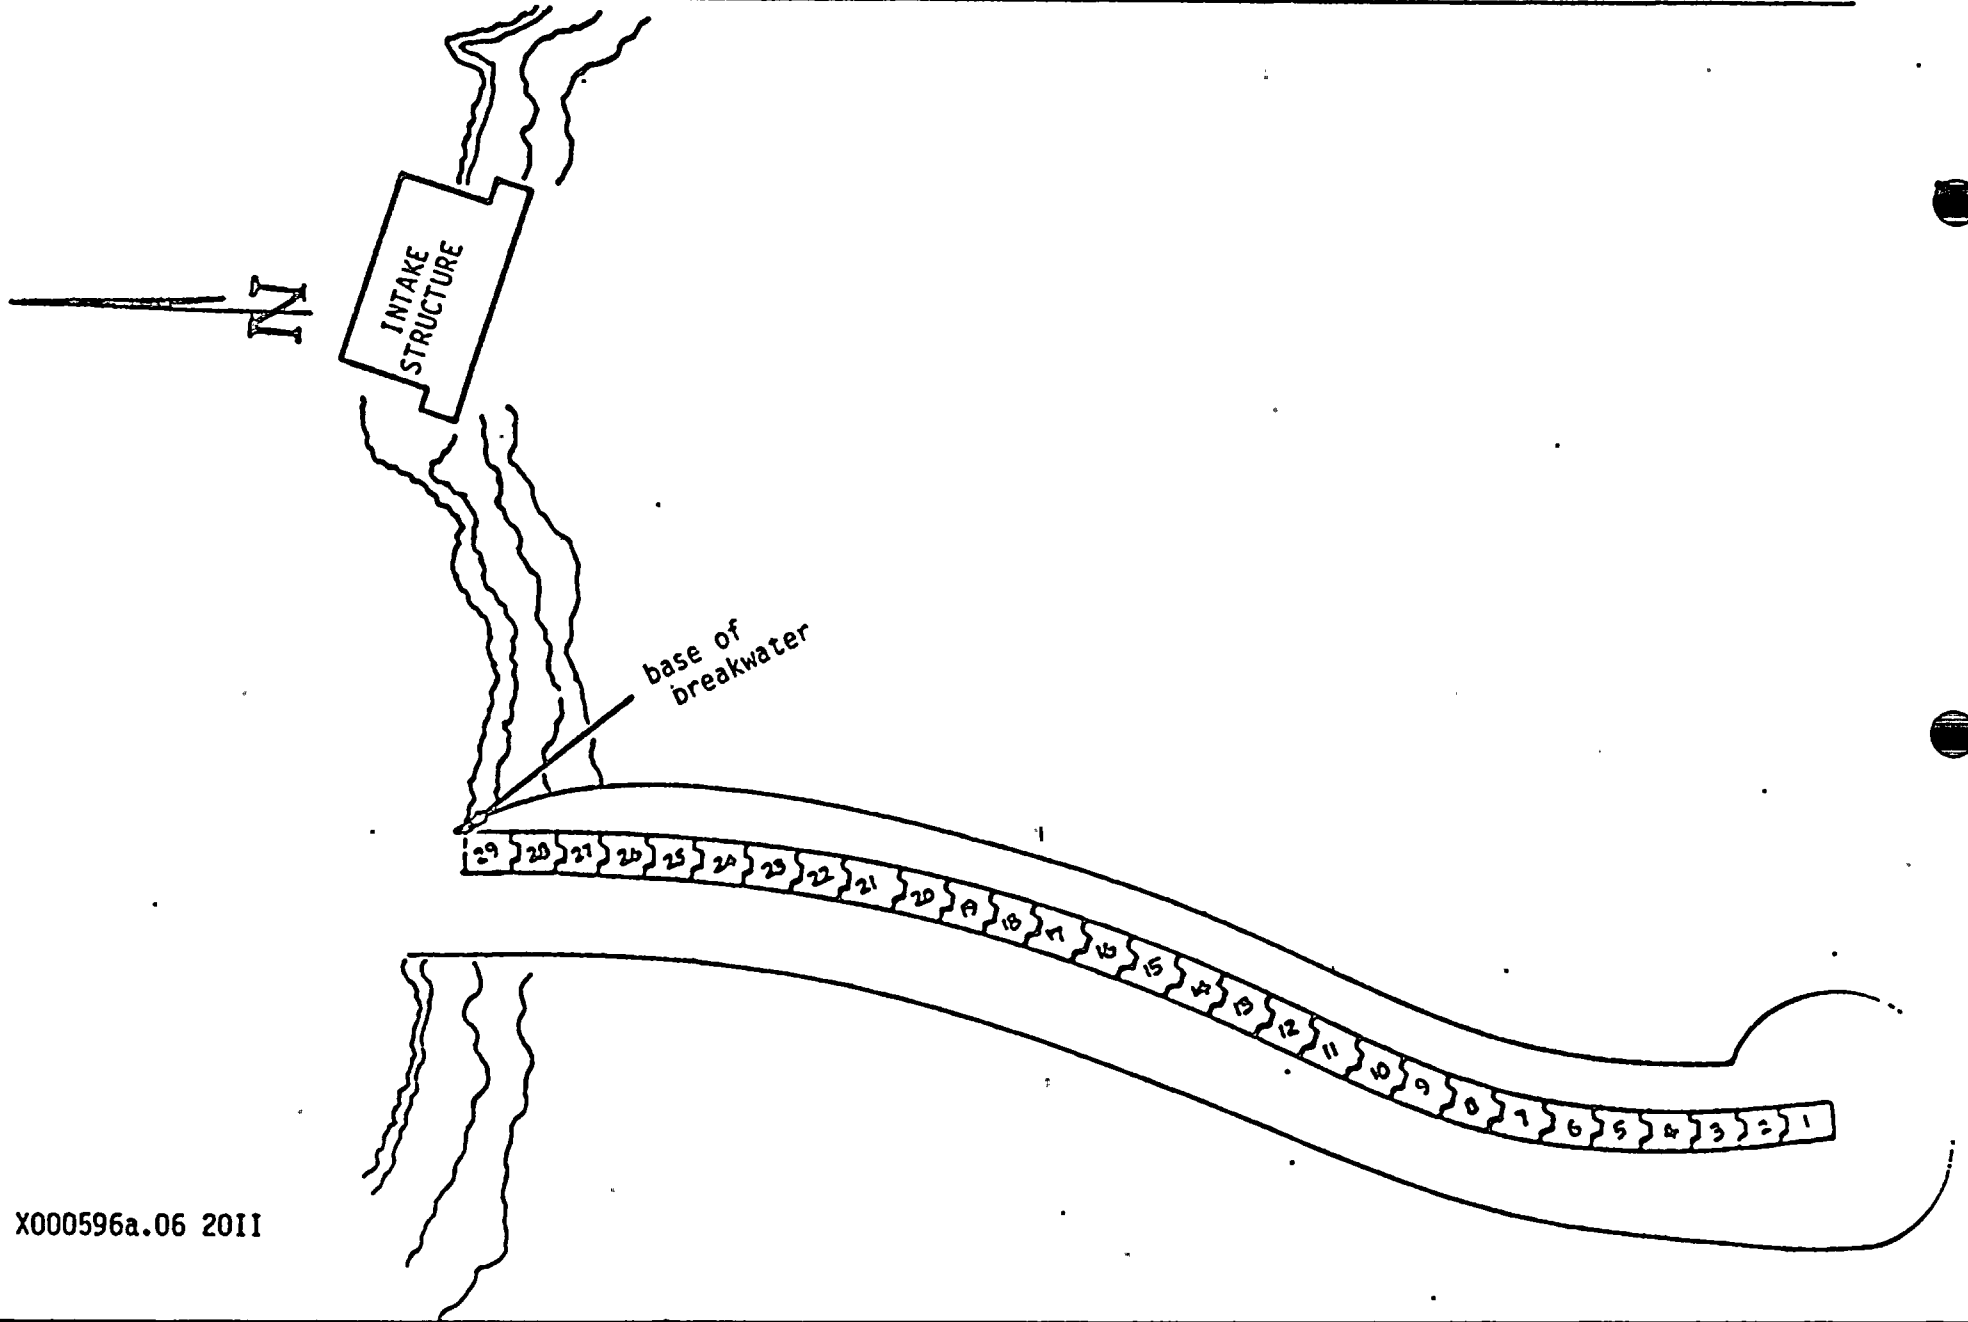
TITLE: WEST BREAKWATER (FIGURE 2) - STP H-90

<u>CAP SECTION NO.***</u>	<u>COMMENTS</u>	<u>N/A</u>
1	<i>no visible signs of deterioration</i>	[]
2		[]
3		[]
4		[]
5		[]

6 *no visible signs of deterioration*

<u>CAP SECTION NO.***</u>	<u>COMMENTS</u>	<u>N/A</u>
13	<i>no visible signs of deterioration</i>	[]
14		[]
15		[]
16		[]
17		[]
18		[]
19		[]

<u>CAP SECTION NO.***</u>	<u>COMMENTS</u>	<u>N/A</u>
20	<i>no visible signs of deterioration</i>	[]
21		[]
22		[]
23		[]
24		[]
25		[]
26		[]

<u>CAP SECTION NO.***</u>	<u>COMMENTS</u>	<u>N/A</u>
27	<i>no visible signs of deterioration</i>	[]
28		[]
29		[]
