Subject: Dresden Station Unit 2 Feedwater Nozzle Examination NRC Docket No. 50-237

DRESDEN STATION UNIT 2 FEEDWATER NOZZLE EXAMINATION

1976 REFUELING OUTAGE

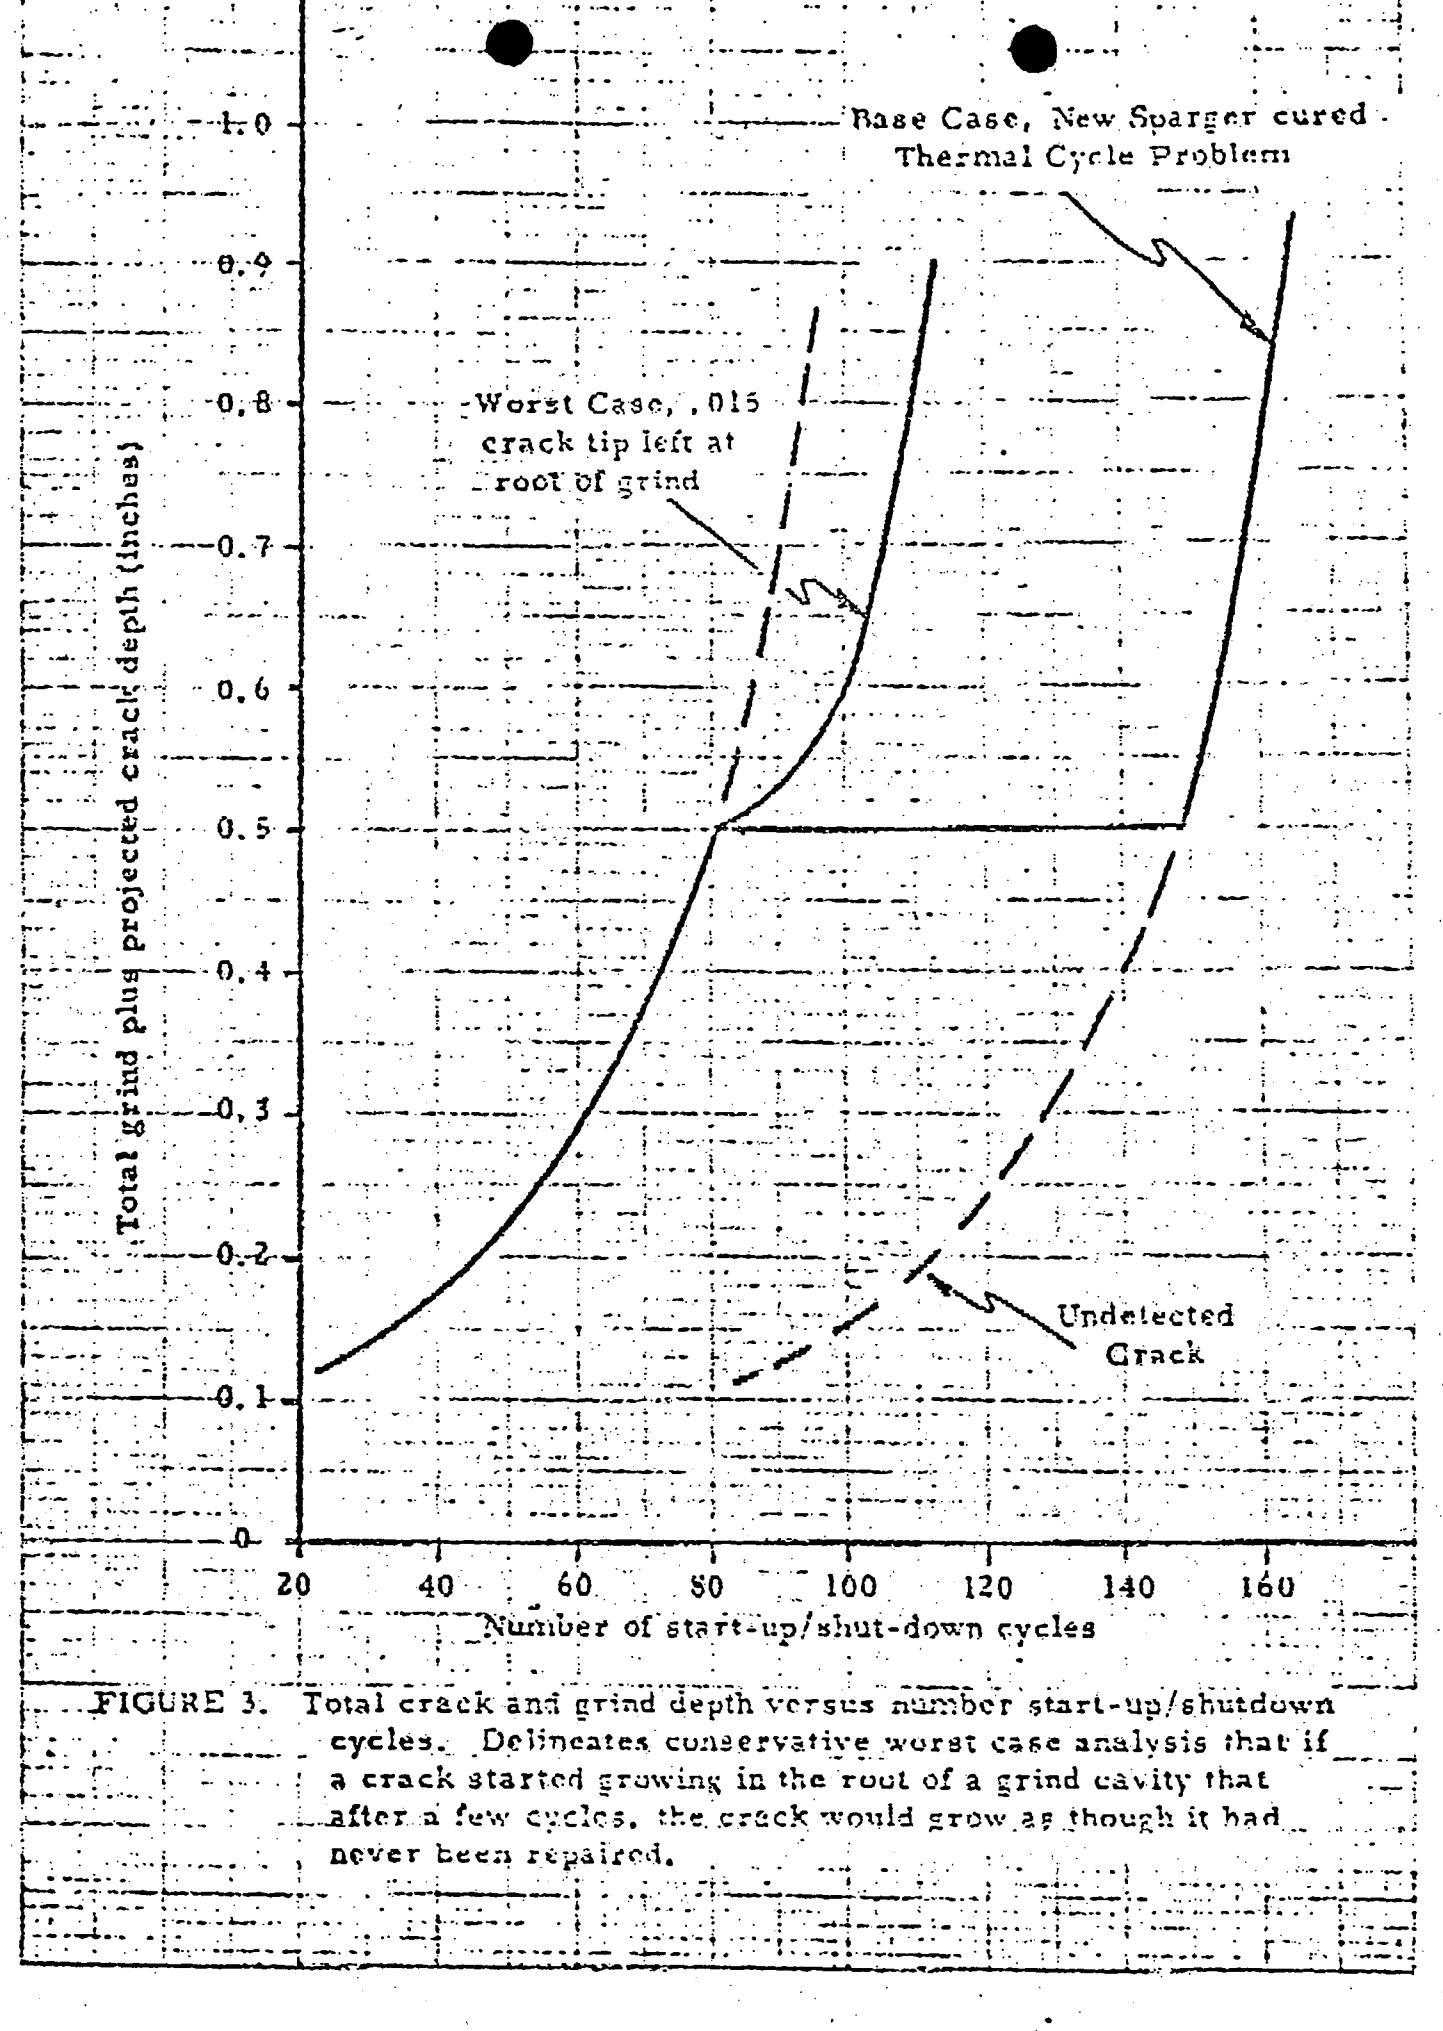
The results of the PT inspection are consistent with the General Electric Company (G.E.) model for predicting crack initiation and crack growth⁽¹⁾. For a reactor with interference fit feedwater spargers and complete crack removal, this model predicts no new cracking in unfatigued cladding. It has been calculated that the effects of previous high frequency fatigue extend to a depth of approximately 1/8 inch into the cladding. The cracks detected by the PT inspections were all less than 1/8 inch in depth measured from the unground cladding surface; therefore, all cracks detected were in previously fatigued material. The two (2) PT indications which were removed by grinding were less than 0.070 inches deep which is well within the predicted 0.140 inches of the G.E. initiation and growth model. The G.E. model predicts that cracks having this depth will not grow beyond a maximum depth of 1/4 inch during the next operating cycle. This minor cracking does not require removal because the cladding does not constitute a structural portion of the reactor pressure vessel.

(1) This model was described to the NRC by General Electric Company in a meeting on February 25, 1976. The model is graphically summarized by the following curve of Total Grinding plus Projected Crack Depth versus Number of Startup/Shutdown Cycles. The curve shown is for an initial crack and grind out of 0.5 inch depth. Similar curves can be used to project the growth of initial cracks which were ground out to other depths.
