SUBJECT: Forwards drawings of mod to resolve essential svcr water single failure issue. Mod allows manual shutoff valves in RHR room & corrects loss of both RHR pumps in one div.

Pennsylvania Power & Light Company

SUSQUEHANNA STEAM ELECTRIC STATION
RESPONSE TO LICENSE CONDITION 2.C.(32)
ER 100450 FILE 841-2
PLA-1656

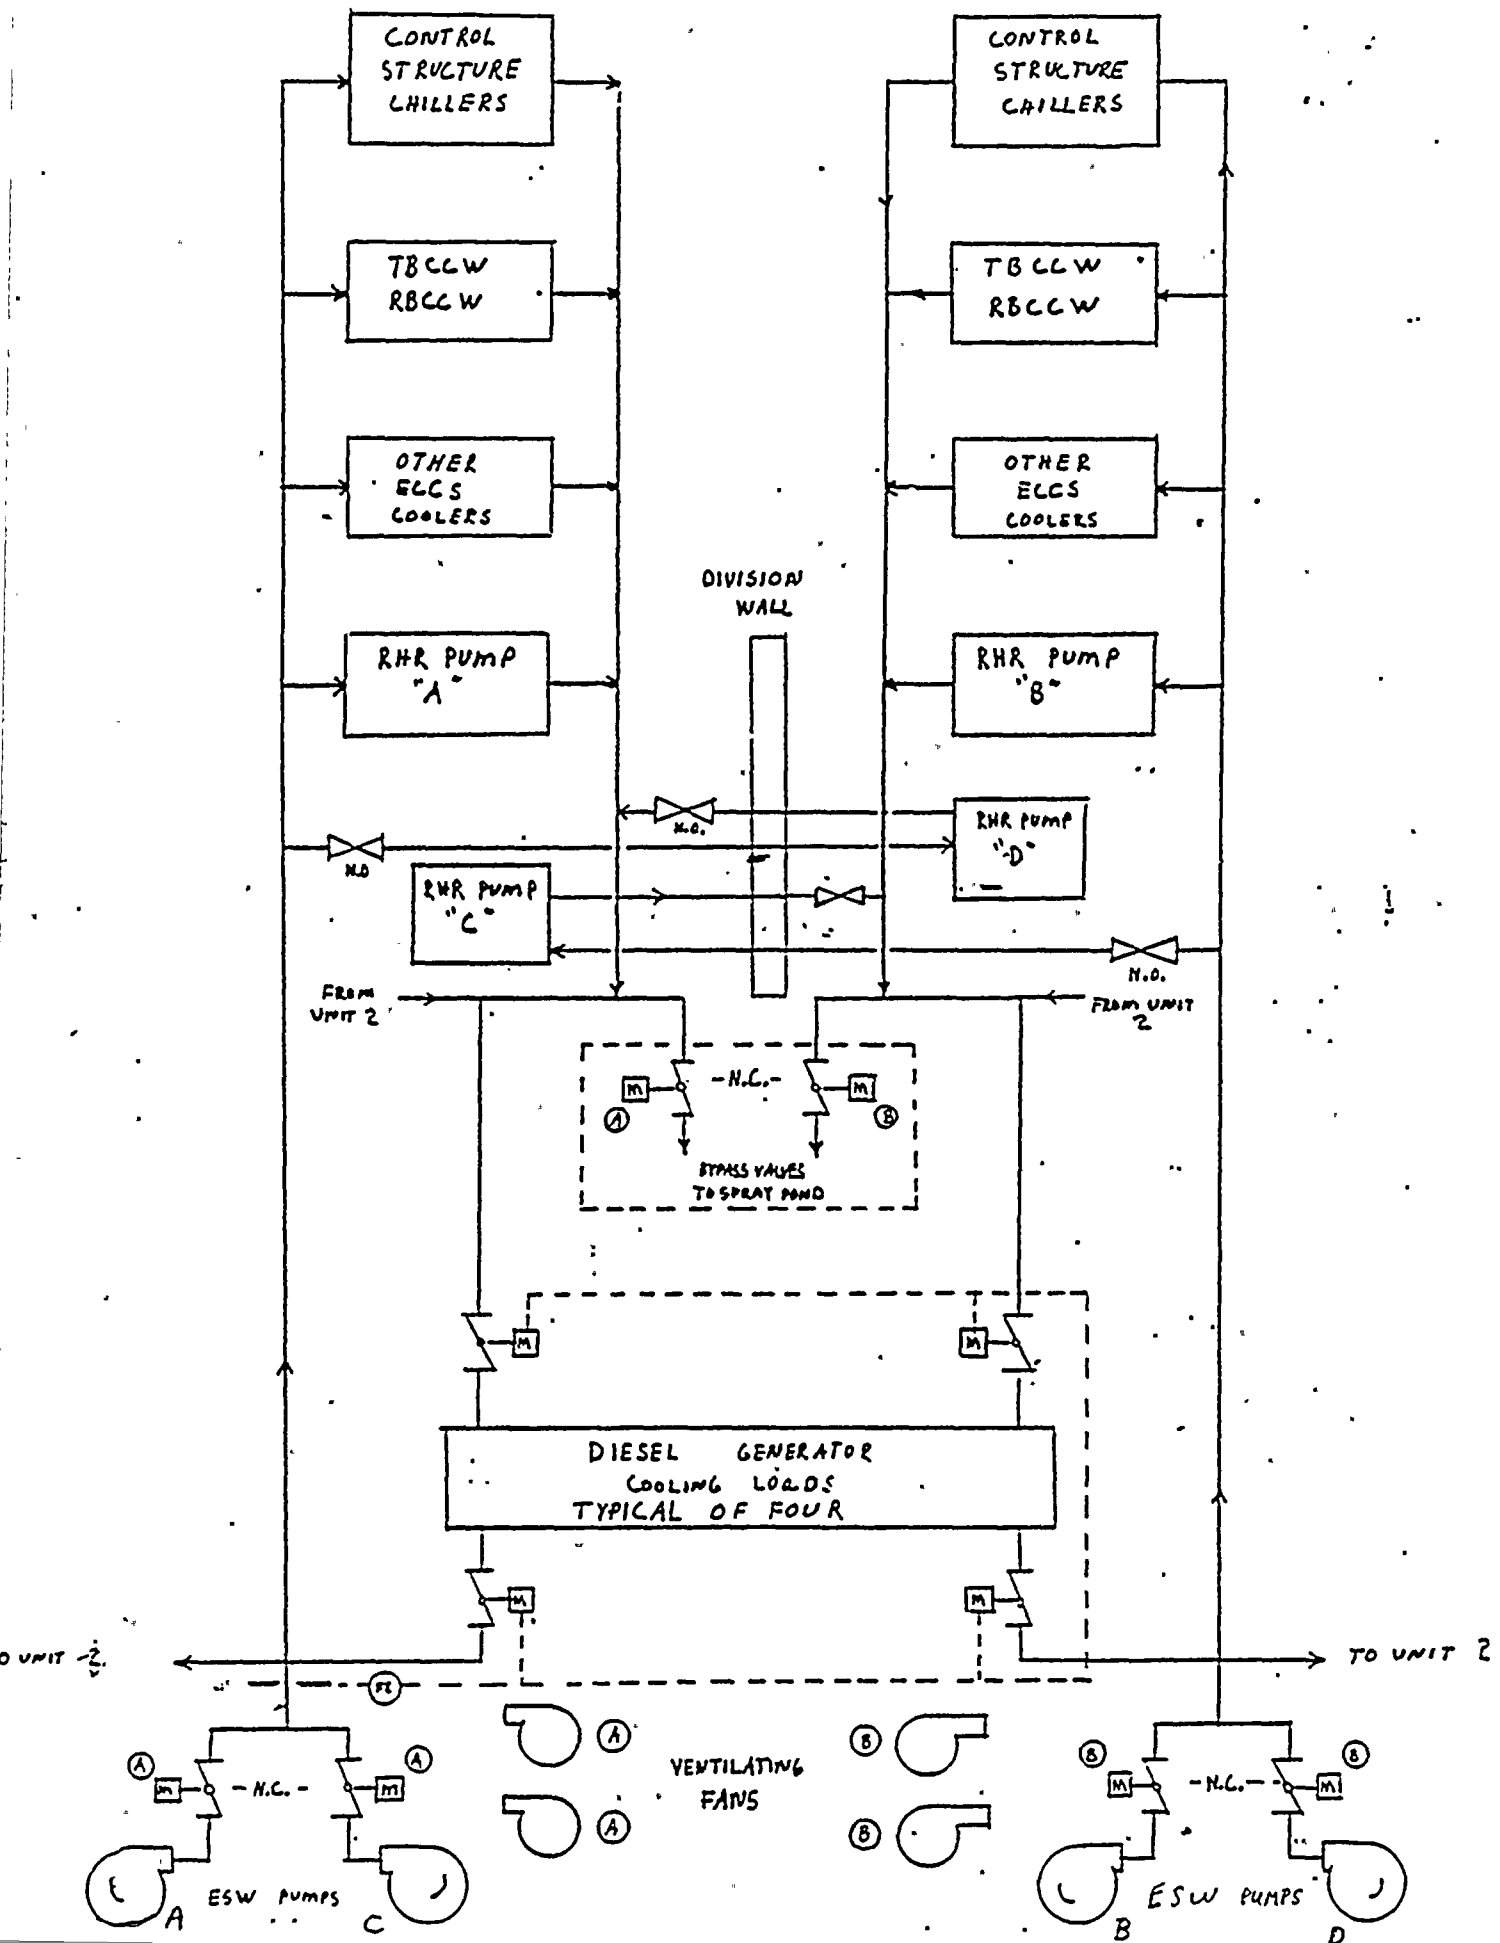
Since that time, a comprehensive Failure Modes and Effects Analysis has been completed which identified other single failures which could render one loop of ESW inoperable. Consequently, an alternate solution is necessary. In the current configuration of ESW, loss of one loop results in the loss of both RHR pumps in one division due to a lack of cooling water. As a minimum, one RHR pump in each division and one loop of core spray are needed to safely shut down in the most limiting case, a suction side break LOCA.

The attached sketch indicates the modification we have chosen as a solution to this problem. Cooling water from the other division of ESW will be repiped to the C and D RHR pump motor oil coolers, seal coolers and room unit coolers. Hence, one loop of ESW will cool one RHR pump in each division, thus allowing the equipment cooling requirements for safe shutdown to be met. This modification also provides manual shutoff valves in the RHR room where the connection to ESW is made.

NEED 2 PUMPS FOR SAFE SHUT DOWN
