50 DRESDEN NUCLEAR POWER STATION UNIT 2 Regulatory File Cy.

Special Reports

Commonwealth Edison Company

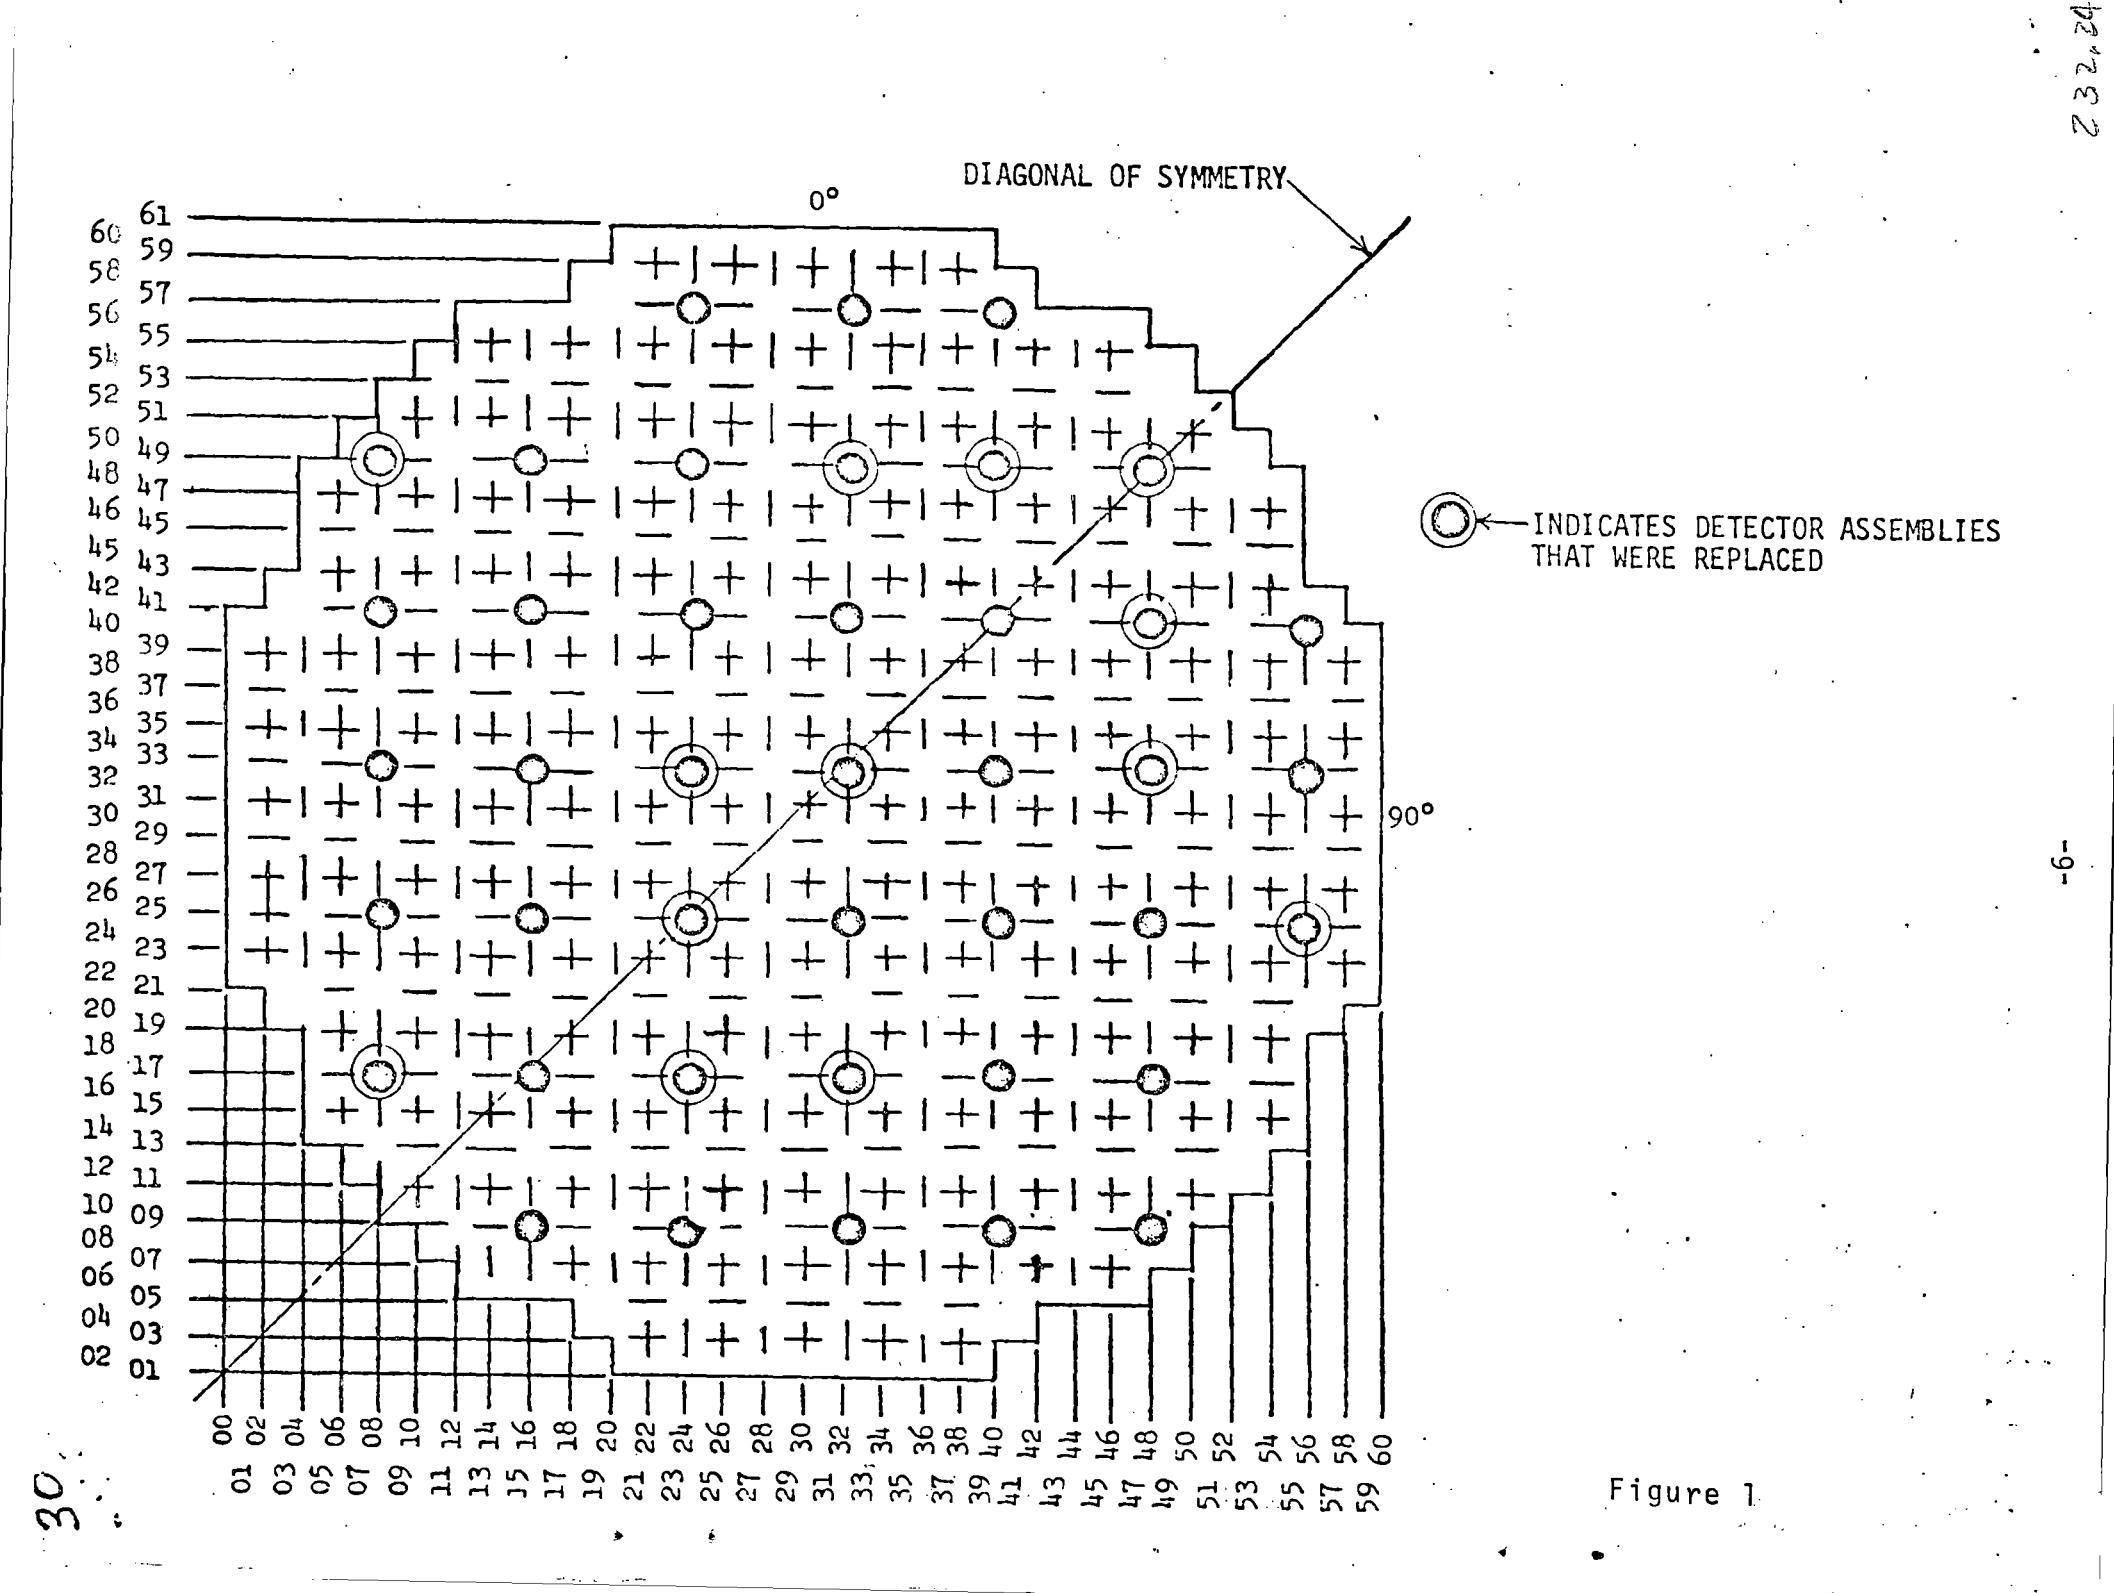
During the July, 1970 shutdown of the Dresden-2 plant, testing was accomplished to provide additional information on the asymmetry of the flux distribution. Operation of the plant prior to the shutdown indicated that some LPRM assemblies had low sensitivity and were not providing reliable information. Within the time limitations available during the shutdown period, some LPRM assemblies were replaced. Selection of the locations in which to replace LPRM's was done to maximize the information to be gained about the power asymmetry indications. Maximum information was gained by comparing power measurements between an old and a new LPRM assembly and by selecting LPRM locations in which the integral ratio was very high. Figure 1 shows the locations in which LPRM's

were replaced. In one case one of the LPRM assemblies, of a pair which had a very high ratio, was replaced and the adjacent high ratio pair was not disturbed. In other locations, both LPRM assemblies of a given pair were replaced. Examination of the TIP ratios, after the reactor was restarted, confirmed that indications of asymmetry in the Dresden-2 core was in part due to mechanical and geometrical variations. In the most severe location the ratio between symmetrical pairs dropped from 1.16 to 1.09.
