Common Calth Edison Dresden Nuclear Power Station R.R. #1 Morris, Illinois 60450 Telephone 815/942-2920

EDE LTR #91-619

Licensee Event Report #91-031, Docket #050237 is being submitted Voluntarily in accordance with Technical Specification 6.6 and NUREG 1022.

Control Rod Drive R-10 [AA] Failure to Latch Due to Collet Piston Binding

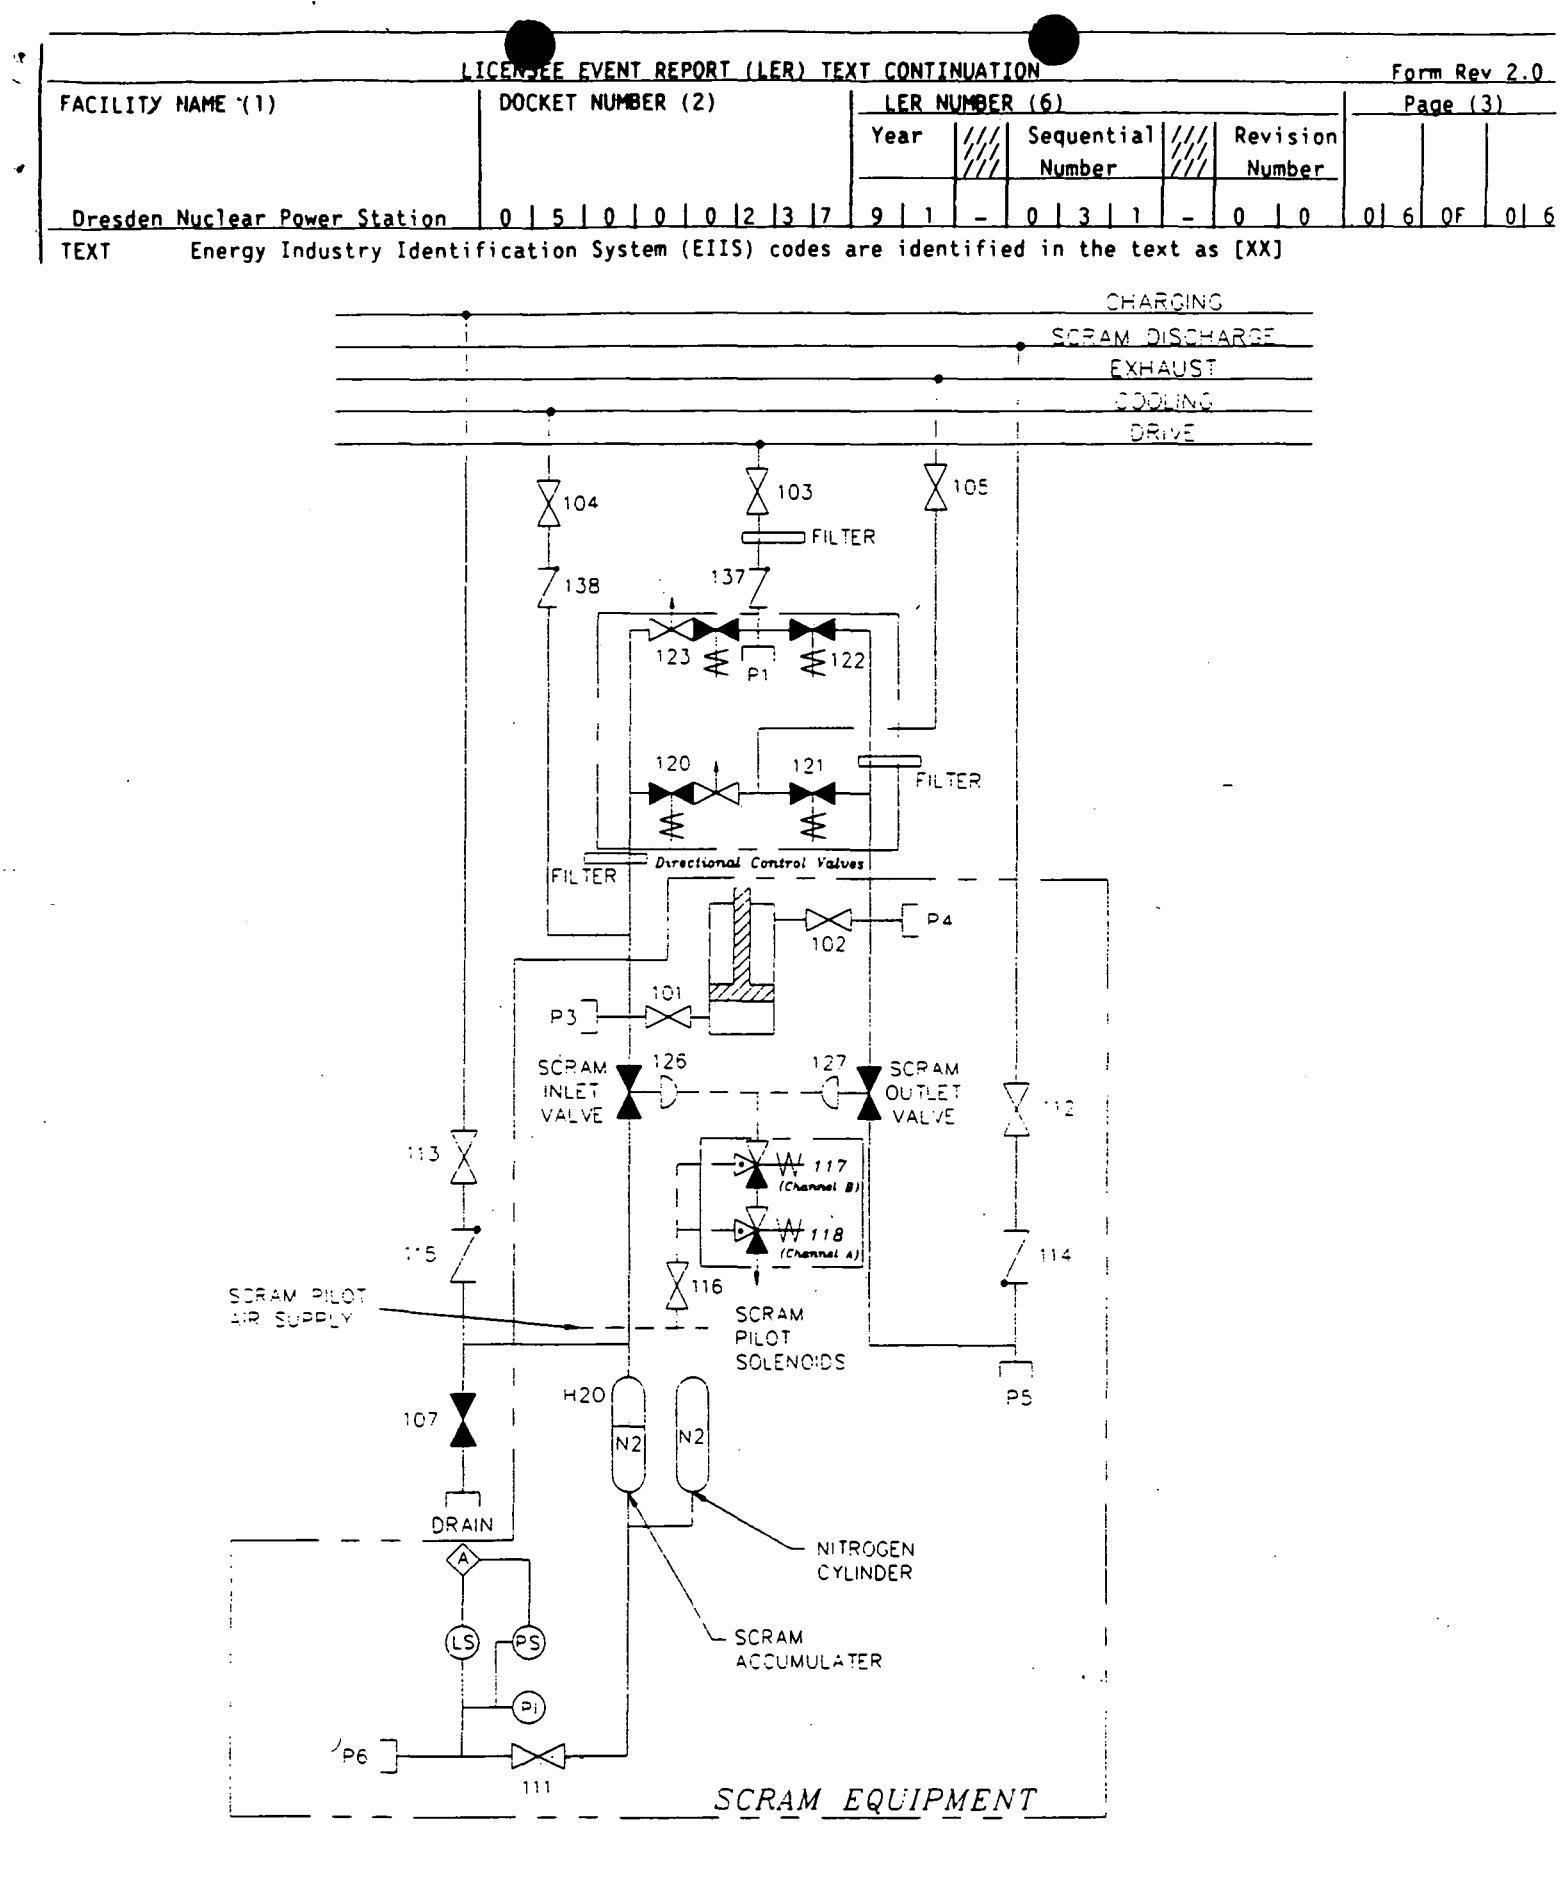
STABLE CRD Hydraulic Control Unit (piping diagram) Figure 1

While troubleshooting CRD R-10, valve 2-305-102, Withdraw Riser Isolation Valve, was isolated to eliminate any potential drive pressure to the CRD overpiston area or CRD collet piston (see Figure 1 attached). The insert signal was then removed and CRD R-10 again failed to latch at position "00". The CRD was returned to position "00" using the Emergency-In/Notch Override Switch and valve 2-305-102 was opened.
