Commonwealth Edison
1400 Opus Place
Downers Grove, Illinois 60515

Subject: Dresden Nuclear Power Station Unit 3
Deferral of IGSCC Inspection Plan Welds
from the Fall 1991 Refueling Outage
NRC Docket No. 50-249

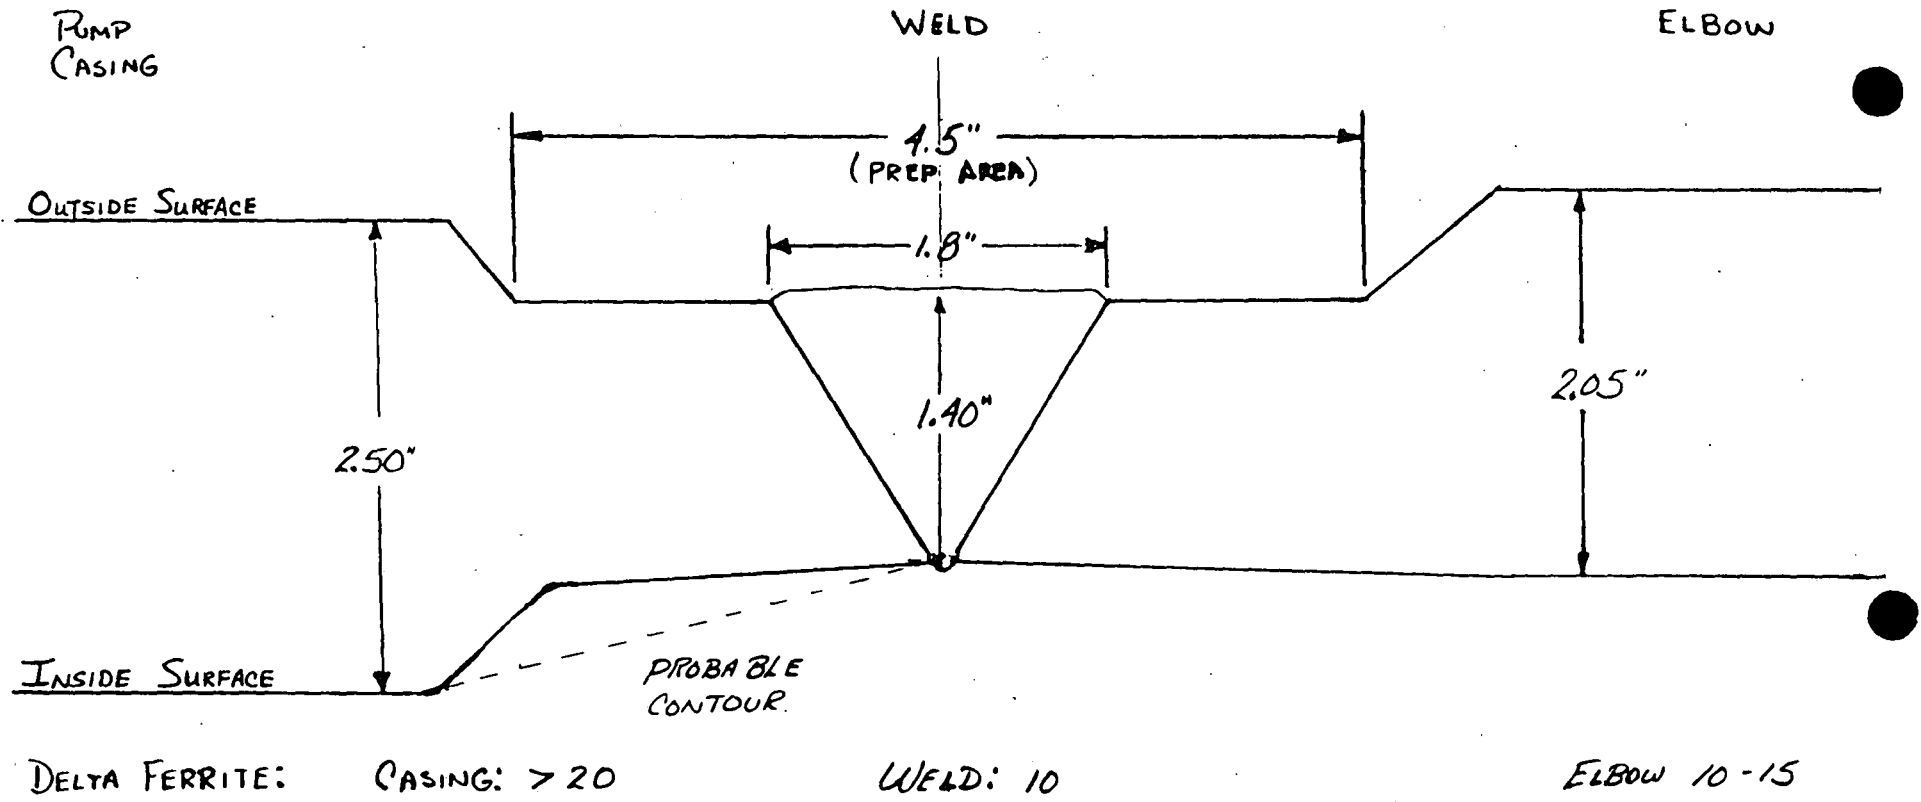
FIGURE 1
DIAGRAM OF WELD 28-11

Once the welds are accessible for inspection purposes, the current configuration (outside surface contour) of each weld is not conducive to obtaining a meaningful examination. The contour of each weld is shown in Figures 1 (weld 28-11) and 2 (weld 28-K12). As shown in the Figures, the 1.8" wide weld crown is located in the middle of a trough approximately 4.5" wide. This configuration is too restrictive for proper placement and movement of the transducer search unit(s) to obtain sufficient weld coverage. In order to obtain a meaningful examination, machining of elbow material would be required, which would result in an additional exposure of approximately 10 person-rem for each weld. Machining on the elbow would also necessitate detailed evaluations to ensure structural integrity is maintained. In addition to the configuration considerations, CECo does not currently possess a calibration block for this weld application which meets the requirements of ASME Section XI.

For each weld, CECo has obtained ferrite measurements (presented in the Figures) for the elbow, weld, and pump casing. The high value of the measured ferrite numbers indicate that the welds should be resistant to IGSCC, and therefore deferral of the inspection for one refueling outage should pose no safety concern.
