Commonwealth Edison Dresden Nuclear Power Station 6500 North Dresden Road Morris, Illinois 60450 Telephone 815/942-2920

GFSLTR 94-0148

HPCI Room Cooler Fan Minimum Starting Voltage Above Second Level Undervoltage Relay Setpoint

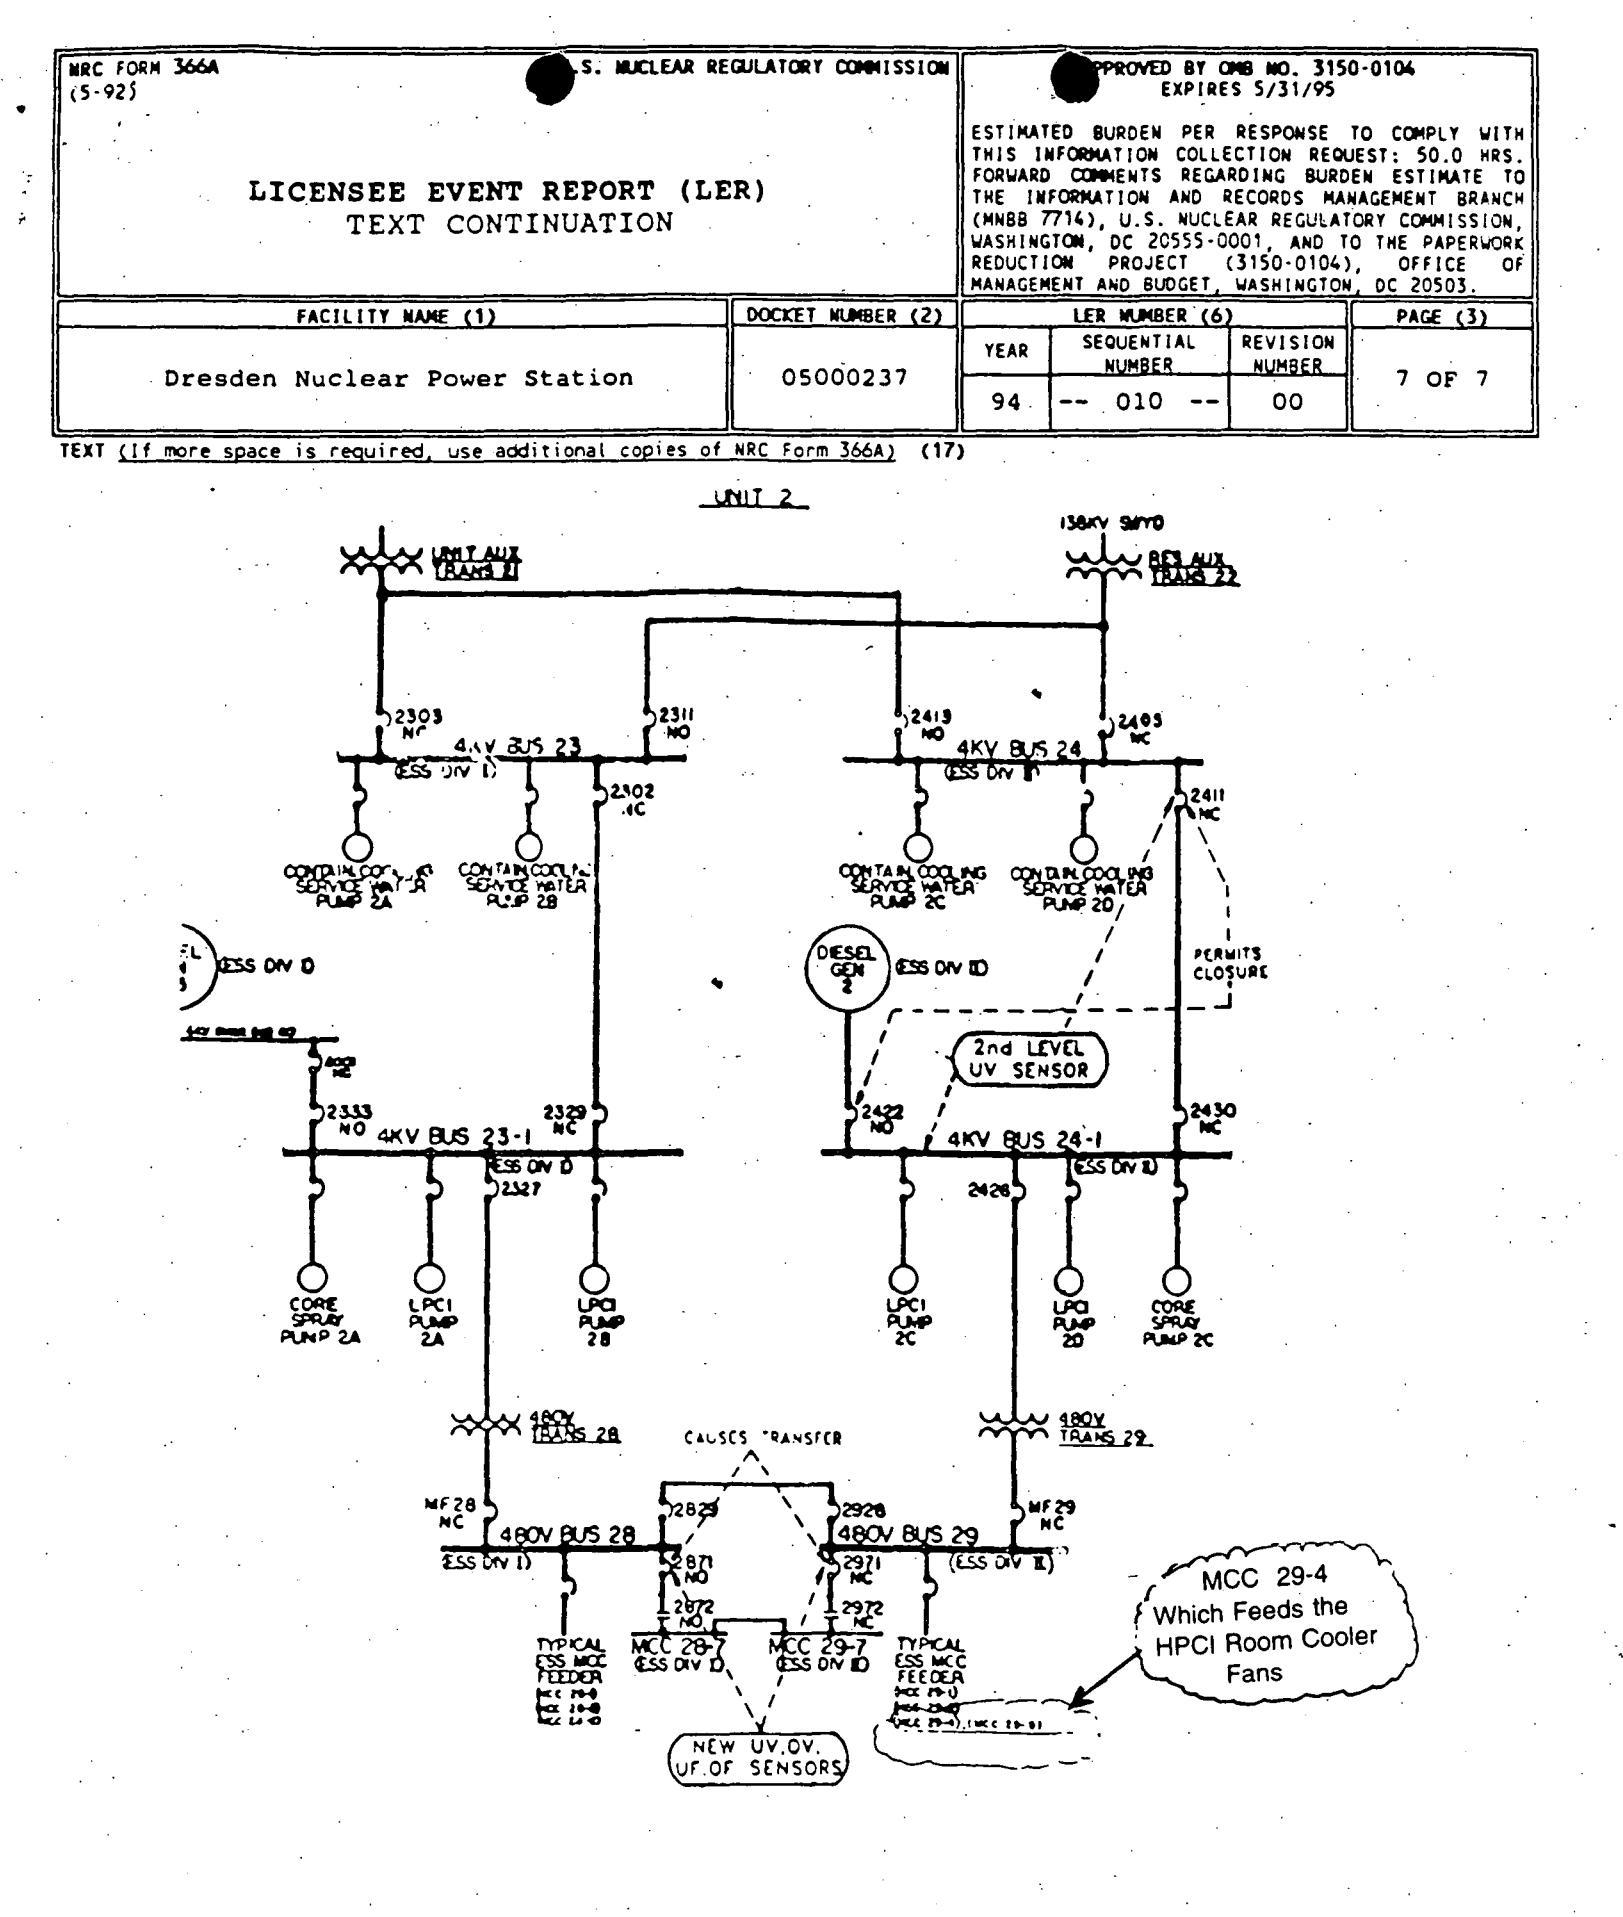
SKETCH 1

On April 12, 1994 with Unit 2 at 99% rated power and Unit 3 in a Refuel Outage, during a review of Sargent & Lundy calculation 8982-19-19-2 it was discovered that the control circuit contactor (motor starter) pick up voltages for the HPCI Room Cooler Fans were above the set point for the second level degraded voltage relay settings. The calculation was originally prepared during August, 1989 and was being reviewed in response to an NRC unresolved item of Engineering and Technical Support Inspection No. 94-003. The review identified that under degraded voltage conditions for Unit 2, only 86.8 Volts is postulated to be available at the control circuit contactor (motor starter) when 97.72 Volts is required to assure its operation. Similarly, under degraded voltage conditions for Unit 3, only 87.7 Volts is postulated to be available at the motor starter when 97.70 Volts is required to assure its operation. Therefore, it could not be assured that the HPCI Room Cooler Fans would start. Additionally, the review identified that the concern was isolated to the 120 Volt motor starters, and that the voltages at the 480 Volt HPCI Room Cooler Fan motors were calculated to be acceptable.

According to CECo's Nuclear Engineering Department Mechanical Structural Group (NED M&S) letter concerning the Emergency Core Cooling System (ECCS) Room Cooler Operability Requirements, dated February 3, 1993, CHRON #198404, the HPCI room cooler fans are required to function in the event of a DBA LOCA. These room cooler fans are fed from Unit 2 480V Bus 29 (MCC 29-4) and Unit 3 480V Bus 39 (MCC 39-1); both of these busses are affected by their respective second level degraded voltage relay settings. (See attached sketch, Unit 3 is similar).
