NRC FORM 366A (5-92)	RC FORM 366A U.S. NUCLEAR REGULATORY COMMISSION 5-92)			APPROVED BY ONB NO. 3150-0104 EXPIRES 5/31/95				
	LICENSEE EVENT REPORT (L) TEXT CONTINUATION	ER)	ESTIMA THIS I FORWARI THE IN (MNBB WASHING REDUCTI MANAGE	TED BURDEN PER NFORMATION COLLE COMMENTS REGAU FORMATION AND F 7714), U.S. NUCLI GTON, DC 20555-0 ION PROJECT ( MENT AND BUDGET,	RESPONSE ECTION REQU REDING BURD RECORDS MA EAR REGULAT 001, AND T (3150-0104) WASHINGTON	TO COMPLY WITH JEST: 50.0 HRS. IEN ESTIMATE TO NAGEMENT BRANCH FORY COMMISSION, 0 THE PAPERWORK 0, 0FFICE OF 1, DC 20503.		
	FACILITY NAME (1)	DOCKET NUMBER (2)		LER NUMBER (6)	>	PAGE (3)		
Durandan Nu		05000040	YEAR	SEQUENTIAL NUMBER	REVISION NUMBER	2 07 14		
Dresden Nu	clear Power Station, Unit 3	05000249	94	009	01	3 OF 14

Type B and C Leakage Limit Exceeded Due to Valve 3-1301-3 Not Fully Closed

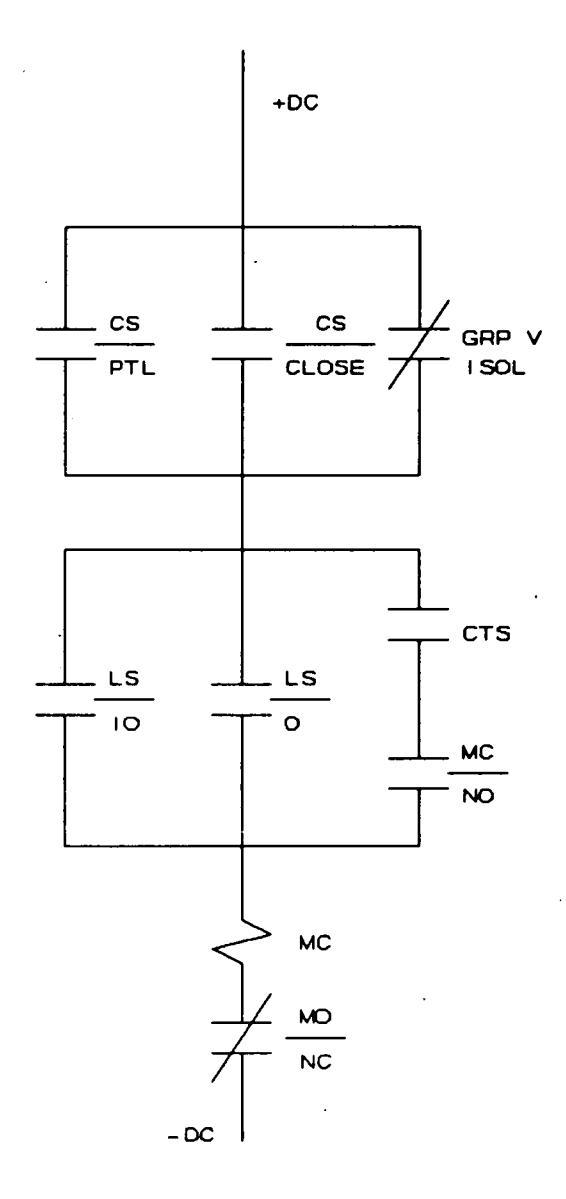
FIGURE 1 MOV 3-1301-3 Simplified Schematic

closed torque switch trip. See attached Figure 1, MOV 3-1301-3 Simplified Schematic.

The logic for MOV 3-1301-3 includes an interlock (MO/NC) between the open and close contactors that prevents energizing the close contactor (MC) if the open contactor (MO) is energized. When a close signal is received from either the control switch or the Group V isolation logic and the valve is in the full open position (LS/O) or the intermediate open position (LS/IO), the throttling valve will start to go closed, as the close contactor (MC) is energized. Upon energization of the closing contactor (MC), auxiliary contact (MC/NO) will close bringing the close torque switch into the circuit. The close torque switch contacts (CTS) are normally closed and open upon the close torque switch setting being reached (valve full closure).

The Operator's normal action to full close this valve is to move the control switch to the CLOSE position (closing contact CS/CLOSE) and to hold it there until 5 seconds after full close indication is received. The Operator can stop the valve anywhere in its closing cycle by releasing the control switch and allowing it to spring return to the AUTO position (opening contact CS/CLOSE). The valve can be given a close signal again through either the control switch or the Group V isolation logic and the valve would close as long as the valve was in the intermediate position (limit switch contact LS/IO is closed).

The closing logic is designed with close contactor auxiliary contact (MC/NO) in series with the close torque switch (CTS) since this valve has non-locking actuator gears. Once the actuator stops, the gear engagement relaxes slightly, allowing relaxation of the spring pack, thus resulting in reclosure of the close torque switch contact (CTS). The close contactor auxiliary contact (MC/NO) prevents anti-hammering of the valve by opening on initial deenergization of the close contactor (MC) and eliminating circuit continuity through the close torque switch (CTS) despite its reclosure.

As with any MOV, when the close signal is removed, the valve momentarily continues to move in the close direction due to close contactor drop out time and MOV inertia. For this valve, this creates a condition in which the control switch could be released while the valve is in the intermediate position (LS/IO closed) and the valve could coast into the closed indication region (LS/IO open) but not be fully seated (achieve close torque switch trip). In order to fully seat the valve, the valve would first have to be opened to at least the intermediate position and then reclosed. This condition has been recognized and is explained to the Operators in step F.9 of Dresden Operating Surveillance DOS 1300-3, Manual Operation of the Isolation Condenser:

During a feedwater transient in 1987, the reactor operators observed that small changes in 3-1301-3 valve position were difficult to perform due to the rapid speed of valve movement. A modification request form was submitted to consider providing a slower speed gearing ratio for the 3-1301-3 valve in order to facilitate fine adjustment of 3-1301-3 valve position. This has been accomplished through installation of modification M12-3-92-001 which increased the gear ratio for the 3-1301-3 valve to support commitments to NRC Generic Letter 89-10. In addition, the closing limit switches have been repositioned closer to valve seat contact. These changes have improved the thrust capability and valve controllability.
