9508210208 950814 PDR ADDCK 05000237 S PDR L-V3604201/237/18094/010.R01

HPCI Room Cooler Fan Minimum Starting Voltage Above Second Level Undervoltage Relay Setpoint

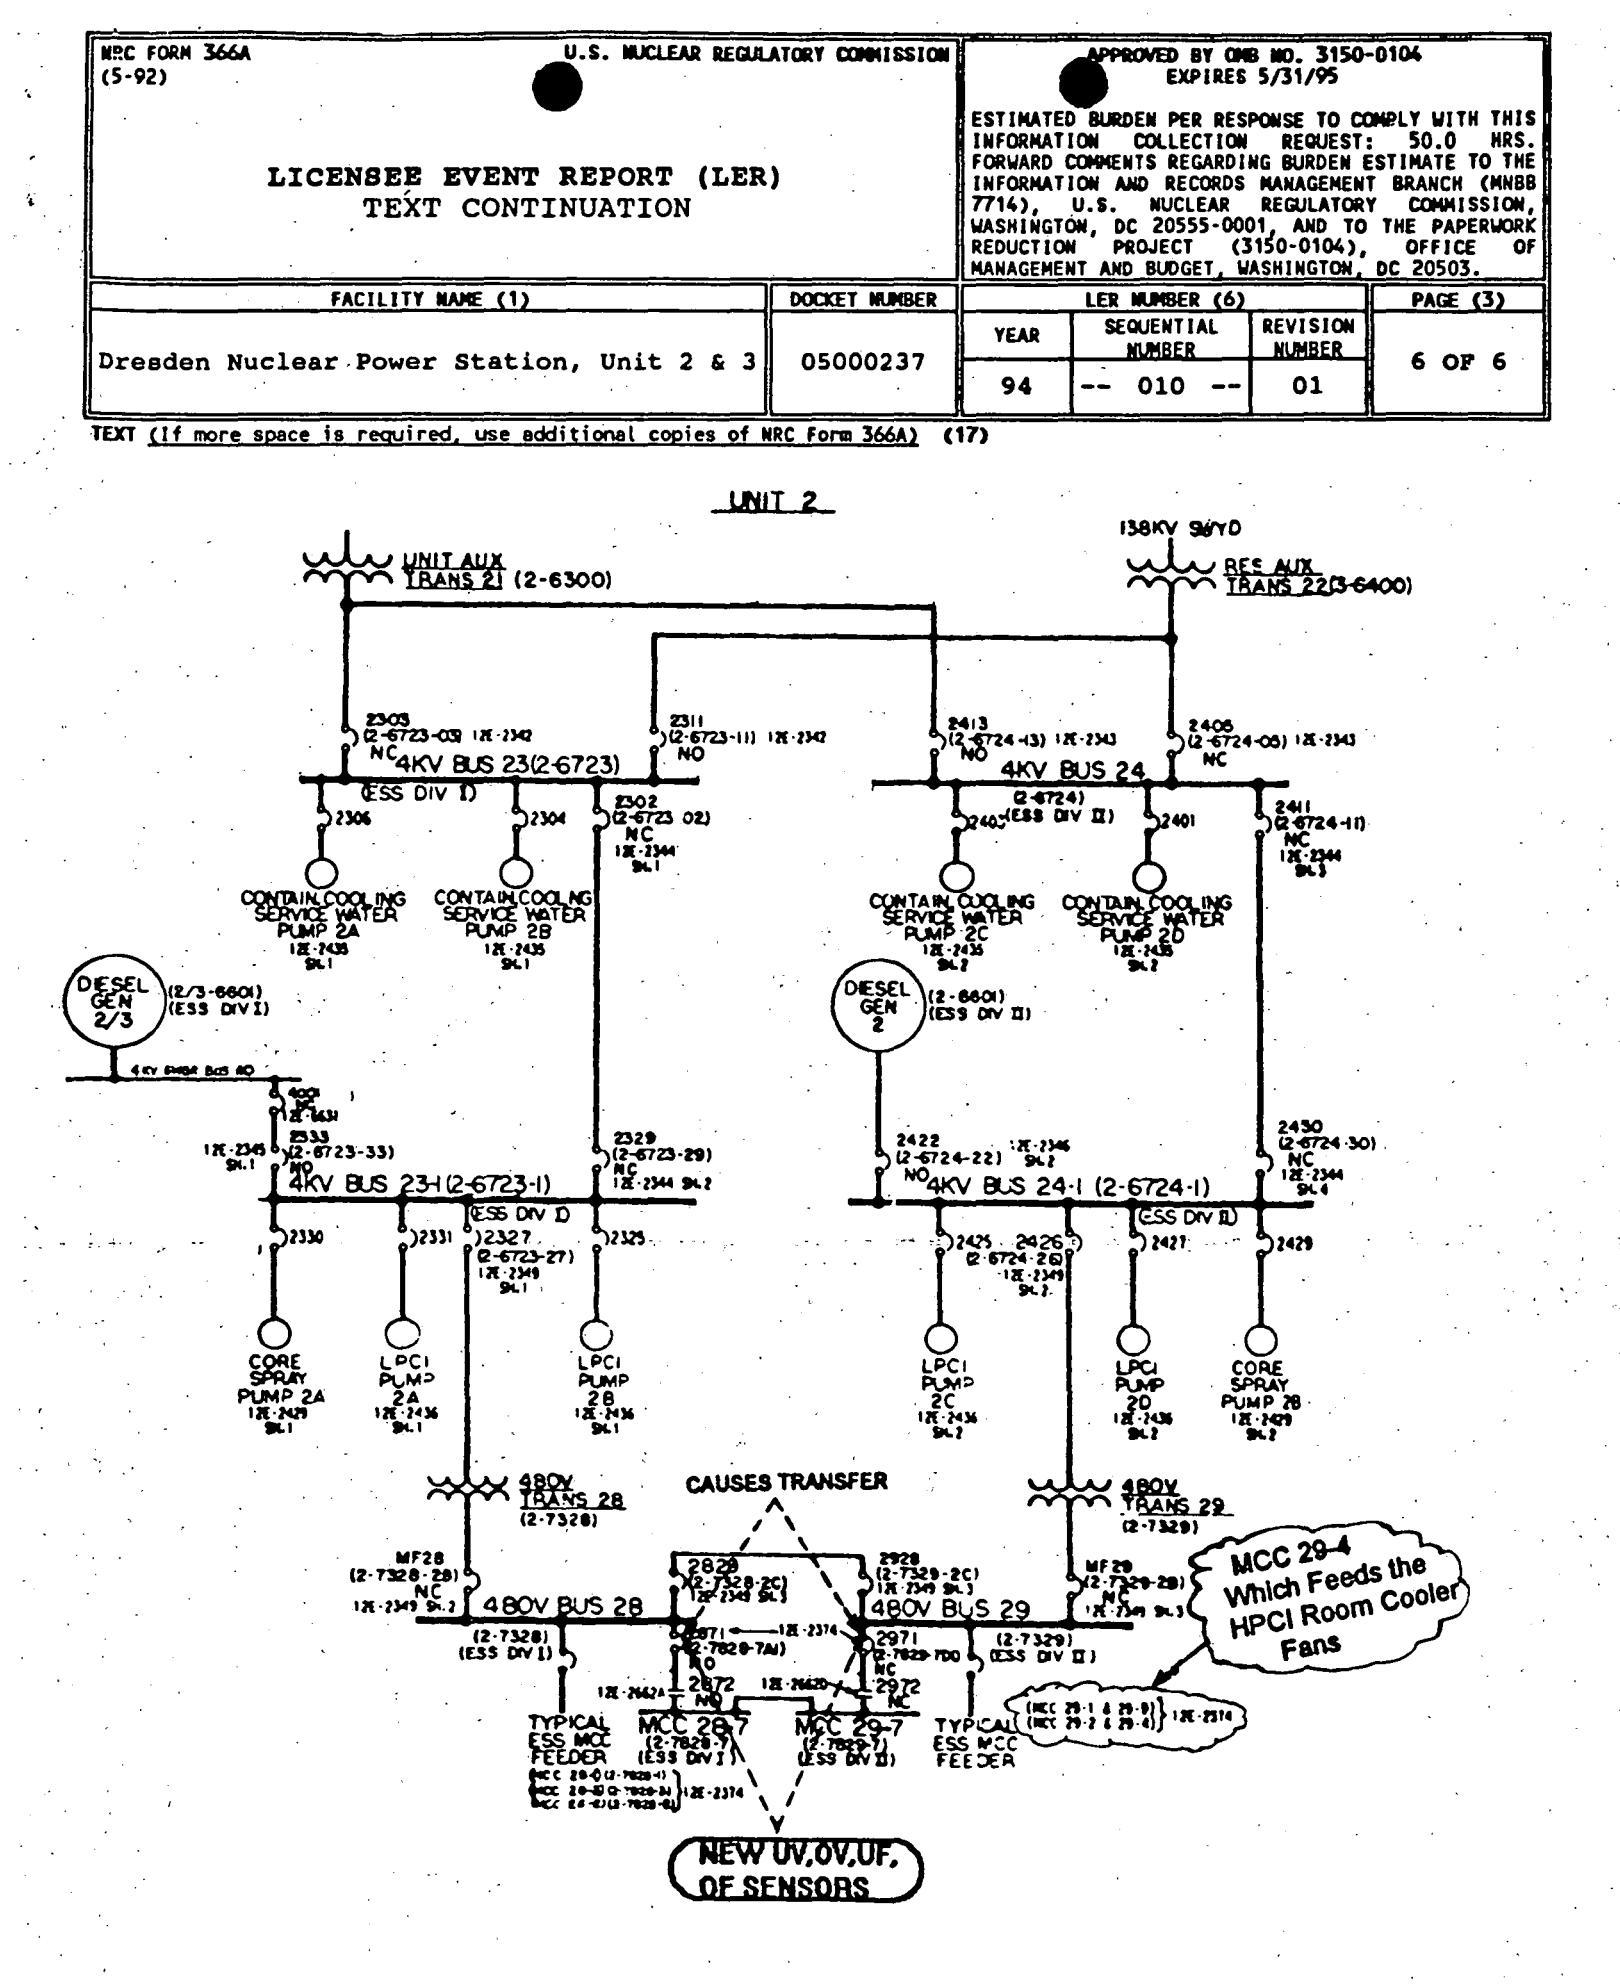
According to Commonwealth Edison's (ComED) Nuclear Engineering Department Mechanical Structural Group (NED M&S) letter concerning the Emergency Core Cooling System (ECCS) Room Cooler Operability Requirements, dated February 3, 1993, CHRON #198404, the HPCI room cooler fans are required to function in the event of a Designed Basis Accident (DBA) Loss Of Coolant Accident (LOCA). These room cooler fans are fed from Unit 2 480 VAC Bus 29 (MCC 29-4) and Unit 3 480 VAC Bus 39 (MCC 39-1); both of these busses are affected by their respective second level degraded voltage relay settings. (See attached sketch, Unit 3 is similar).
