Subject: Dresden Nuclear Power Station Unit 2, Core Shroud Examination Final Results NRC Docket No. 50-237

DRESDEN UNIT 2 CORE SHROUD EXAMINATION SUMMARY

DRESDEN UNIT 2 CORE SHROUD EXAMINATION ROLL OUT

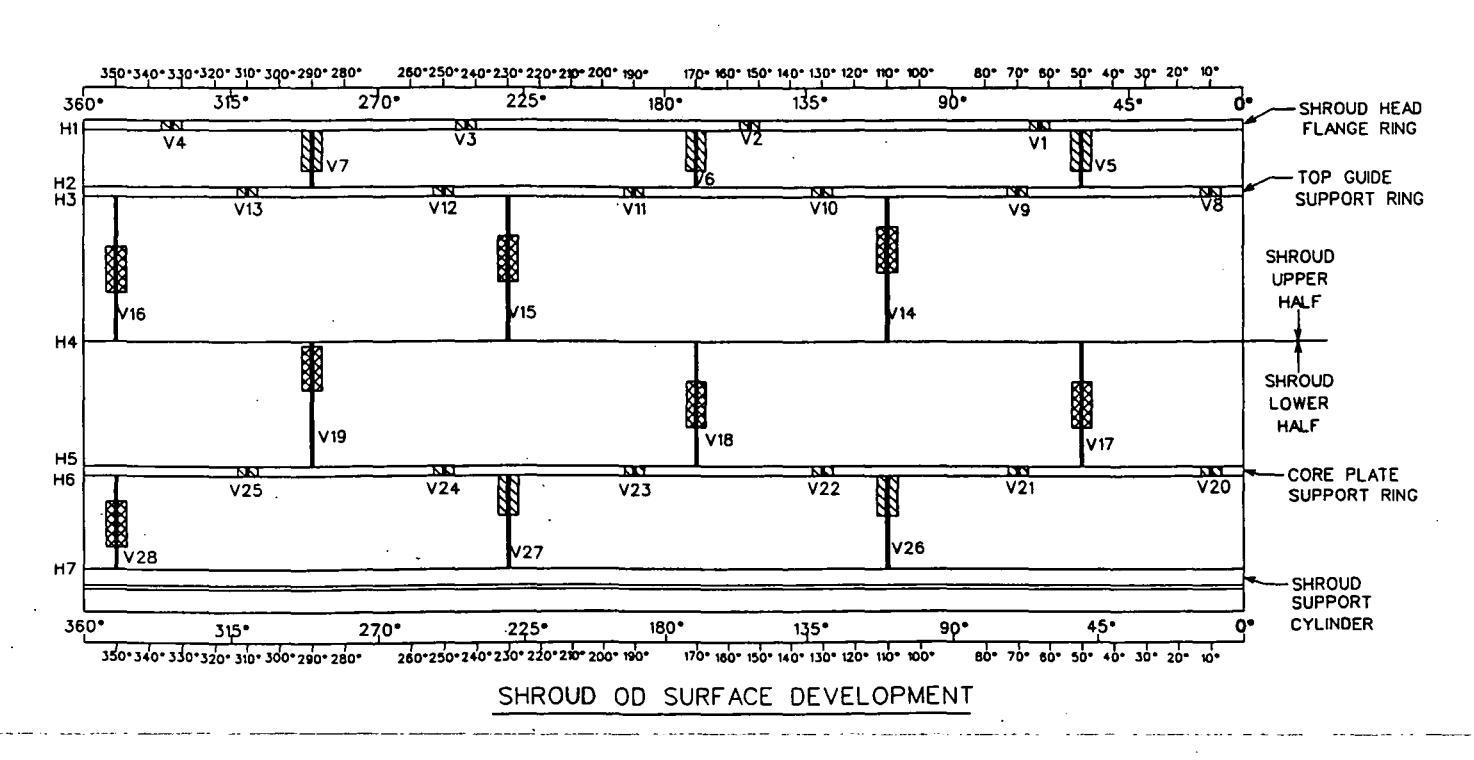
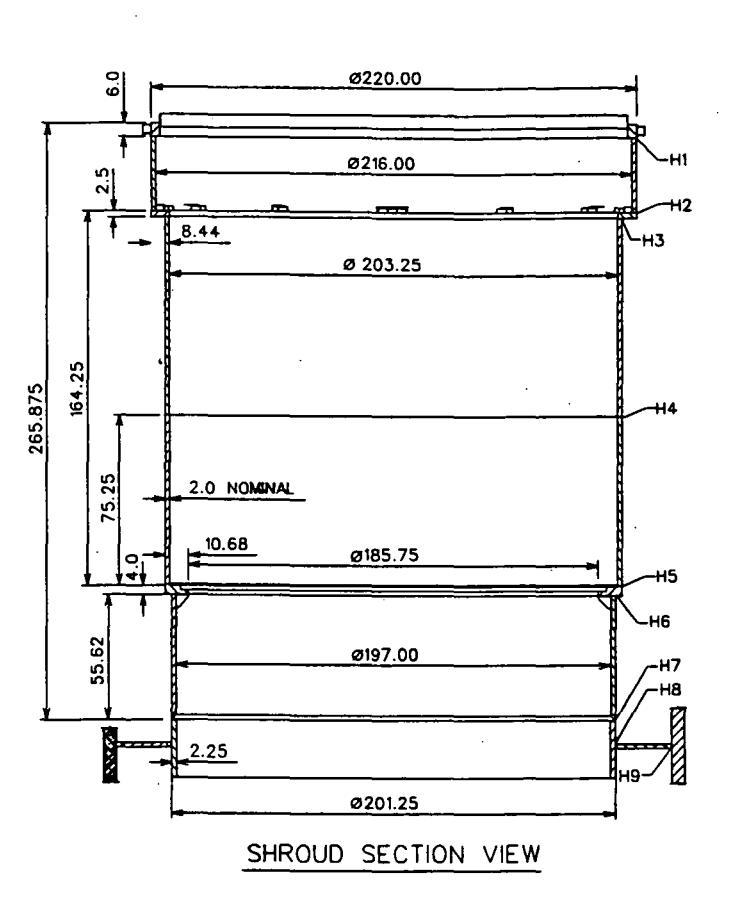
FIGURE 1

- o The ultrasonic examination scope consisted of shroud vertical welds V14 through V19 (located in the beltline region between horizontal welds H3 and H5), and V28 (located between horizontal welds H6 and H7). Approximately 27 inches, or between 30% and 50% of the total length of each vertical weld, was examined. These examinations resulted in no reportable indications.
- o The enhanced visual examination scope consisted of the ring segment welds associated with the shroud head flange ring, top guide support ring, and core plate support ring; vertical welds V1, V2, V3, V26, and V27; the H8 and H9 horizontal welds at the shroud repair hardware locations; and the shroud repair hardware attachment sites at the shroud head flange ring and the jet pump support plate. These examinations resulted in no reportable indications in the area of interest.

However, circumferential cracking associated with the H3 and H5 welds was identified during performance of the ring segment weld examinations. The H3 and H5 welds were not part of the core shroud examination scope per the Reference 4 Inspection Plan, because the installed comprehensive shroud repair was designed to structurally replace horizontal shroud welds H1 through H7. Therefore, the observed cracking has no adverse impact on core shroud structural integrity. Details of the cracking observed in the H3 and H5 welds are provided below.

One circumferential crack indication approximately 2 inches long was identified in the core plate support ring, and significant circumferential cracking (approximately 60 inches, or 85% of the of the area examined) was identified in the top guide support ring. The crack indication in the core plate support ring is located on the OD surface and is associated with the lower heat affected zone (HAZ) of the horizontal H5 weld. The cracking in the top guide support ring is located on the ID surface and is predominantly associated with the upper HAZ of the horizontal H3 weld, although some minor cracking (less than 12 inches) was also identified in the shroud plate material associated with the lower HAZ of the H3 weld.
