Dresden Unit 2 Core Spray Flaw Evaluation Report

September 10, 1995

DRESDEN UNIT 2 - CORE SPRAY FLAW EVALUATION REPORT

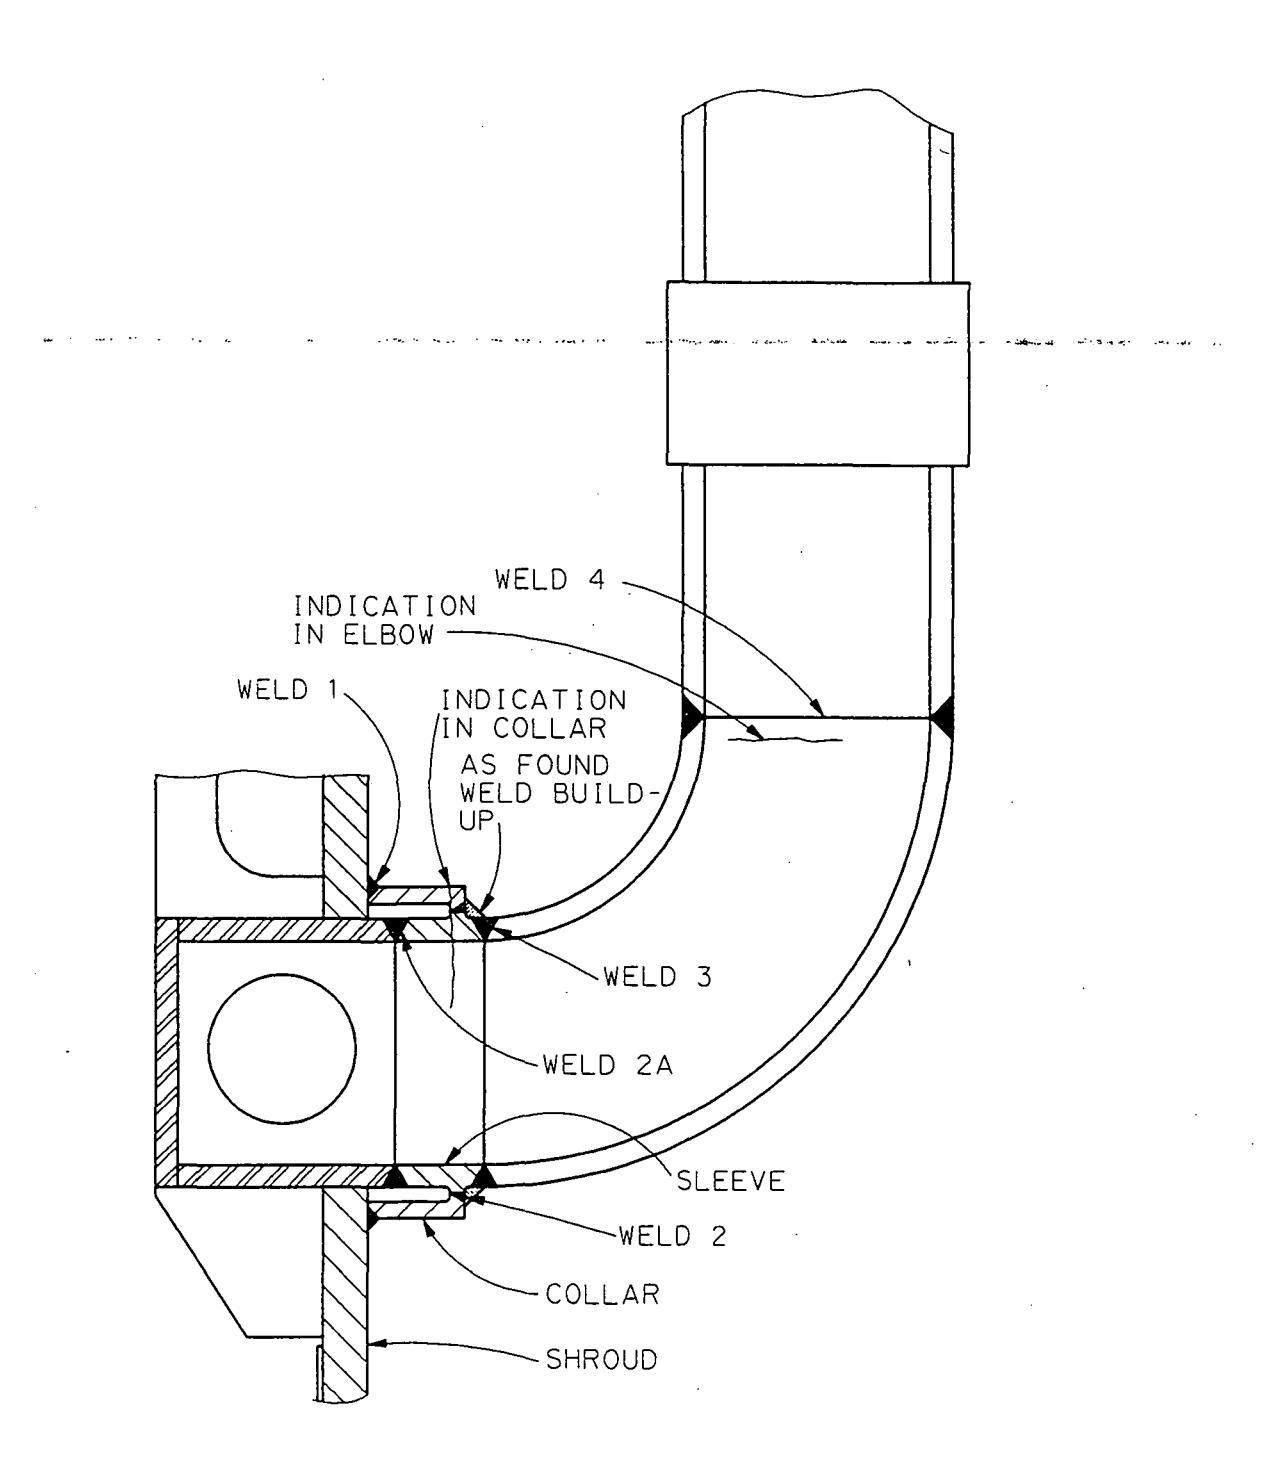
The flaw is located in the elbow side of the pipe to elbow weld, within the heat affected zone of weld 4 (See Figure 2.2). The flaw is located between the 9:30 position and the 12:00 position. Significant branching was observed within the length of the flaw. The total flaw length is estimated to be 3.5 inches.

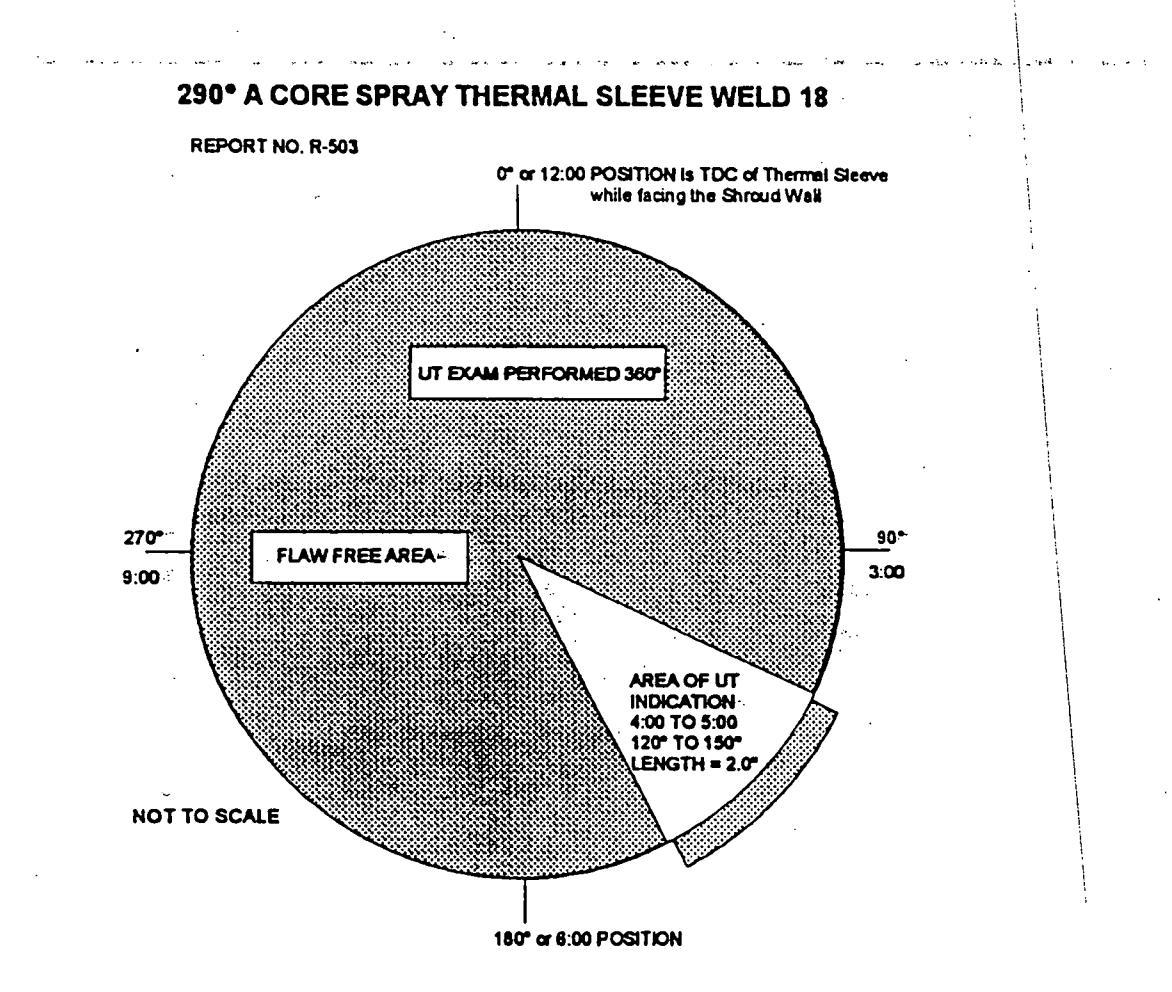
The enhanced visual examination detected a crack in the thermal sleeve collar, approximately 0.5 inches back from the face of the collar, between the 4:00 and 5:00 position with an estimated total length of 2 inches. The UT examination of this thermal sleeve, Figure 2.3, confirmed the presence of the crack and indicated it to be ID connected. The crack was identified by UT to extend from approximately 4:00 to 5:00 (same location as OD visual examination) with an estimated length of 2 inches. The UT examination covered 360° of the thermal sleeve circumference, with no additional flaw indications detected.

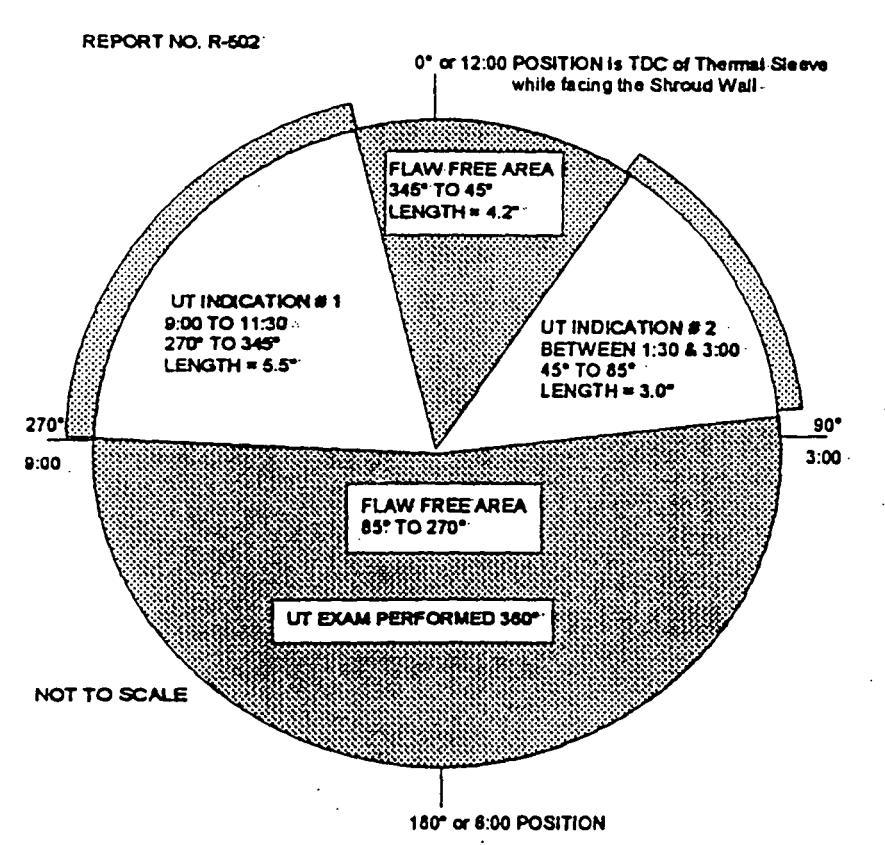
Figure 2.4 Ultrasonic Testing Examination Area And Flaw Location Thermal Sleeve Weld 2

The enhanced visual examination detected a crack in the thermal sleeve collar at approximately 0.5 inches back from the face of the collar, between the 9:00 and 10:00 positions with an estimated flaw length of 2.25 inches. The UT examination of this thermal sleeve, Figure 2.4, confirmed the presence of this crack and indicated it to be ID connected. The crack was identified by UT to extend from approximately 9:00 to 11:30 with an estimated length of 5.5 inches. The UT examination also detected another crack indication (believed to be ID connected) that was not visually detected. The crack was identified by UT to extend from approximately 1:30 to 3:00 with an estimated length of 3 inches. The UT examination covered 360° of the thermal sleeve, with no additional flaw indications detected.

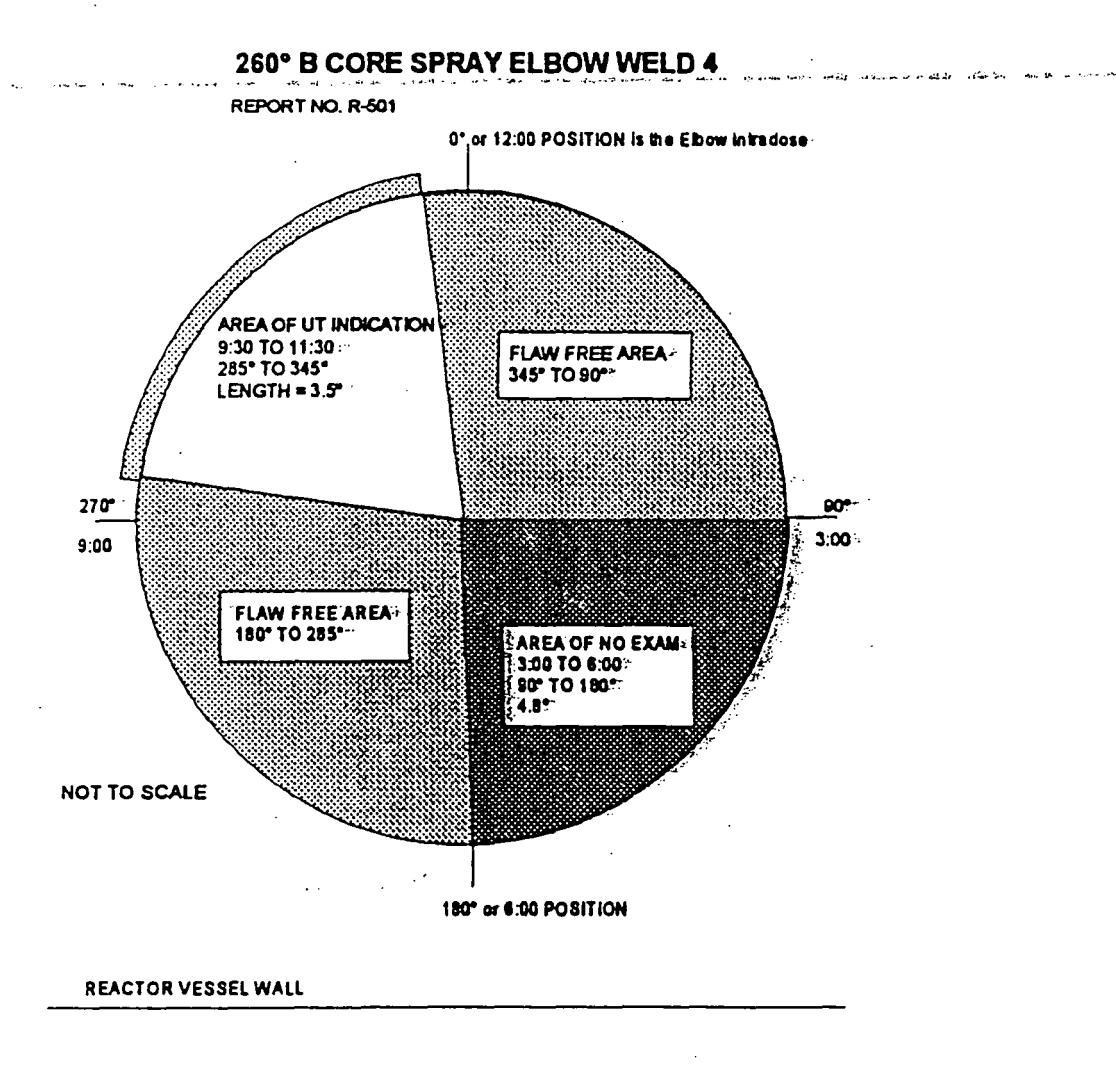
The enhanced visual examination detected a crack in the pipe to elbow weld, within the heat affected zone of weld 4, between the 9:30 and 12:00 position with an estimated length of 3.5 inches. The UT examination of this elbow weld, Figure 2.5, confirmed the presence of the crack and indicated it to be ID connected. The crack was identified by UT to extend from approximately 9:30 to 11:30 (same approximate location as OD visual examination) with an estimated length of no more than 3.5 inches. The UT examination covered approximately 270° of the elbow weld circumference, with no additional flaw indications detected.

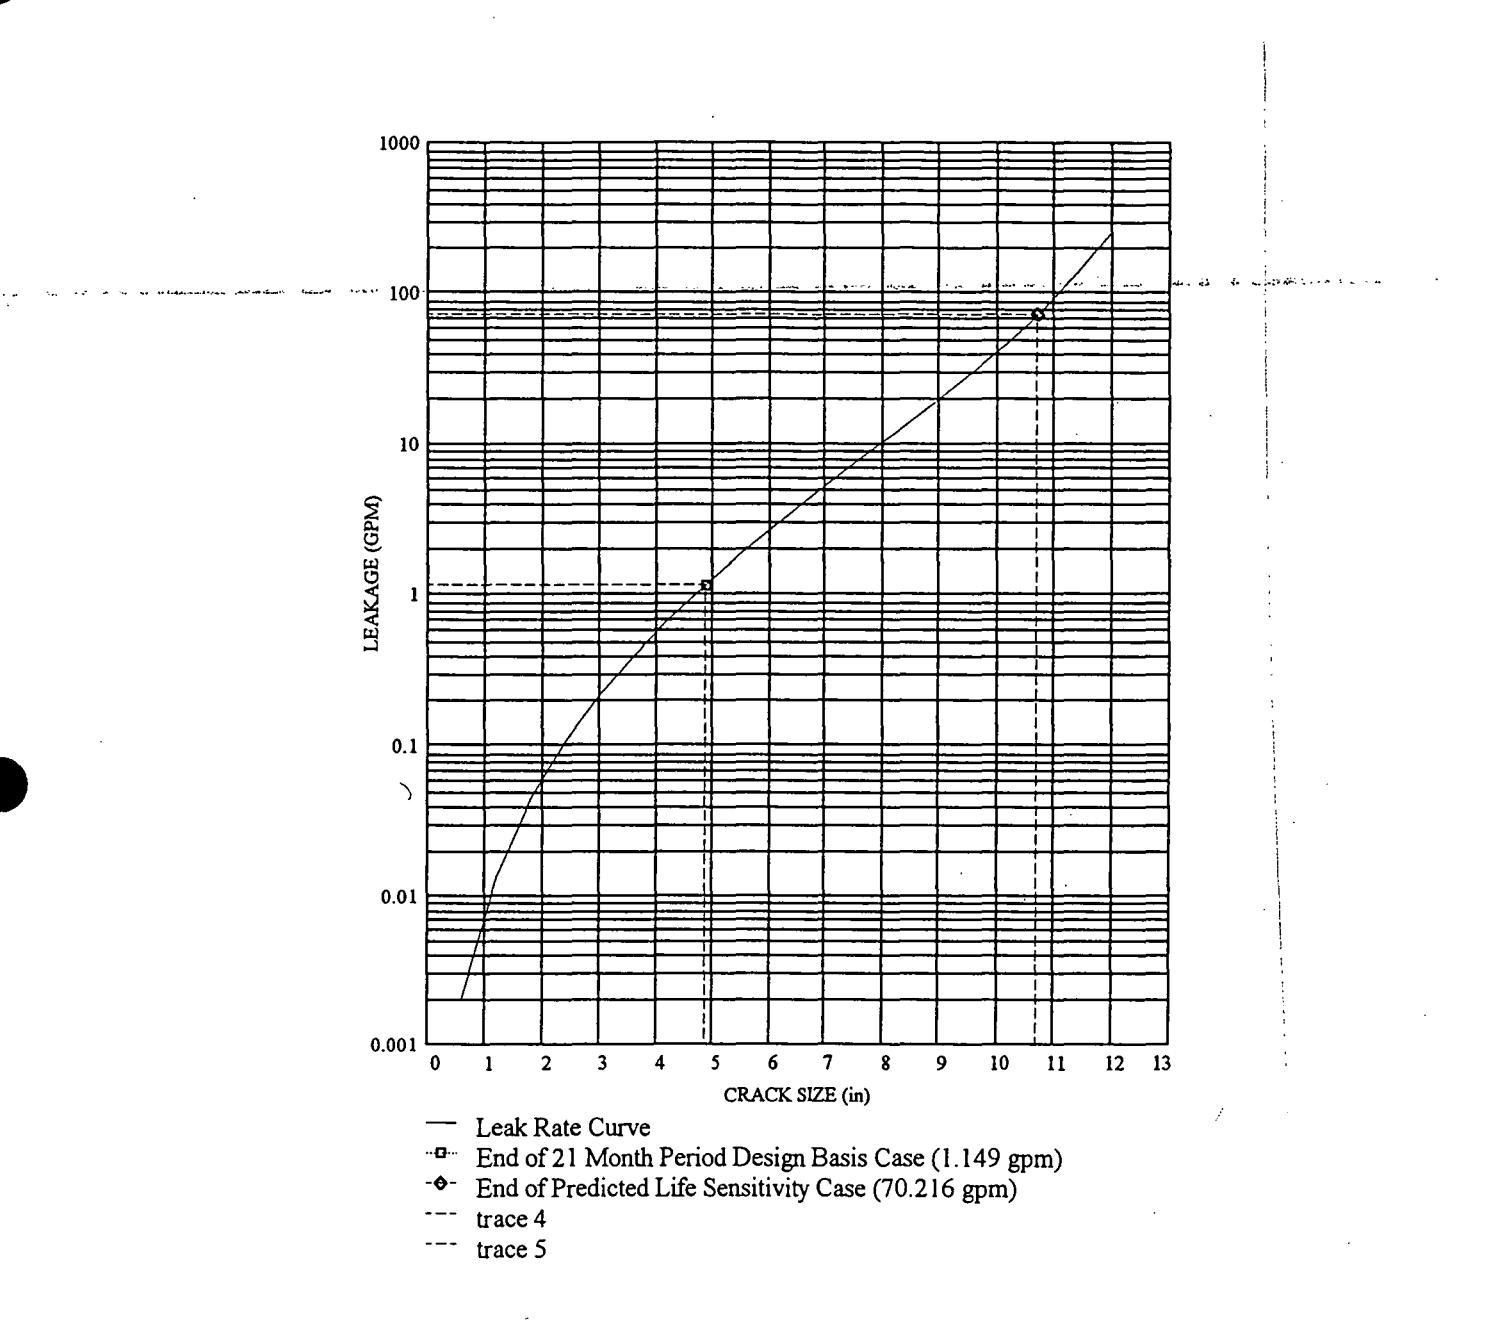
Figure 8.1 Leakage Rate at a Differential Pressure of 47psi

The leakage was calculated based on the previously described loads and material properties and presented in Figures 8.1 and 8.2 for an injection pressure of 47psid and 64 psid respectively. From Figure 8.1, the leak rate for the end of evaluation flaw size is 1.15 gpm and at the end of life is 70.22 gpm. From Figure 8.2, the leak rate for the end of evaluation flaw size is 1.38 gpm and at the end of life is 82.84 gpm. The end of life flow rates calculated here are based the conservative thermal stresses generated from a more rigid model. Since the end of life flaw length is significantly larger than the 60° flaw used in the piping model, the flexibility of the model could be increased, thus reducing the piping membrane and bending stresses and the corresponding leakage flows. The results of this leakage evaluation are compared to the system capacity in Section 9.0 of this report.

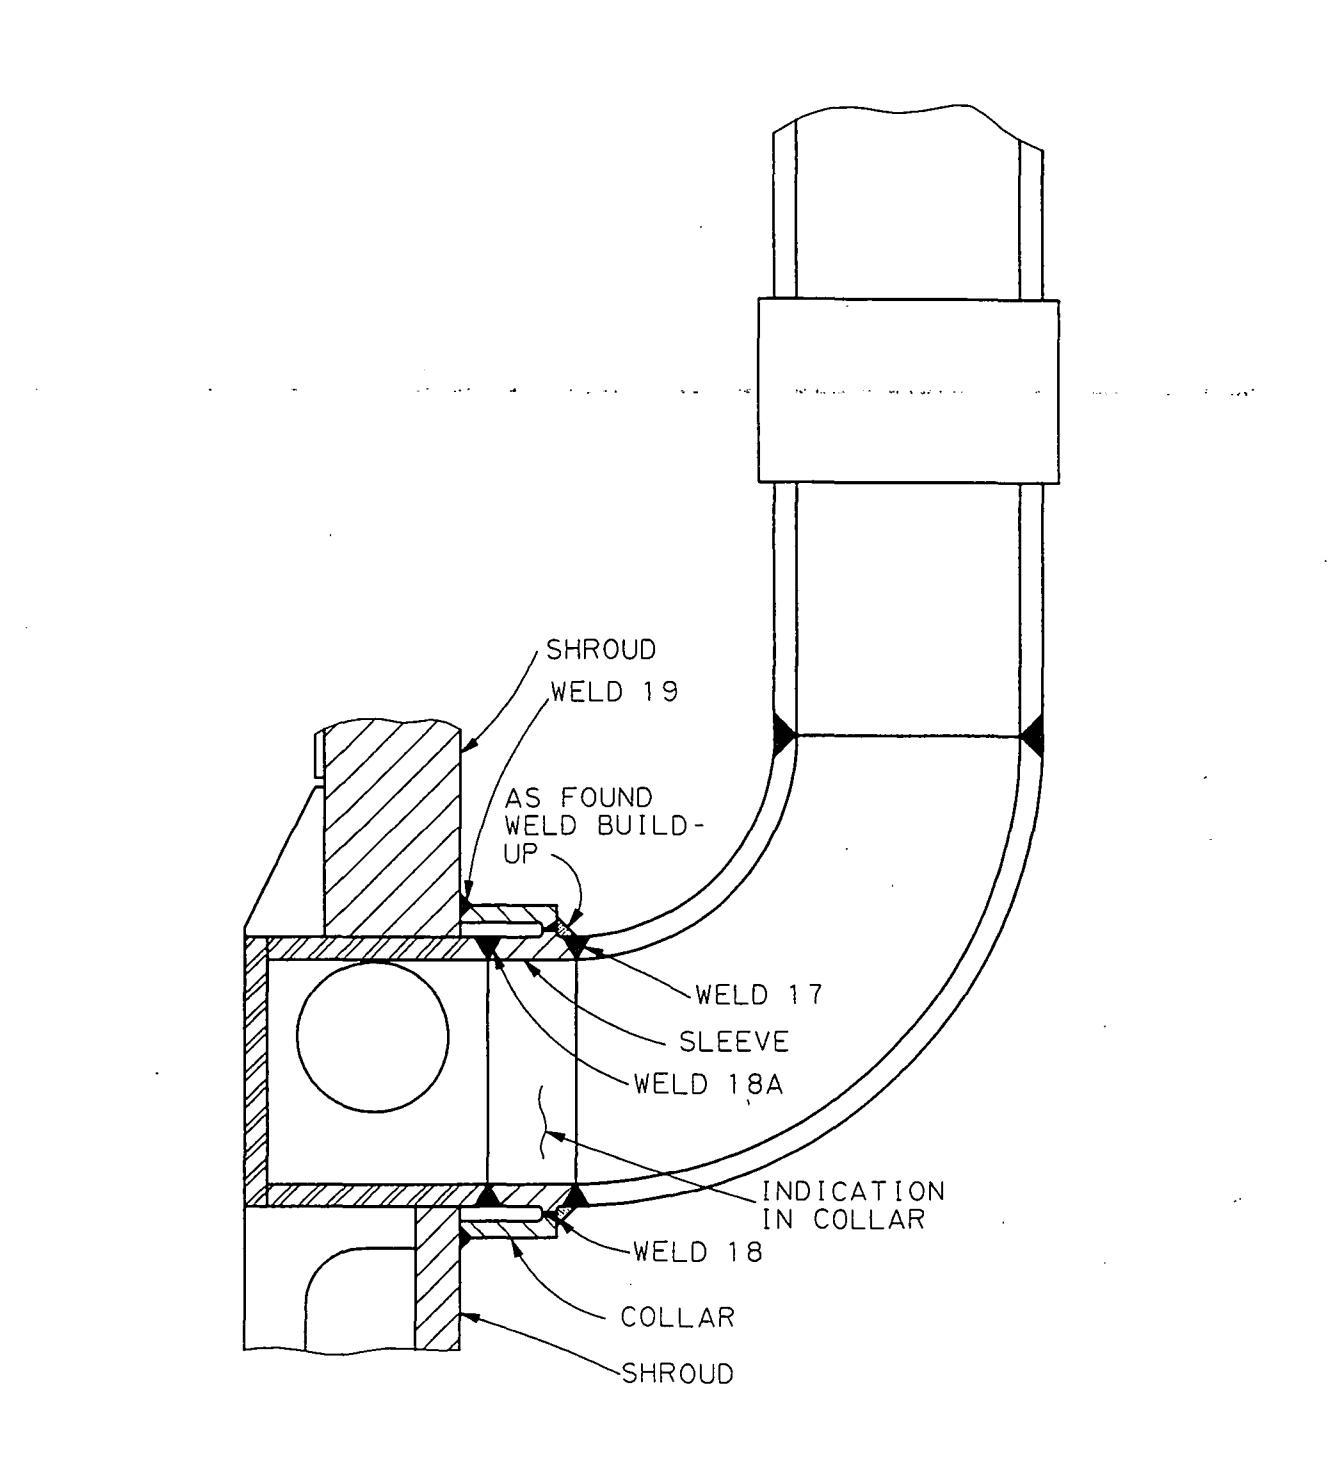
Figure 3.1 Core Spray A-Loop 290° Upper Sparger Inlet Thermal Sleeve

An enhanced visual inspection (0.5 mil wire resolution) was performed during the D2R14 refuel outage, covering 100 percent of the internal core spray piping header and downcomer welds. Crack like indications were identified in three locations. Ultrasonic (UT) examinations were performed to characterize the length of the OD connected flaws which were first detected with an enhanced visual inspection and to detect any ID connected flaws which may be less than through wall in depth. The ultrasonic technique used for the examination of the visually detected flaws in the core spray piping was developed by GE and was qualified using mockups. The UT technique and qualification process was independently reviewed by EPRI (Reference 4) and ComEd and is described in Section 2.2 of Reference 1. Figures 3.1 and 3.2 illustrate the configuration of the core sprayer inlet thermal sleeve collar and elbow. This technique proved to be useful in verifying the endpoints of the visually-detected flaws, whether the flaw extremities are connected to the inside or the outside surface. However, it was not practical to measure crack depth or to distinguish inside-surface from outside-surface cracking because of the thin wall.
