Subject: Dresden Nuclear Power Station, Unit 3 Core Shroud Examination Final Results, Revision 1. NRC Docket No. 50-249

# DRESDEN UNIT 3 CORE SHROUD EXAMINATION FINAL RESULTS

# GE NUCLEAR ENERGY - ROOT CAUSE EVALUATION OF CORE PLATE SUPPORT RING VERTICAL CRACKING

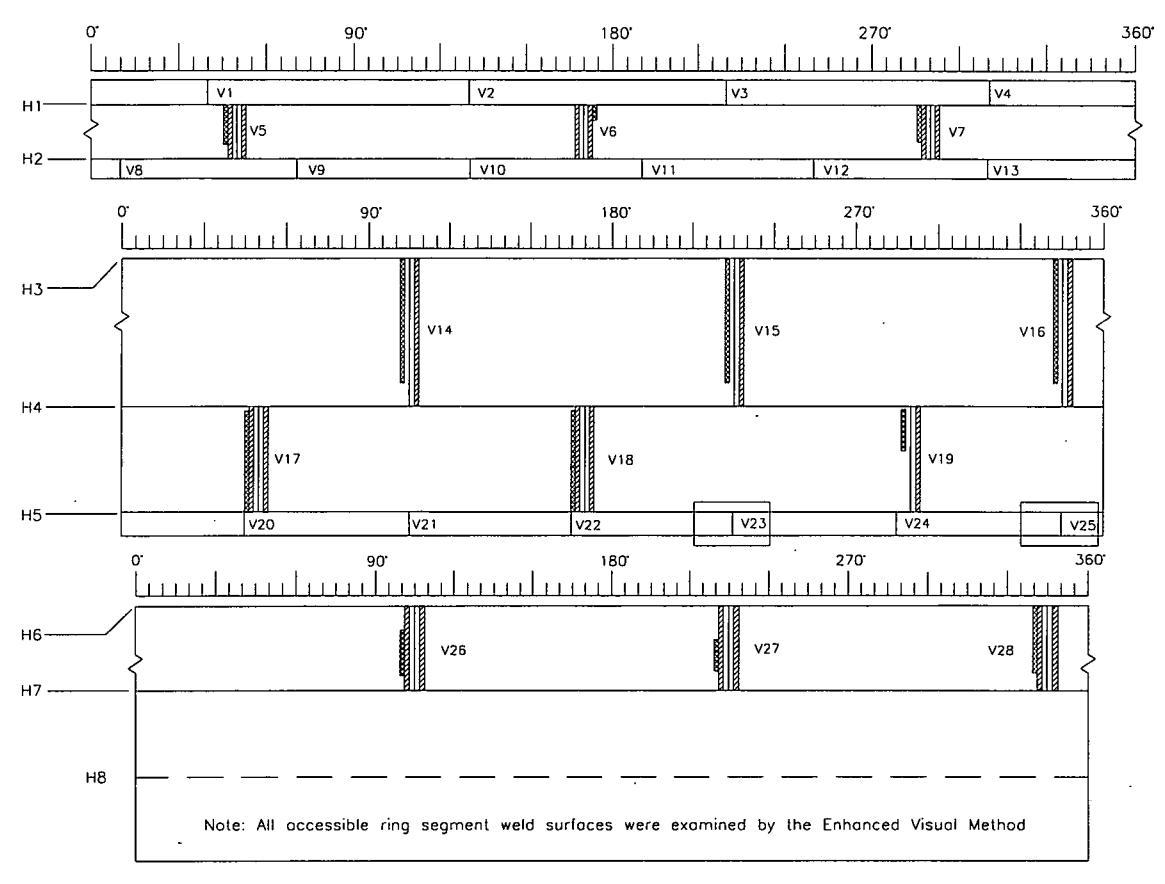
## FIGURE 1

- The ultrasonic examination scope consisted of shroud vertical welds V5 through V7 (located between the H1 and H2 circumferential welds), V14 through V19 (located in the beltline region between circumferential welds H3 and H5), and V26 through V28 (located between circumferential welds H6 and H7). A total of 551 inches of the 760 inches of total cumulative vertical weld length (or 72.5%) was examined by at least one search unit from one side of the weld. Individual UT length coverage of all 12 vertical shroud welds ranged from between 34% and 96% per weld. These examinations resulted in no reportable indications.

- The enhanced visual examination scope consisted of the ring segment welds associated with the shroud head flange ring (V1 through V4), top guide support ring (V8 through V13), and core plate support ring (V20 through V25); the H8 and H9 circumferential welds at the shroud repair hardware locations; and the OD surface of all 12 vertical shroud welds on the side of the weld opposite from the UT search unit. These examinations resulted in no reportable indications in the area of interest.

# DRESDEN UNIT 3 CORE SHROUD EXAMINATION ROLL OUT

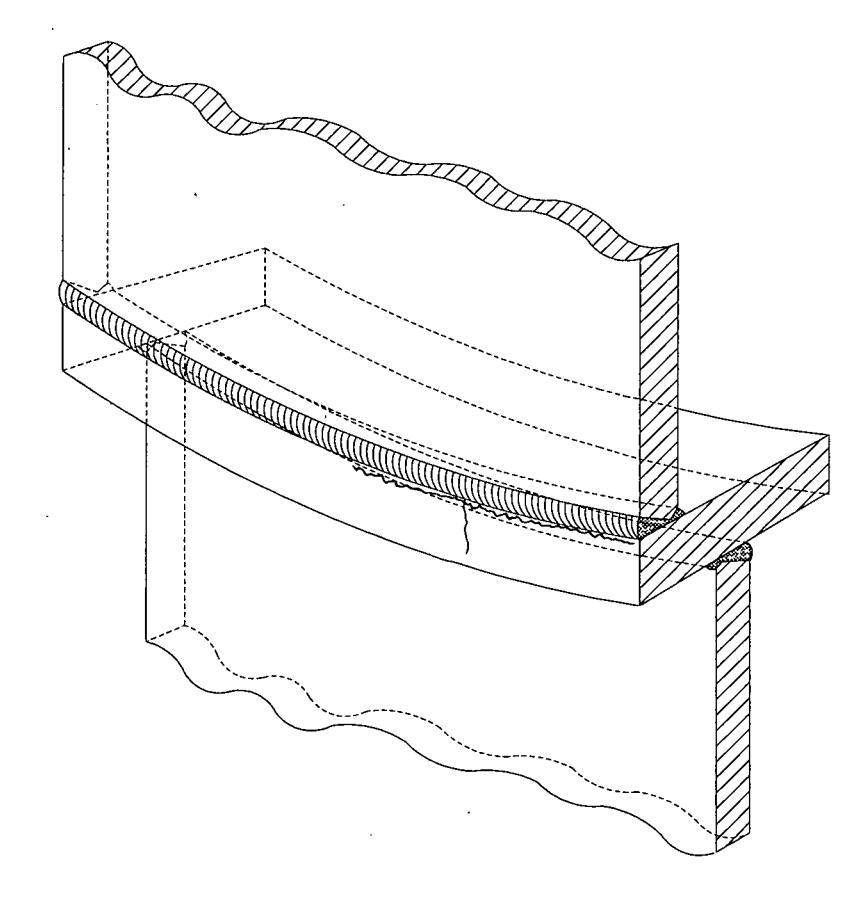
# FIGURE 2

The vertically oriented cracking identified in the vicinity of the V23 and V25 ring segment welds was contained in an area of heavy localized grinding on the OD surface of the ring. The cracking is confined to this area of localized grinding and branches down from the circumferentially oriented cracking in the lower heat affected zone (HAZ) of the H5 weld (see Figure 2).

- Note 1: Vertically oriented cracking was identified visually in the vicinity of the V23 and V25 ring segment welds. Supplemental UT sizing provided the following information:
  - V23 2.8 inches in vertical length extending downward from the H5 circumferential weld. Maximum radial through wall depth was 0.50 inches, with average depth between 0.25 inches and 0.40 inches.
  - V25 Exact vertical length could not be determined due to shallow depth and flaw orientation, however, the area of flaw length sized was 1.2 inches in vertical length extending downward from the H5 circumferential weld. Maximum radial through wall depth was 0.25 inches, with average depth between 0.15 inches and 0.25 inches.

Additionally, even if it were assumed that the vertically oriented cracking was associated with the V23 and V25 ring segment welds, the radial depth of the cracking is shallow and structural margins are ensured for a minimum of 4 operating cycles after applying a radial crack growth rate of  $5 \times 10^{-5}$  inches per hour. The core plate support ring is 4.0 inches thick with a radial width of 10.68 inches, where only an area of 7.4 square inches of unflawed ligament is required for the ring to maintain full structural integrity under all design basis and beyond events. (Reference 8)

# CORE PLATE SUPPORT RING INDICATION (TYPICAL)
