LICENSEE EVENT REPORT (LER)

FACILITY NAME (1)	DOCKET (2)		LER NUMBER (6	}	PAGE (3)	
		YEAR	SEQUENTIAL NUMBER	REVISION NUMBER		
Dresden Nuclear Power Station, Unit 2	05000237	98	006	00	2 OF 6	_

Unit 2 Reactor Scram While Shutdown from Scram Discharge Instrument Volume Level HI-HI, caused by leaks in two 2-0305-102 valves (HCU WITHDRAW VLV).

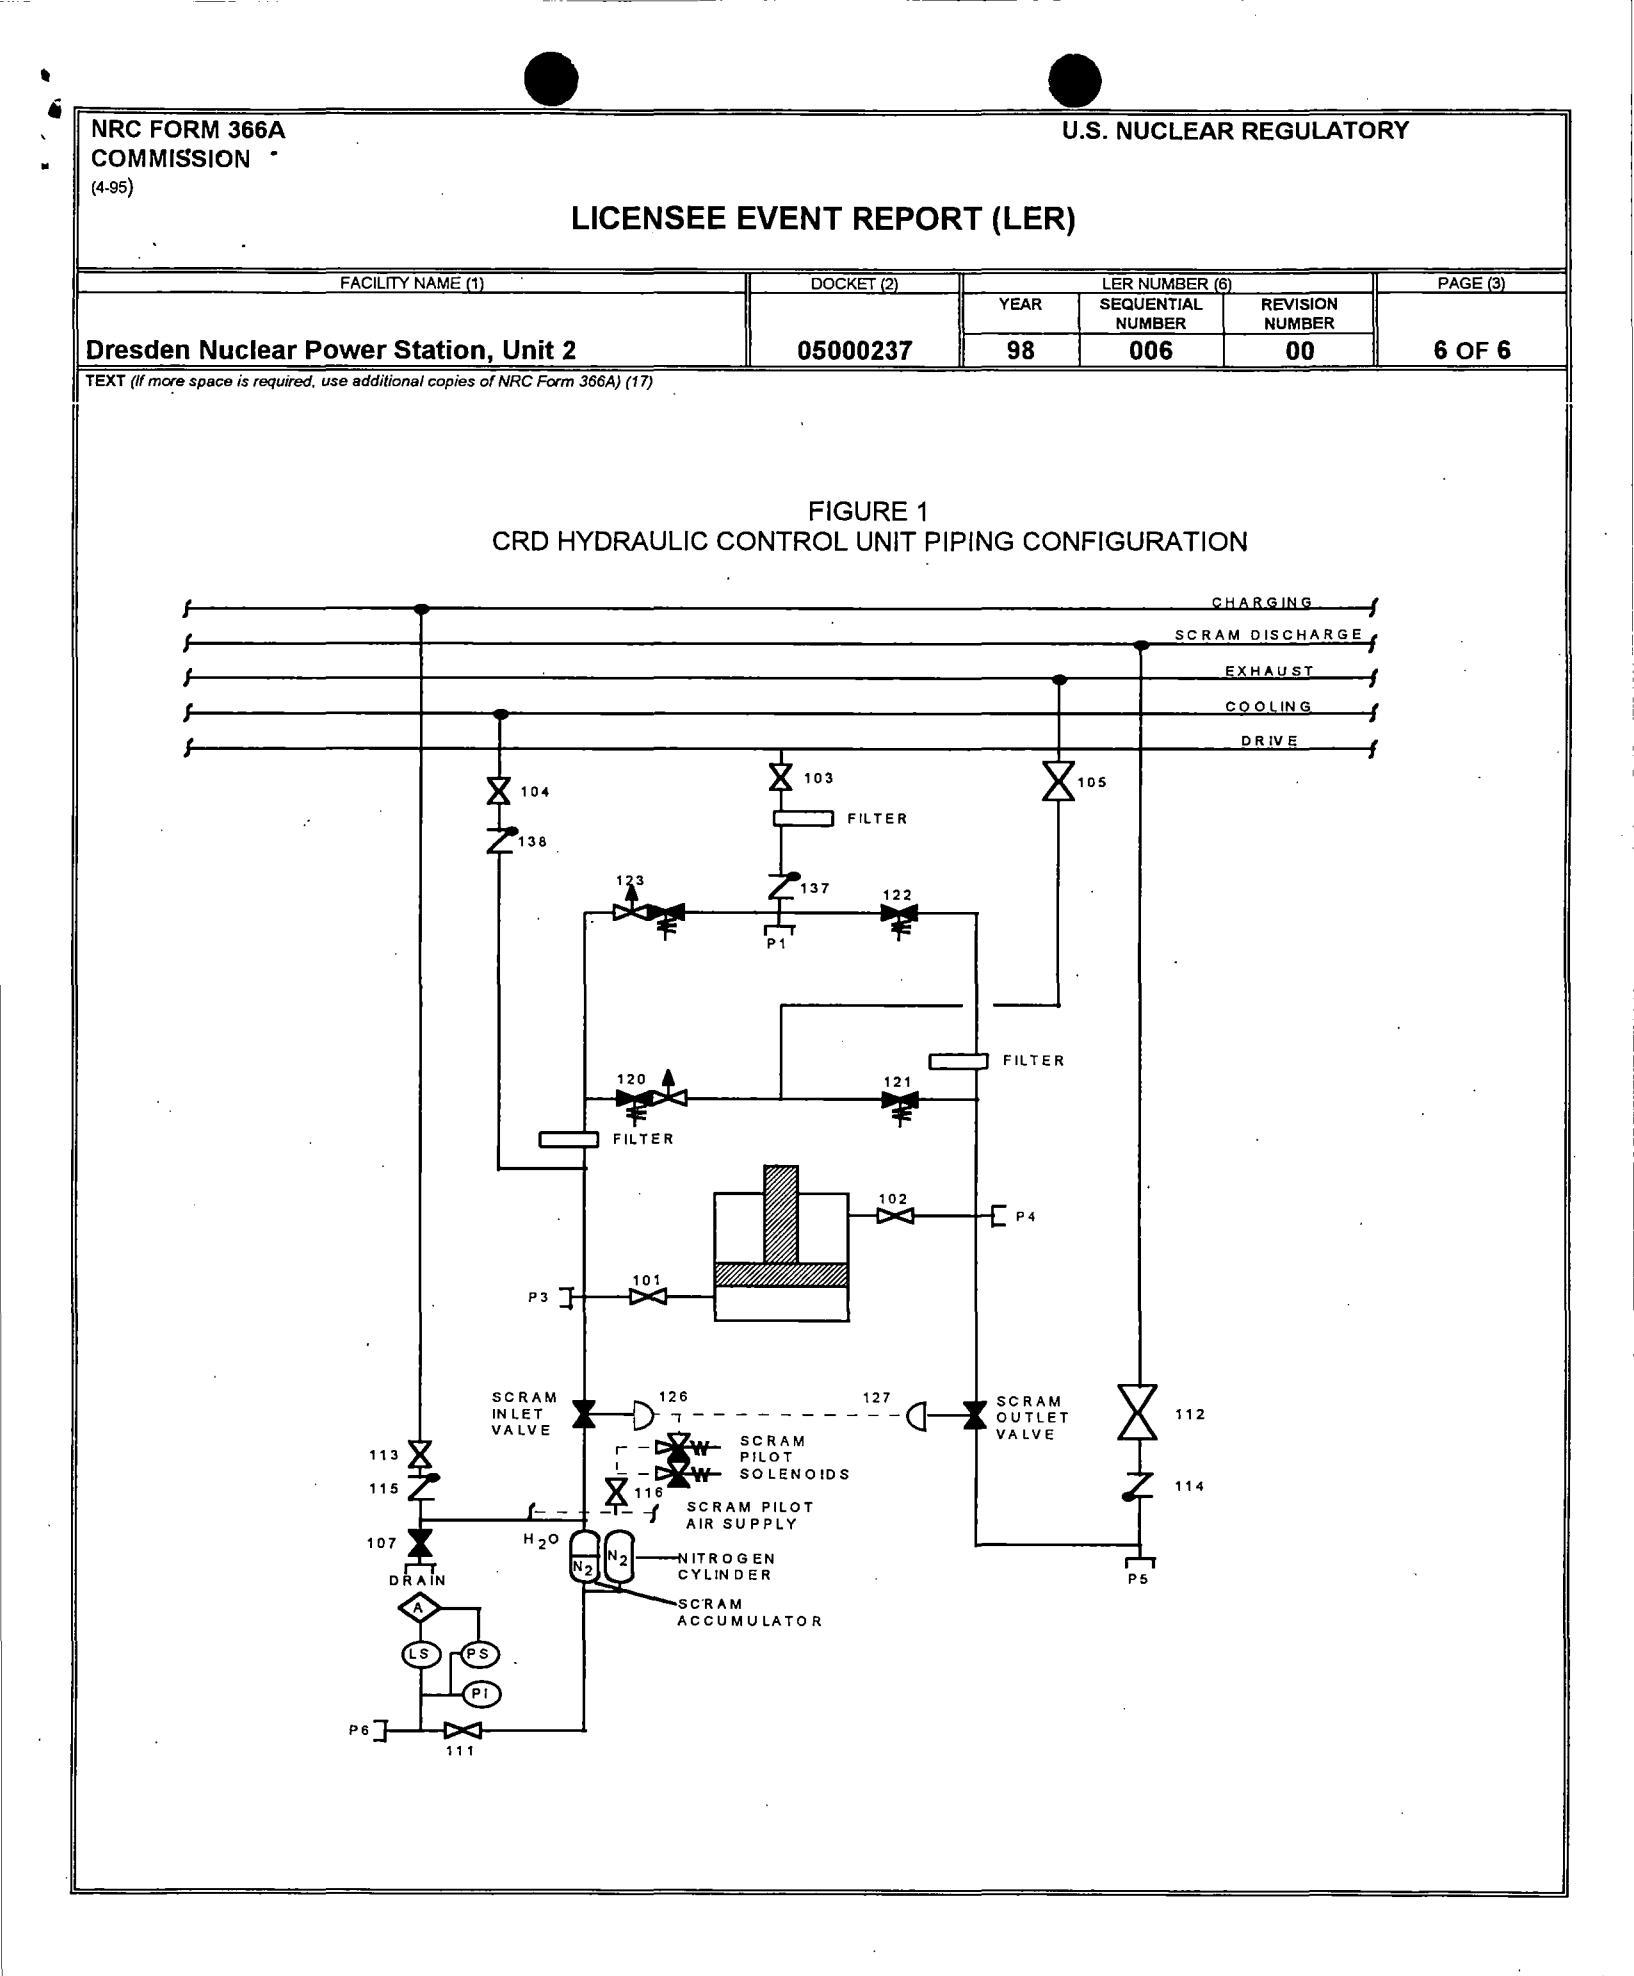
- SIV Volume Not Drained Indication of rising level within the SIV causing no automatic action,
- SIV HI Level Indication of level above the "Not Drained" alarm, and generates a Control Rod withdrawal Rod Block in the Reactor Manual Control System, and
- SIV HI-HI Level Generates an alarm, in addition to generating a full trip of RPS logic. The function of the SIV HI-HI Level RPS trip is to cause the full insertion of all Control Rods while adequate free volume is available within the SIV to receive water exhausted from the Control Rod over-piston during insertion. (Figure 1, CRD Hydraulic Control Unit Piping Configuration)
