Commonwealth Edison Company

Subject: <u>License DPR-19</u>, <u>Dresden Nuclear Power Station</u> Unit #2 Section 6.6.B.2 of the Technical Specifications

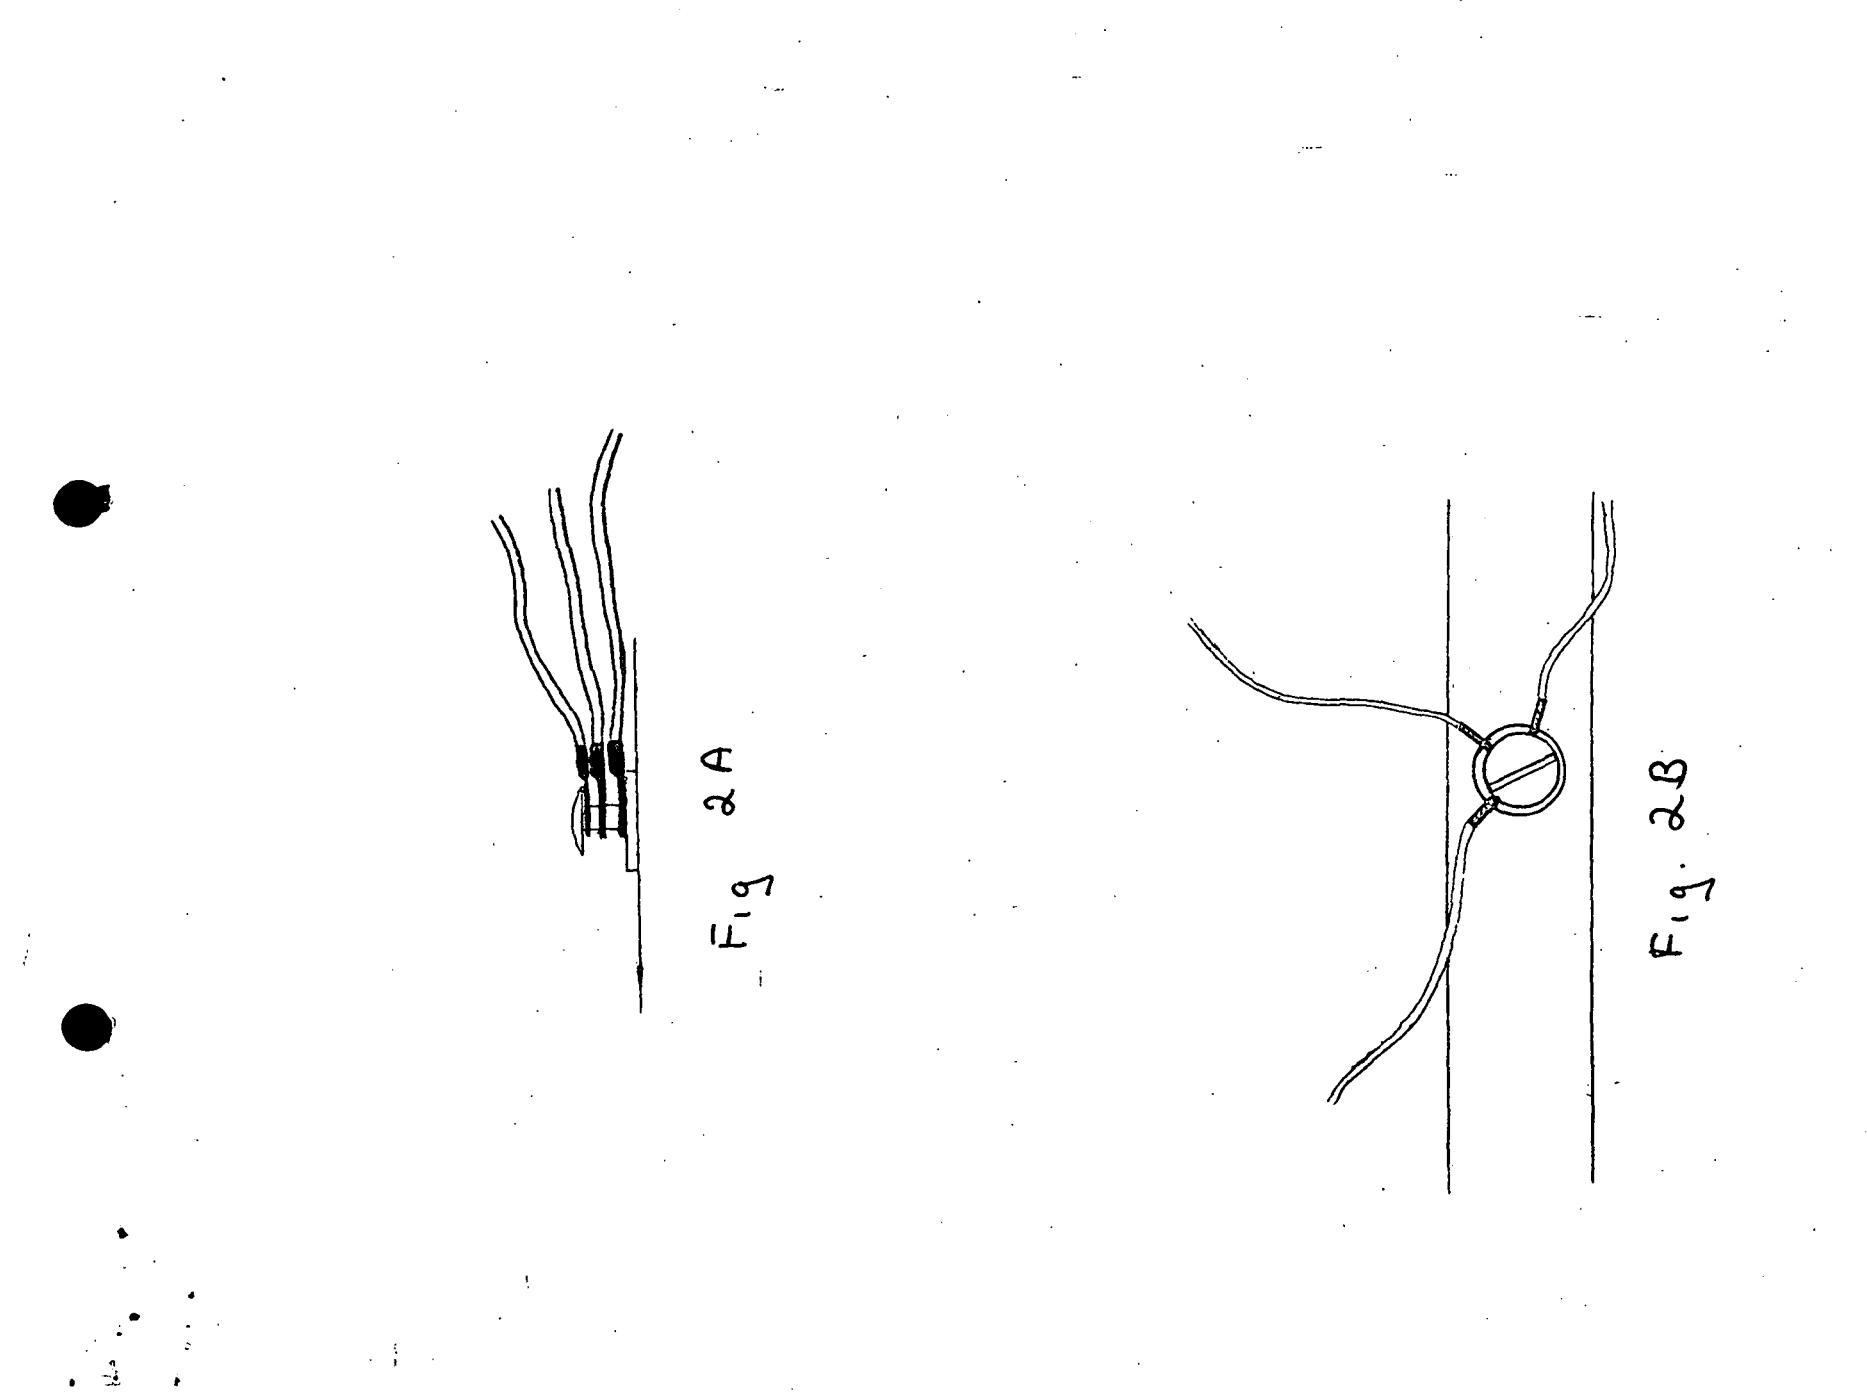
Investigation revealed a loose connector lug at termingl 25A5 (See Figure 1). Because this lug was not properly connected, the SDR relay de-energized when diesel engine vibration caused the circuit to open intermittently. The SDR relay must be energized in order to have the diesel cooling water pump running. The SDR relay also energizes the VSR relay (generator excitation start relay). De-energizing the VSR relay would cause the voltage regulator to shut down.

The terminal connection became loose because of the way the lugs were positioned on the terminal screw (see Figure 2A). The connectors were positioned one on top of the other. This prevented the screw from being

properly tightened. The connector lugs were then repositioned such that the terminal screw could be securely tightened (See figure 2B). The Unit #3 and Unit #2/3 diesel generators were checked and found satisfactory. Following repairs the Unit 2 diesel generator was tested satisfactory and declared operable at 1705 hrs. on July 24, 1972.
