Subject: Response to NRC Bulletin No. 87-01
Dresden Station Units 2 & 3
Quad Cities Station Units 1 & 2
Zion Station Units 1 and 2
LaSalle County Station Units 1 & 2
Byron Station Units 1 & 2
Braidwood Station Units 1 & 2
NRC Docket Nos. 50-237/249, 50-254/265, 50-295/304,
50-373/374, 50-454/455 and 50-456/457

Reference: NRC Bulletin No. 87-01, dated July 9, 1987

DRESDEN STATION

Response to Items 1 - 5 of NRC Bulletin 87-01

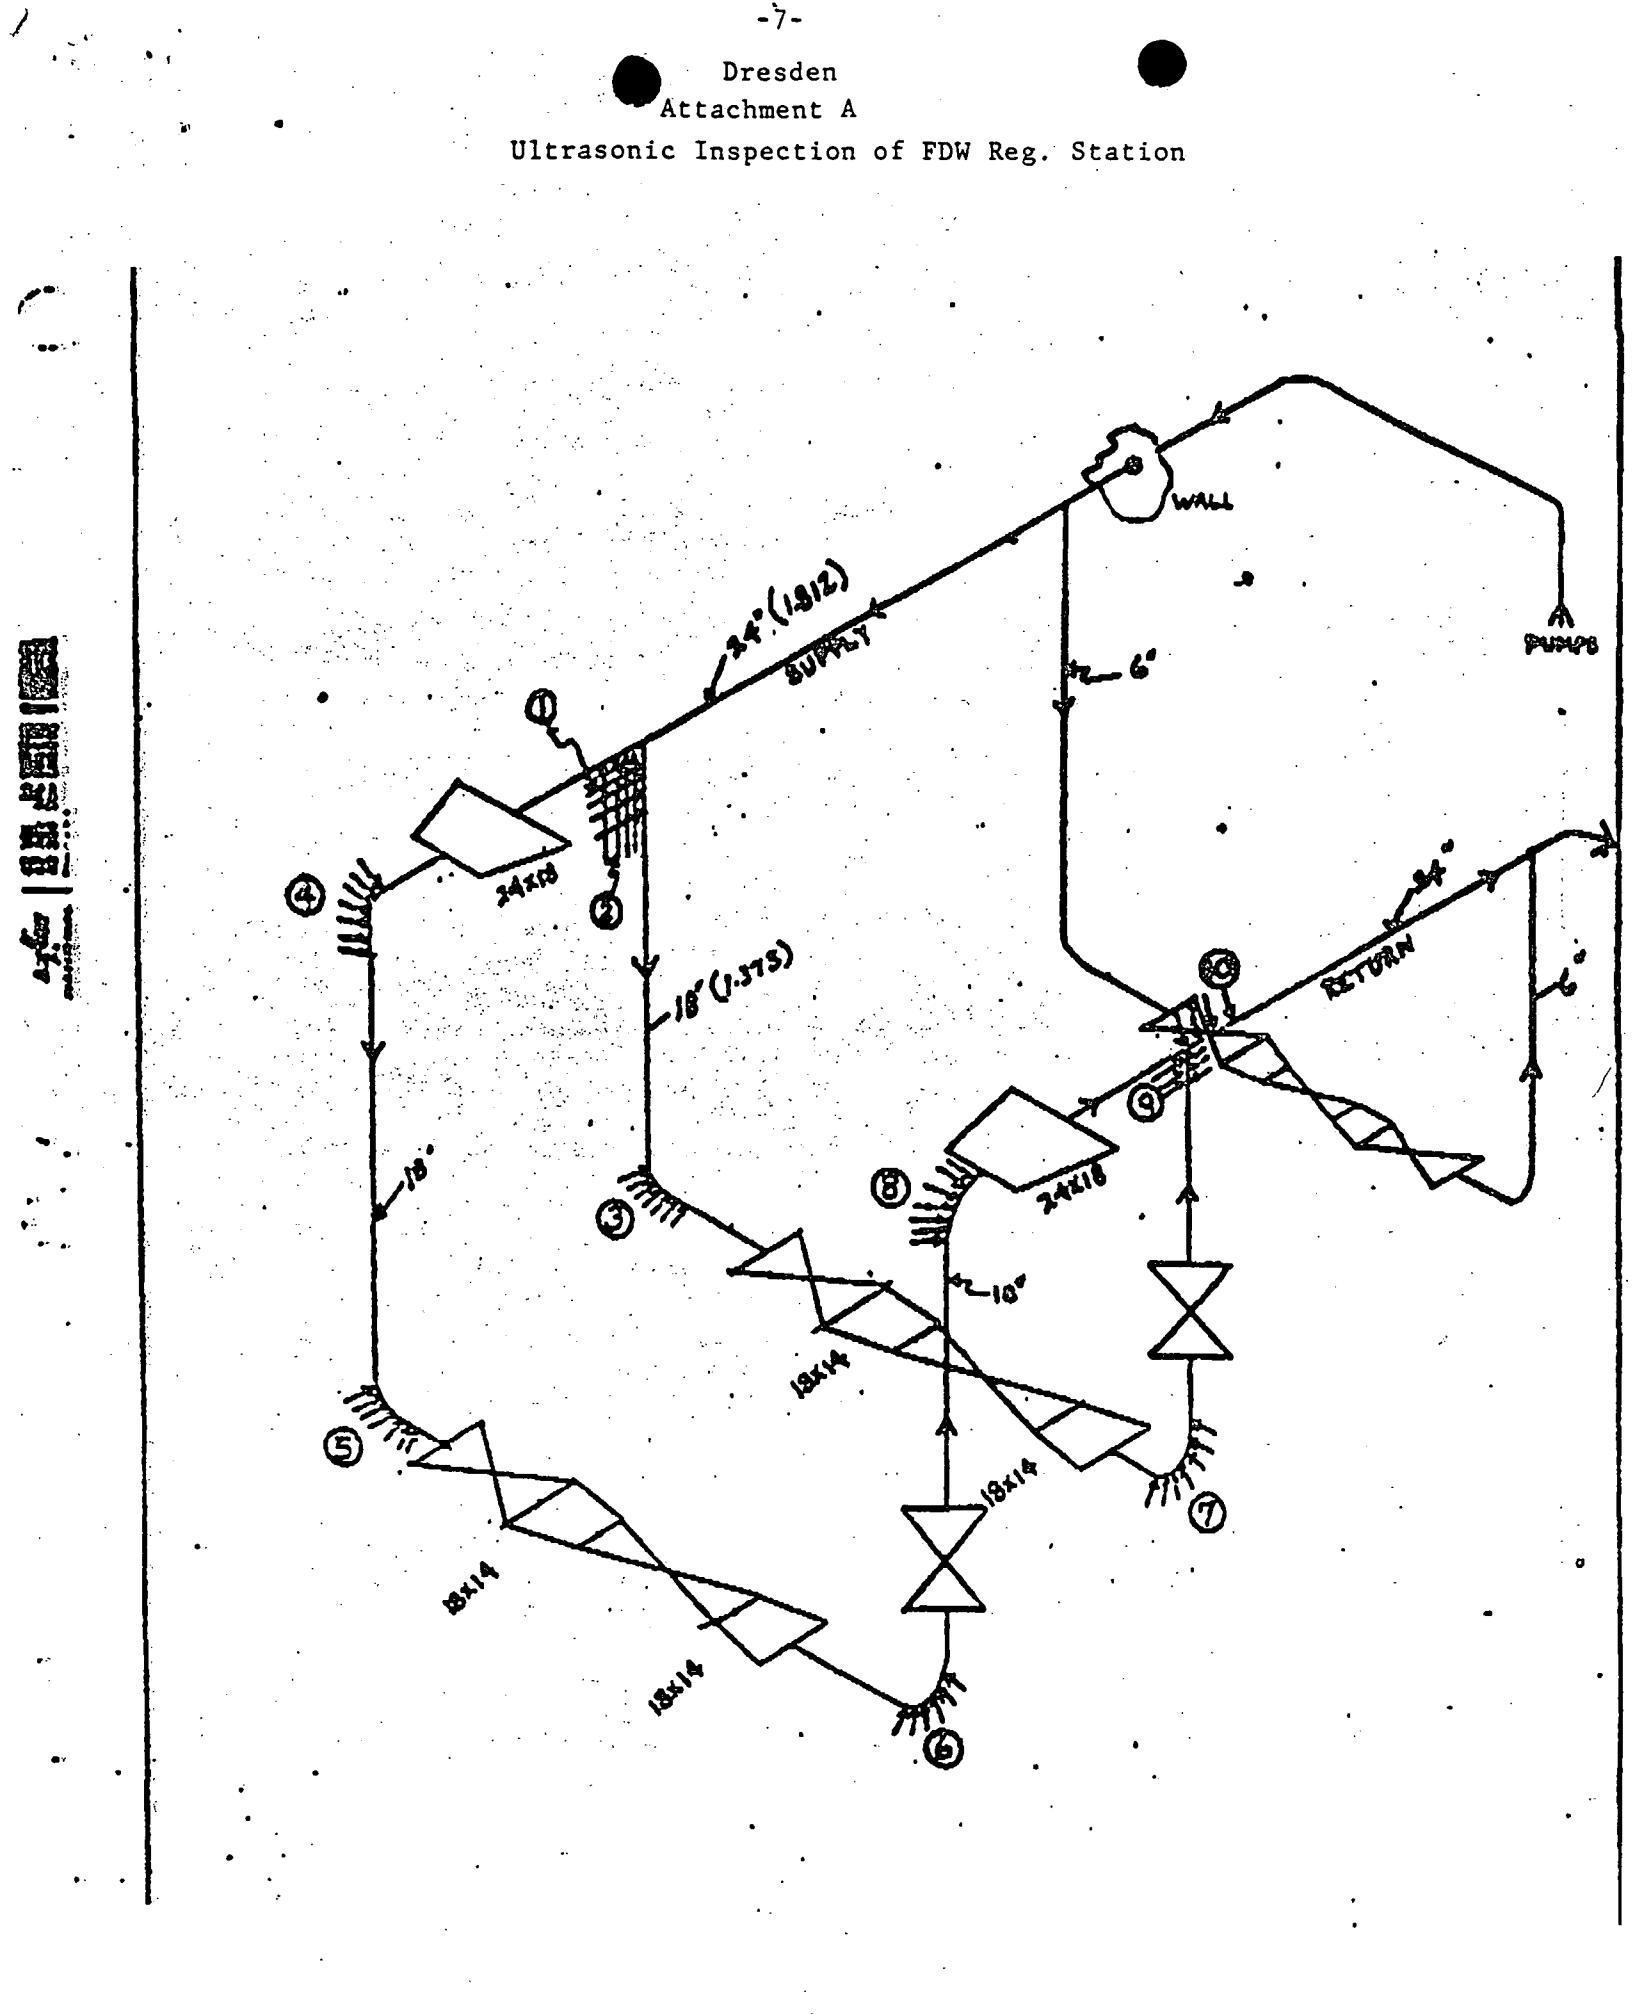
Typical Feedwater Regulating Station

This program was specifically intended to measure pipe wall thicknesses. The piping and points examined are illustrated in Attachment A. Six elbows (18") and two tees (24" x 18") are routinely examined. Data is given for the 1976 and 1986 inspections in Table 1 to illustrate the E/C measured over a ten year period. The Attachment A illustration is used to identify locations for inspection. The piping insulation is marked to show the pieces which require removal for the inspection, however, the piping itself is not marked. No actions, except continued monitoring, have been taken since measured wall thicknesses are within code allowables.

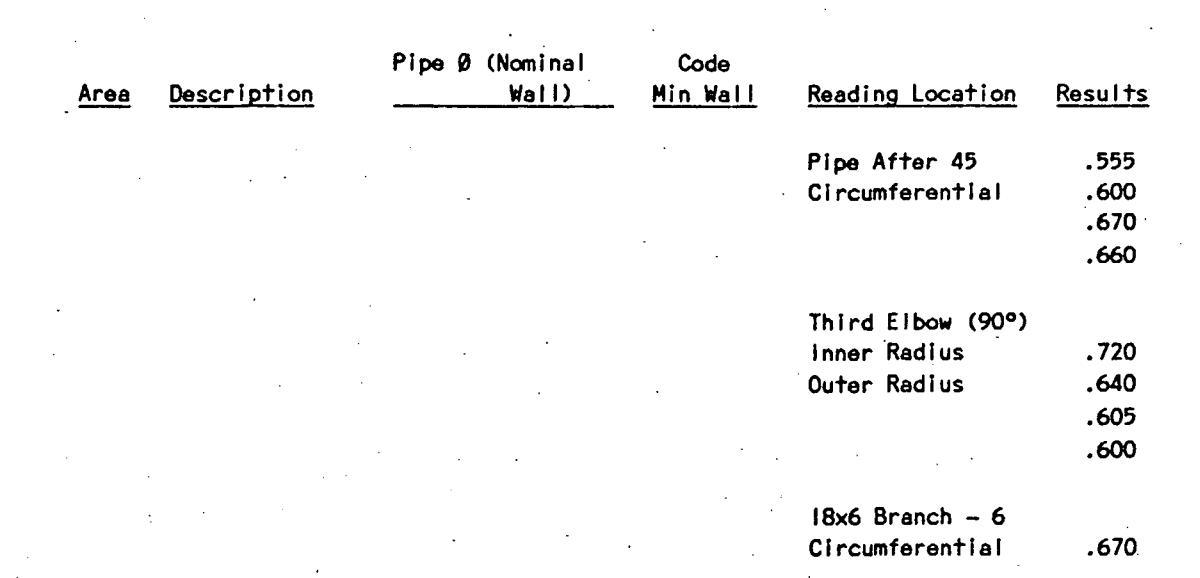
### -16-BLE 2 (Cont'd) UNIT 2 E/C INSPECTION 1986

Feedpump suction elbow information was difficult to obtain. A 2" drain valve is branched off the bottom outer radius and the elbow is directly above the pump oil reservoir. As a result, outside radius readings are all on the inlet end of the elbow. The area that might be expected to contain the most thinning would be past the drain attachment and is not inspectable. As a result of this, the suction piping sample size was increased to include the second elbow on all three loops and the back-to-back 45° elbows on the 'C' loop.

The initial feedpump suction elbow data reports suggested erosion may be present. Downstream circumferential data recorded thicknesses around .675" with outside radius data around .375". Closer inspection revealed that circumferential readings were performed on the pump nozzle adaptor (safe-end). Byron Jackson was contacted and it was revealed that the safe-ends are 12" schedule 80 A-182Gr.F5 (5% Cr, 1/3% Mo) counterbored to 12.100". This corresponds to a counterbore wall of .375" and pipe wall of .688". The elbow material has not been determined but its wall thickness is believed to be diminished. Four additional circumferential readings and additional inner radius readings were taken of each elbow to reach this conclusion. The pump casing casting is a 6% chromium alloy.

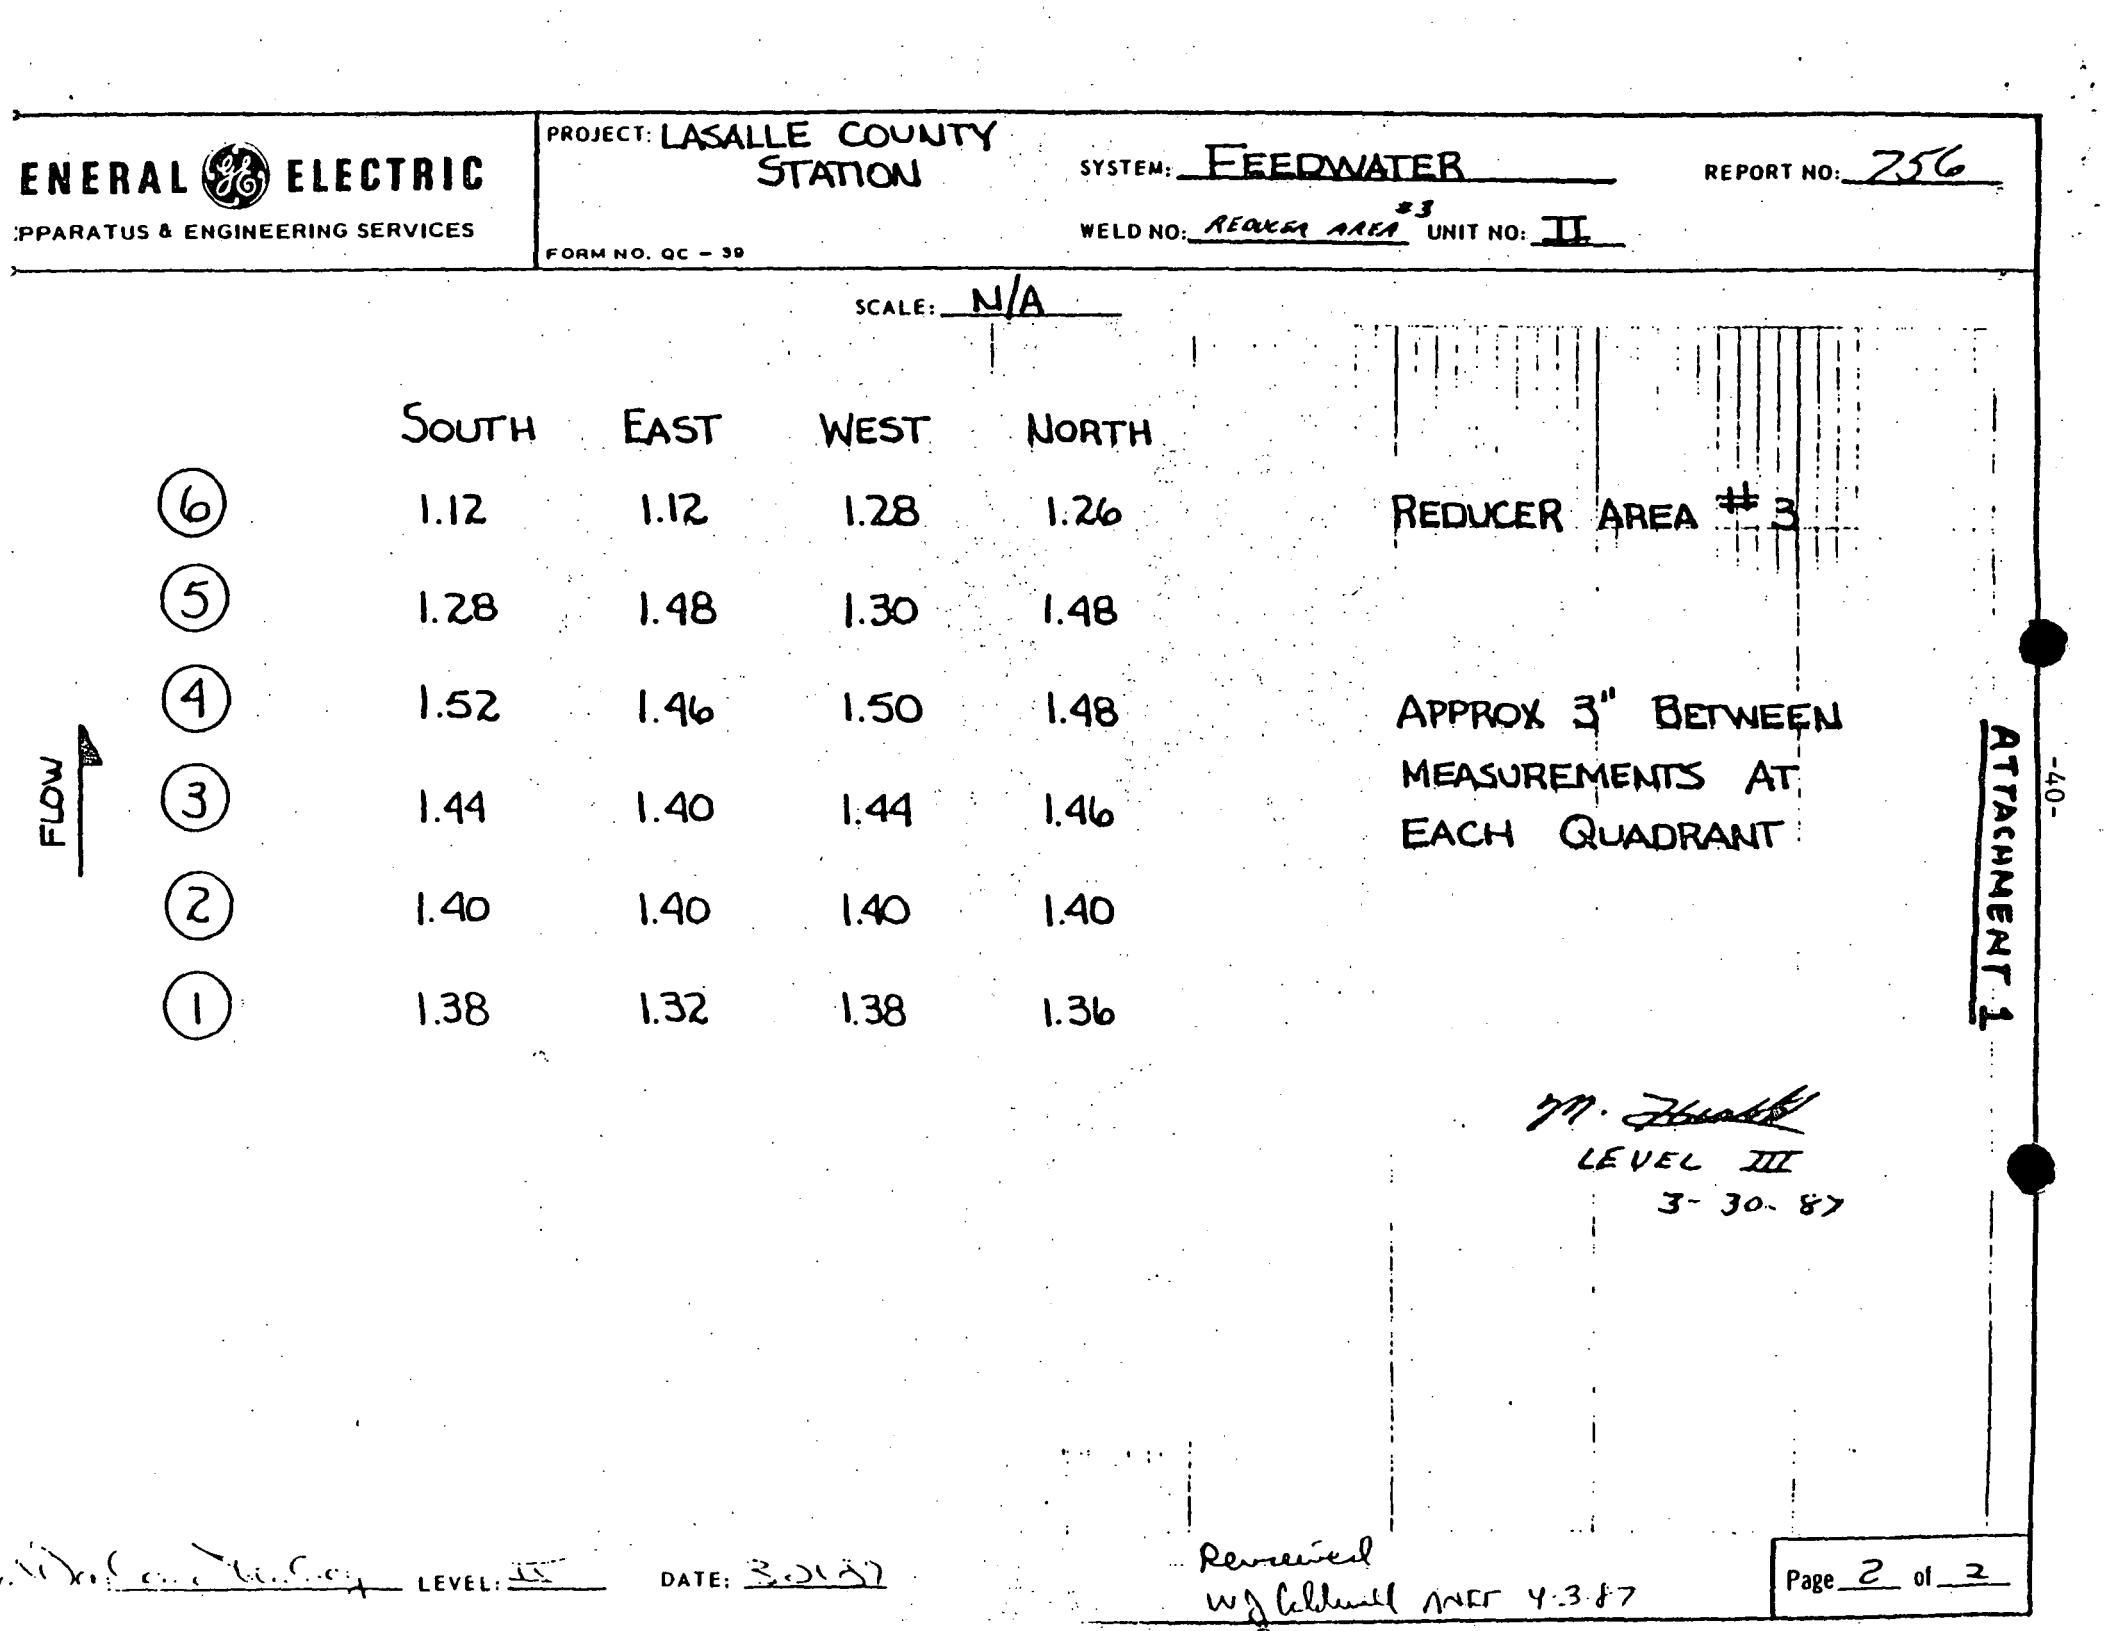
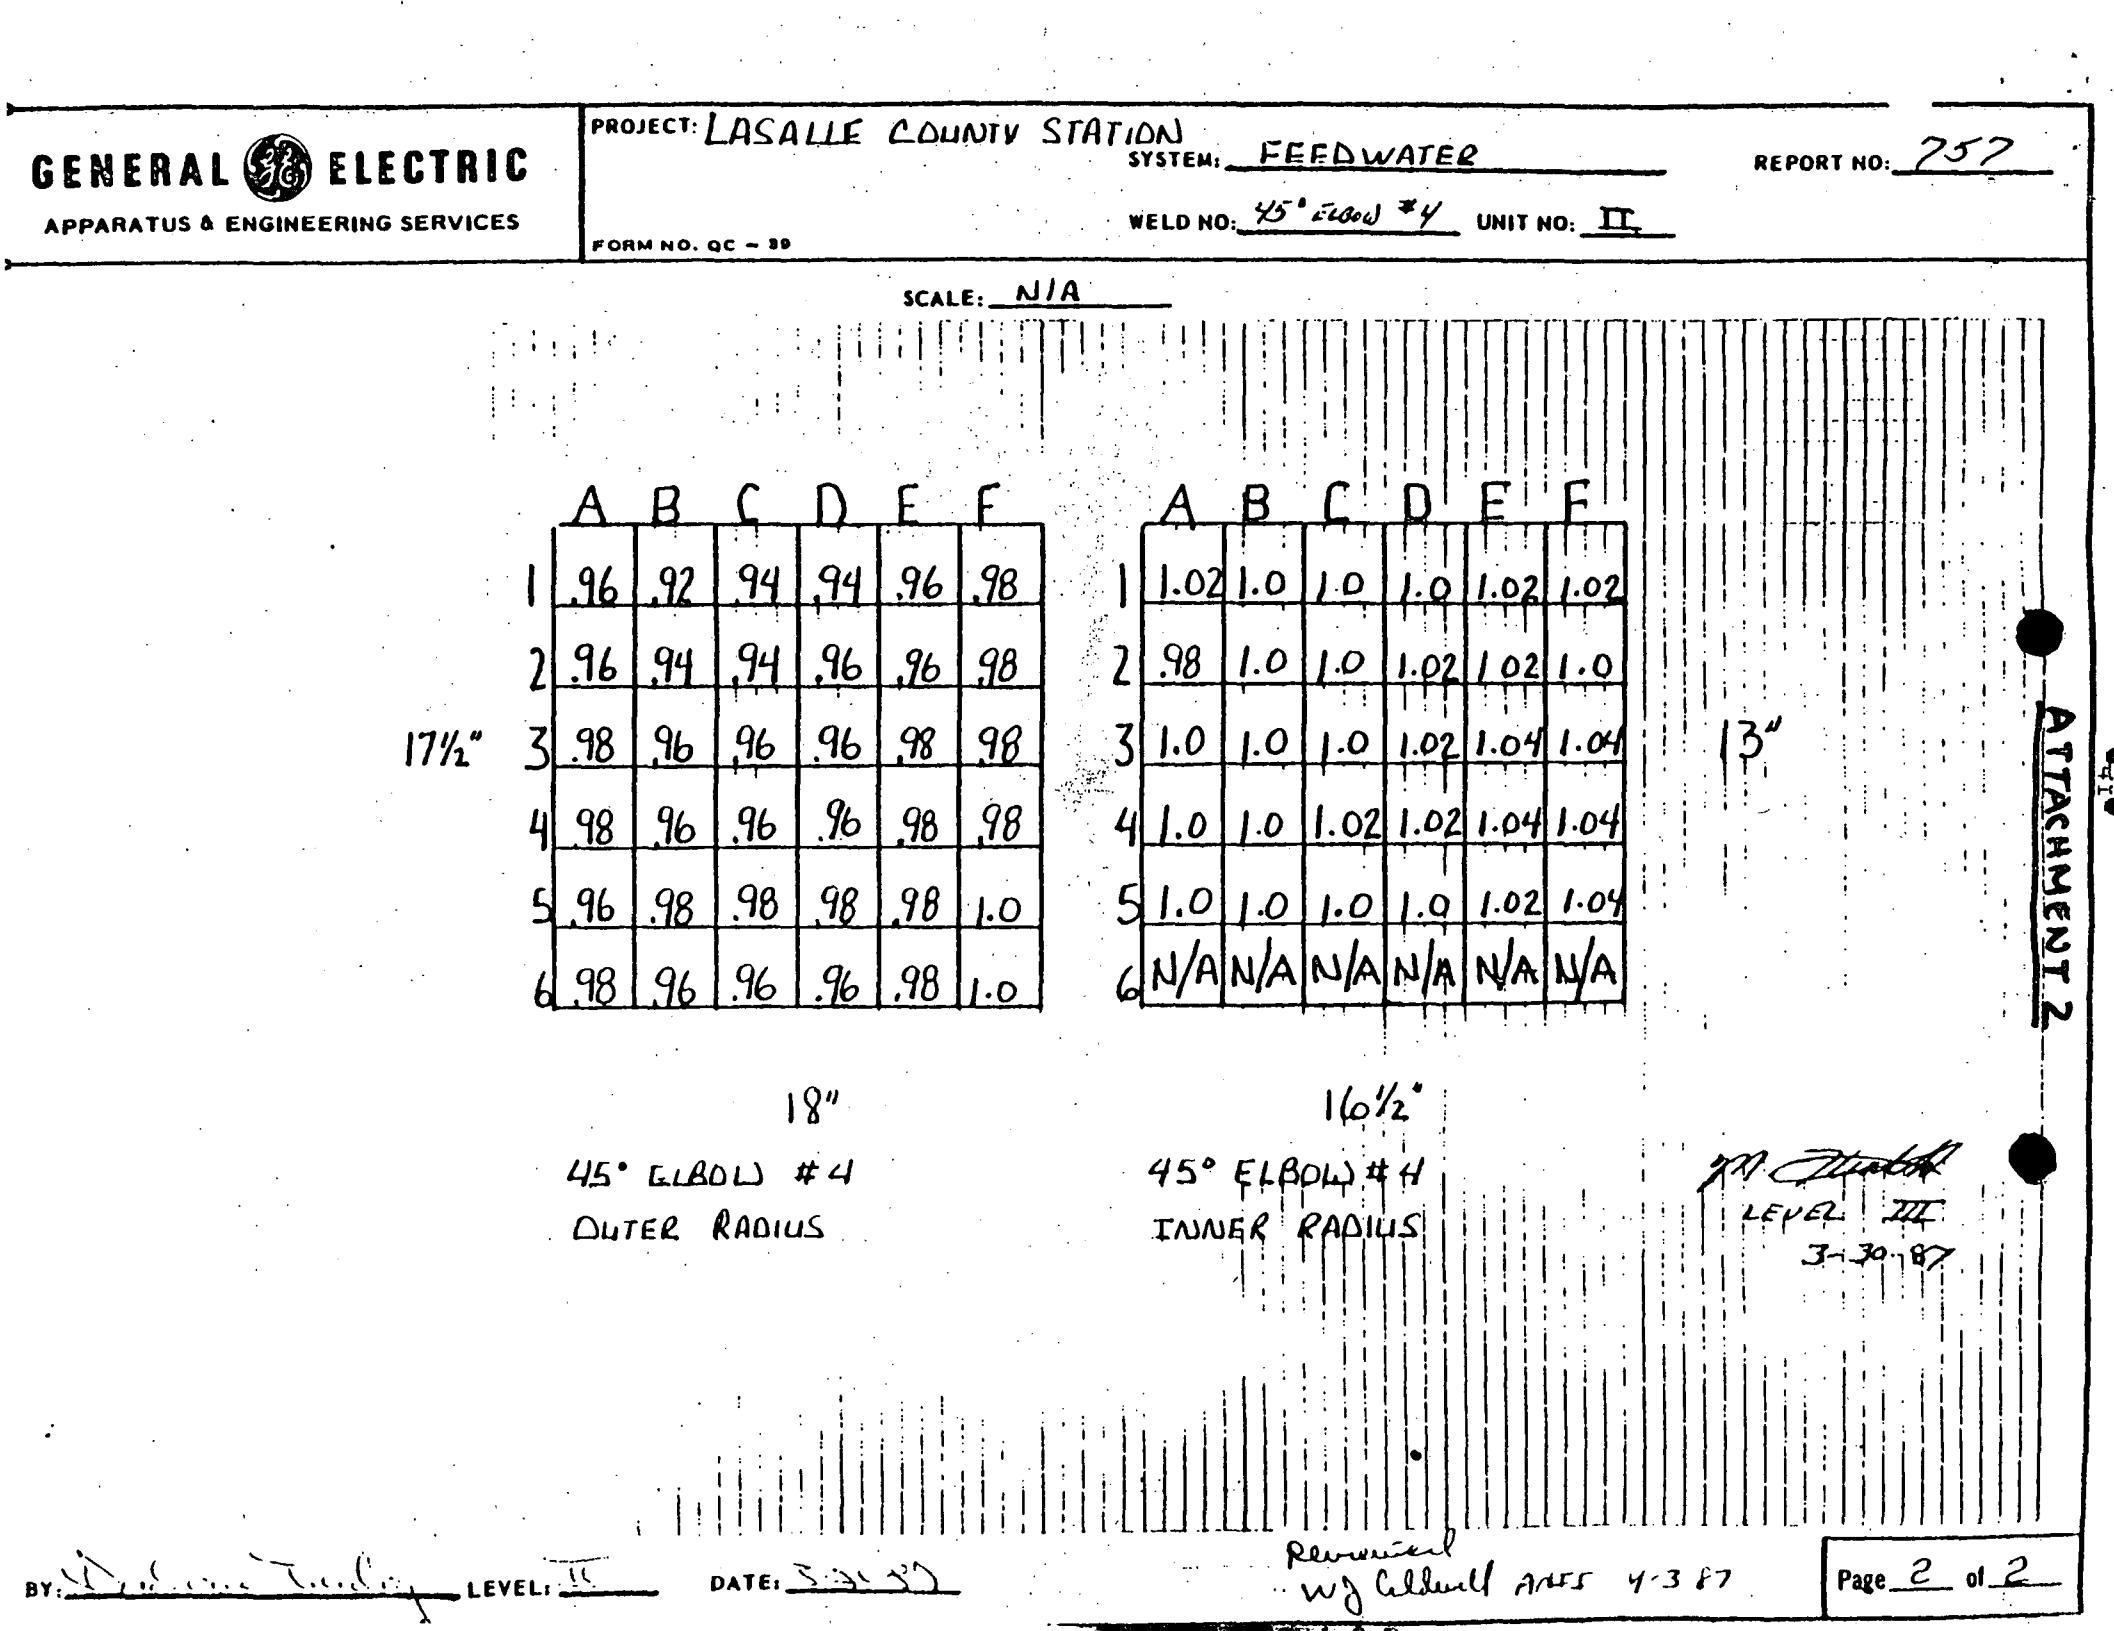
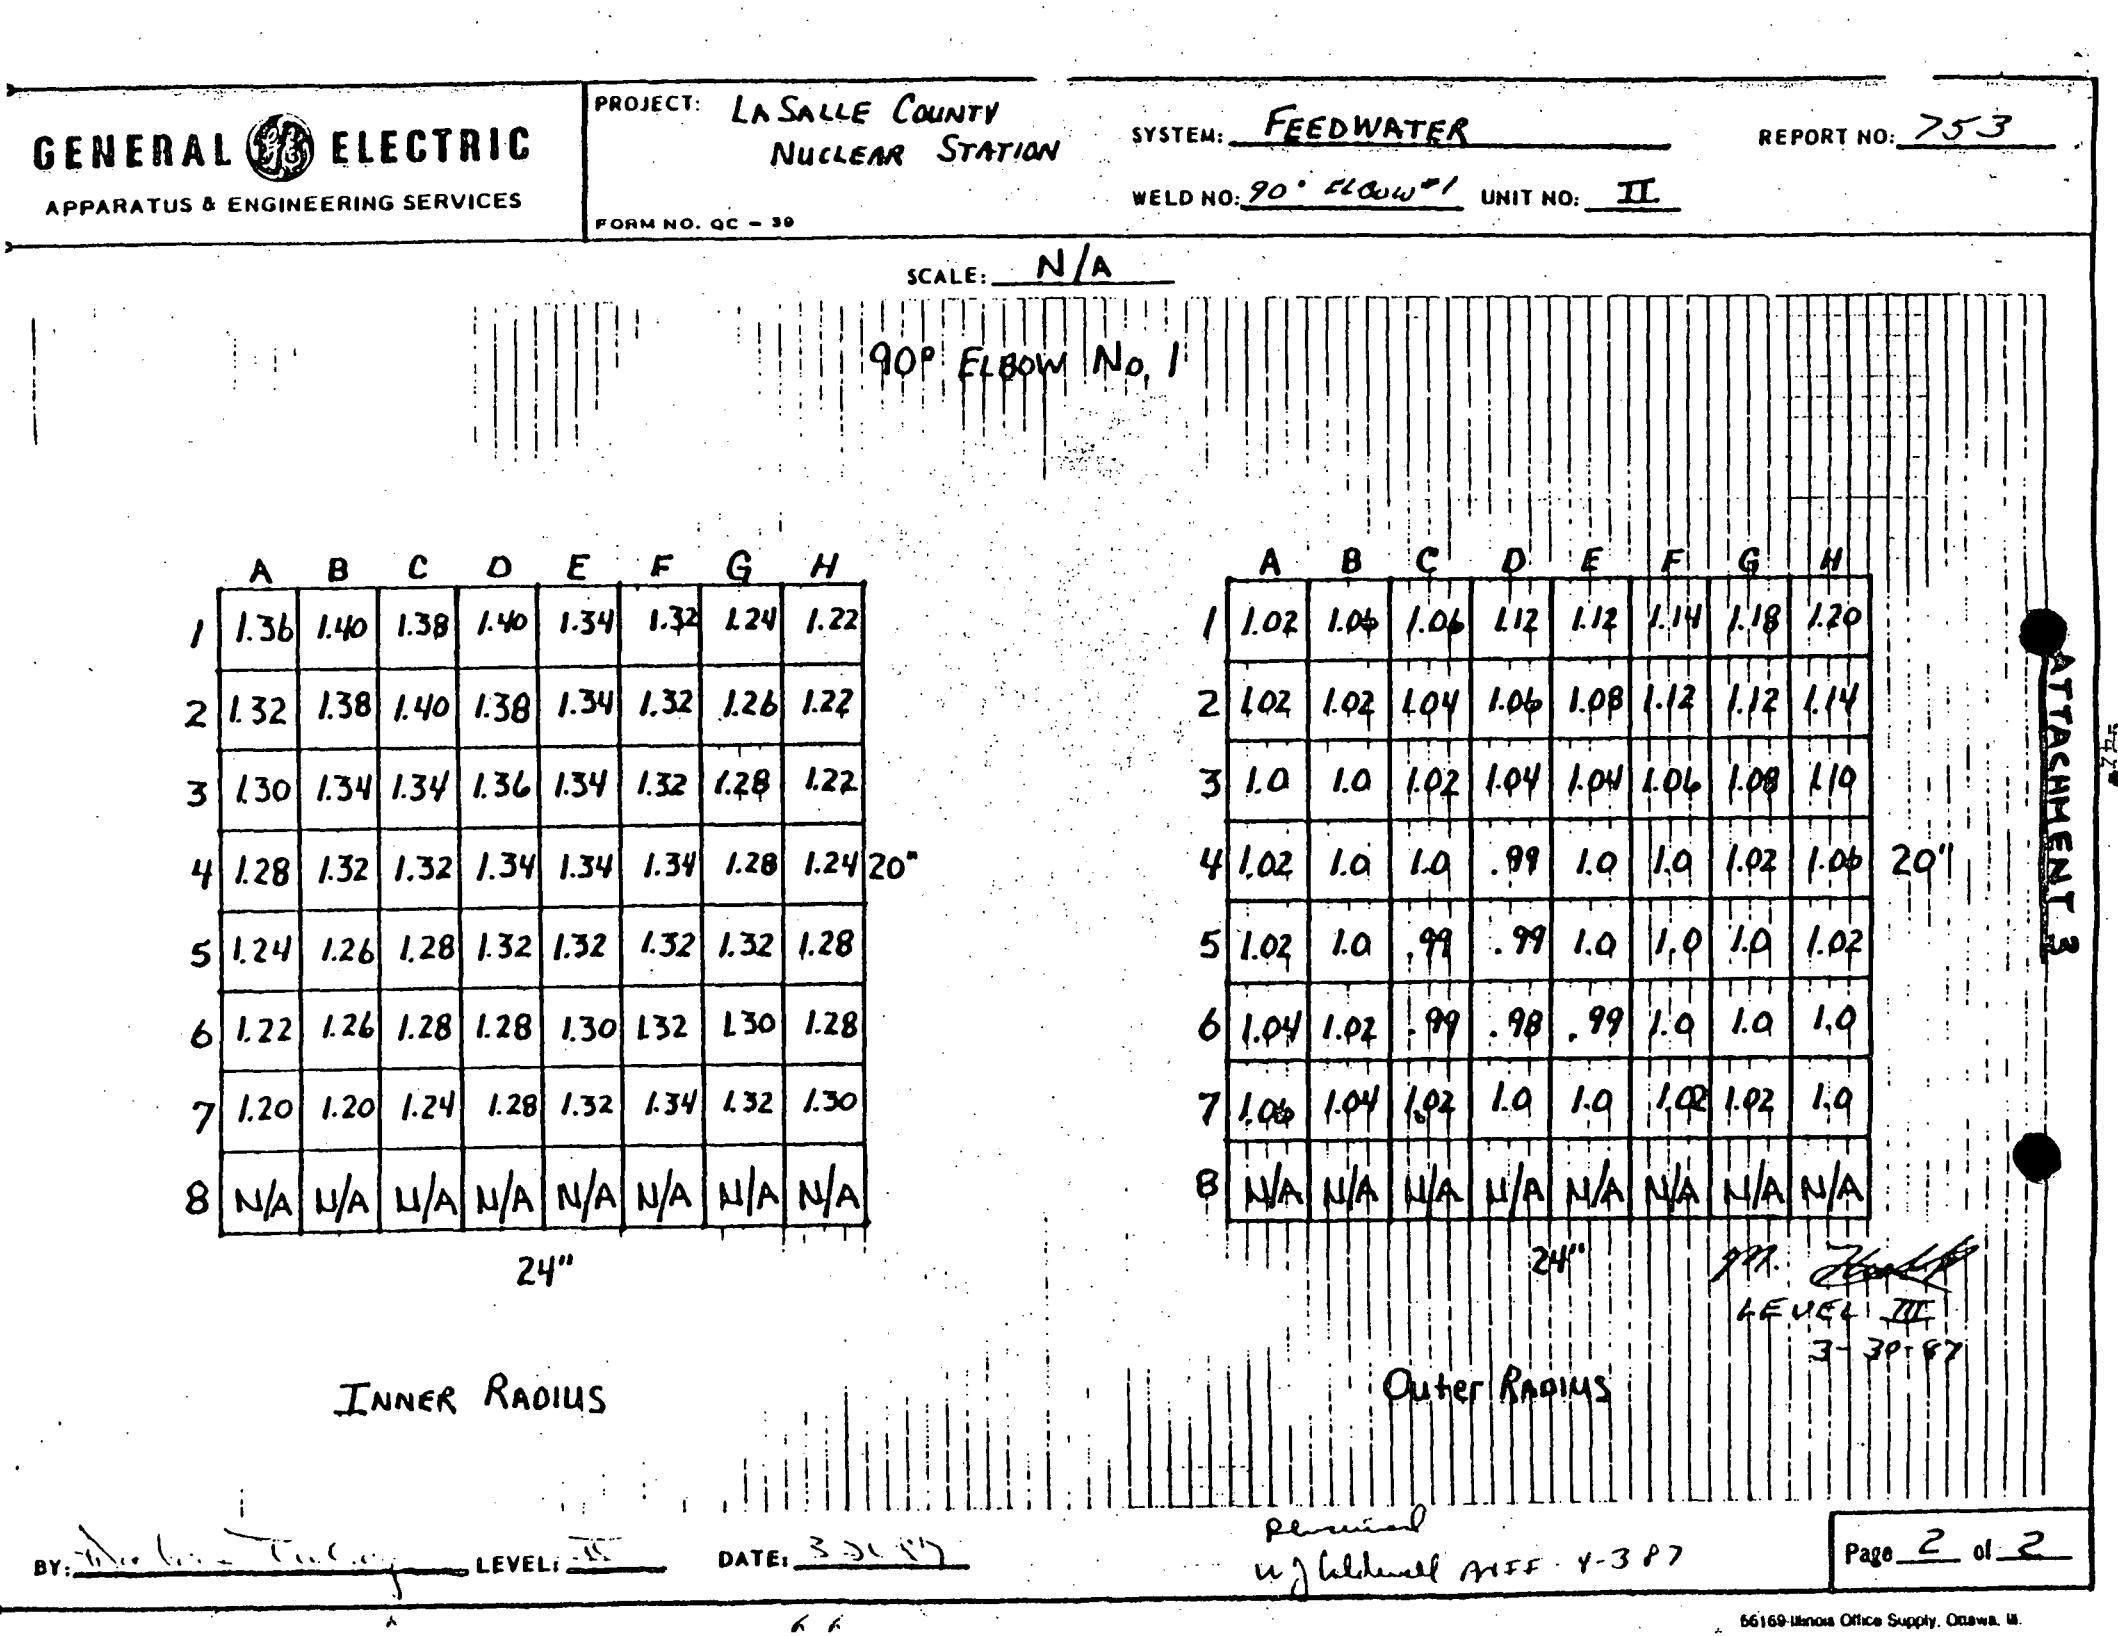
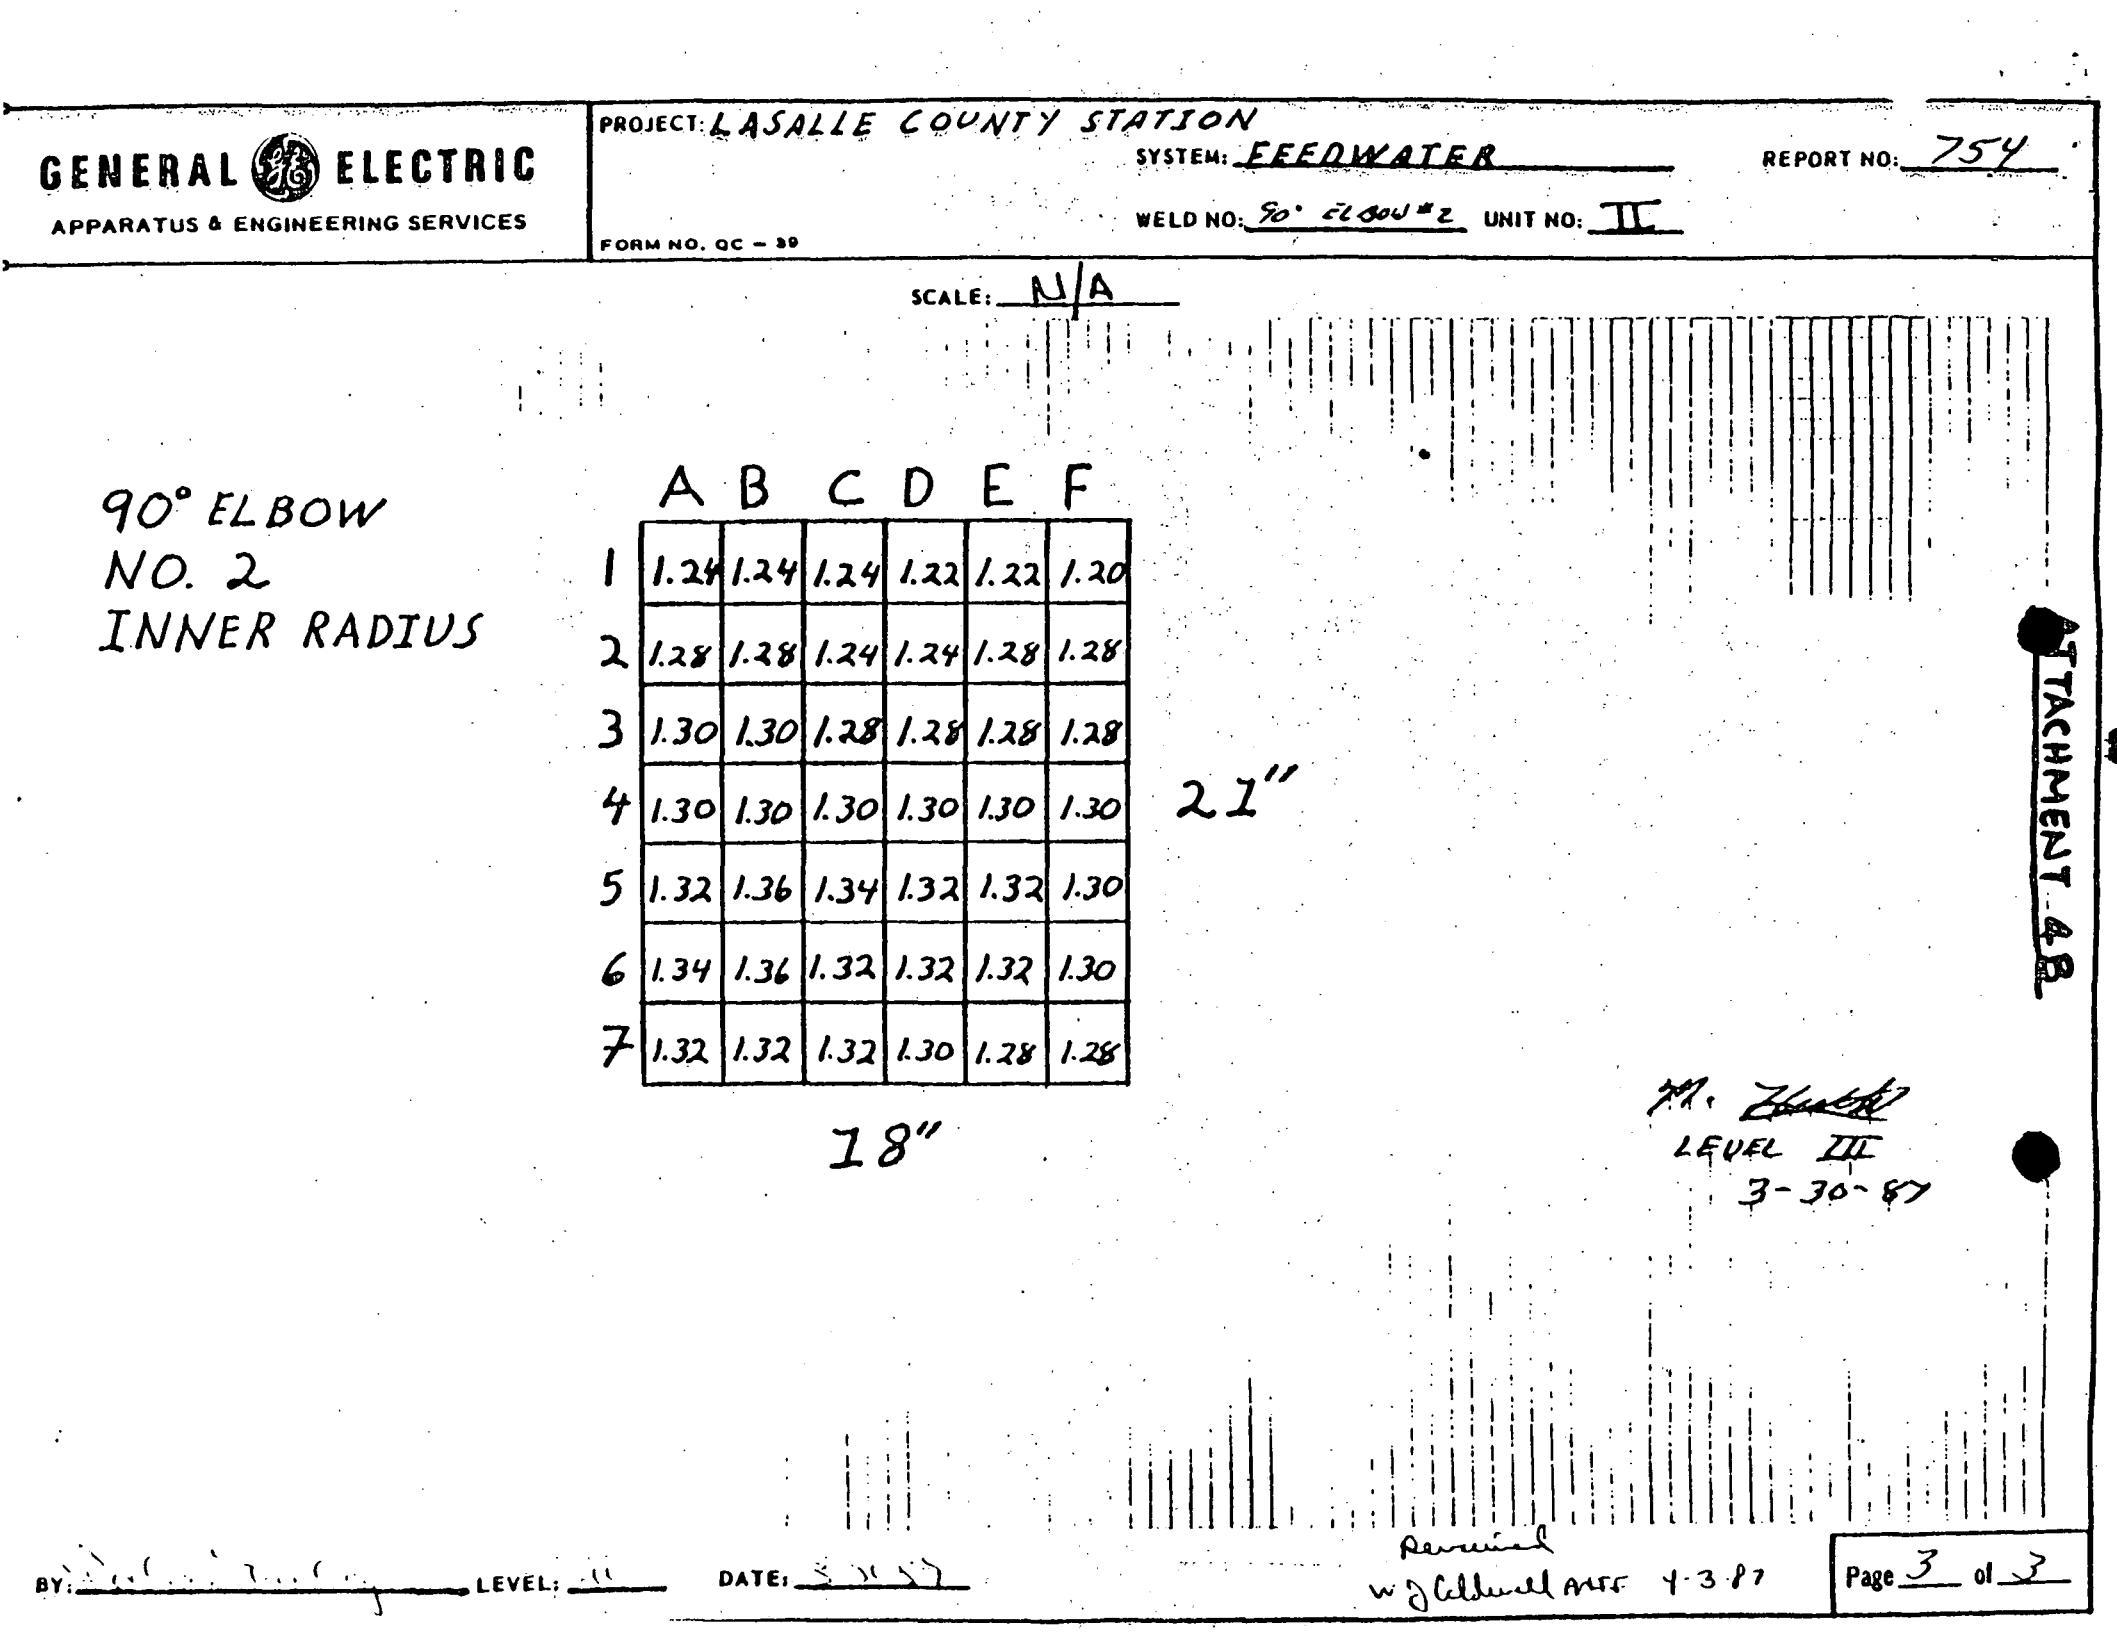
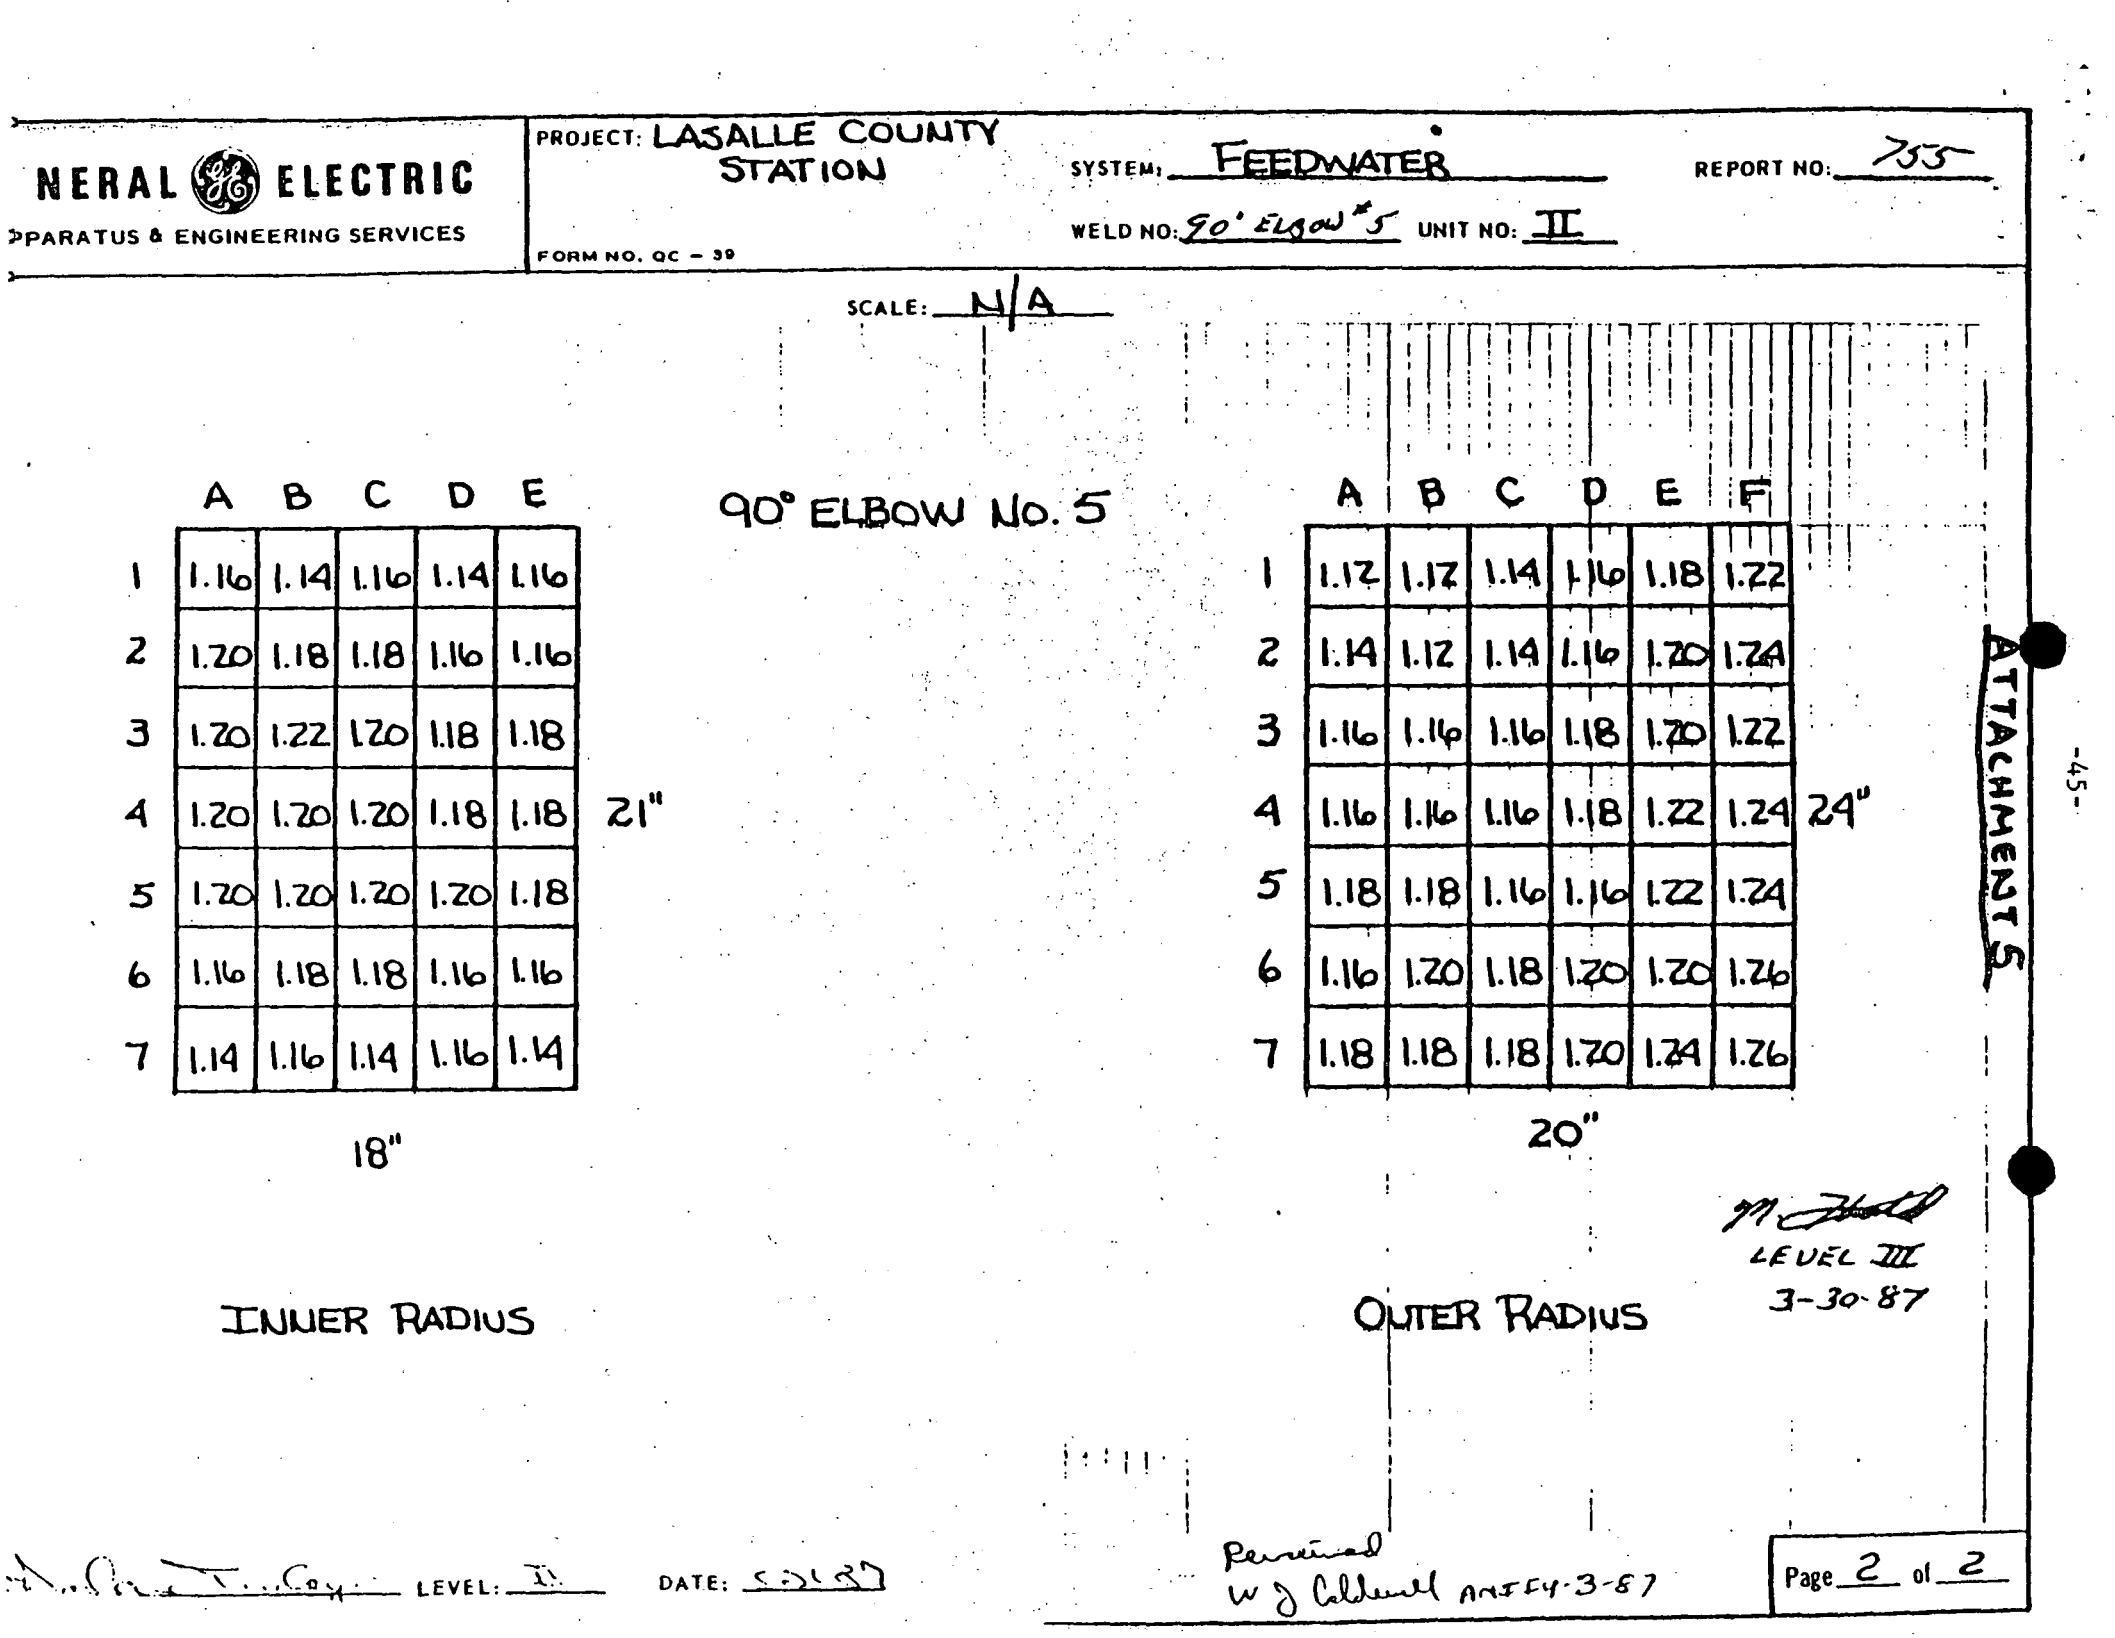
The minimum measured thickness for the four elbows inspected was found to be on the outer elbow radius (extradose). For more detailed information on inspection results, see Attachments numbers 1 through 5.

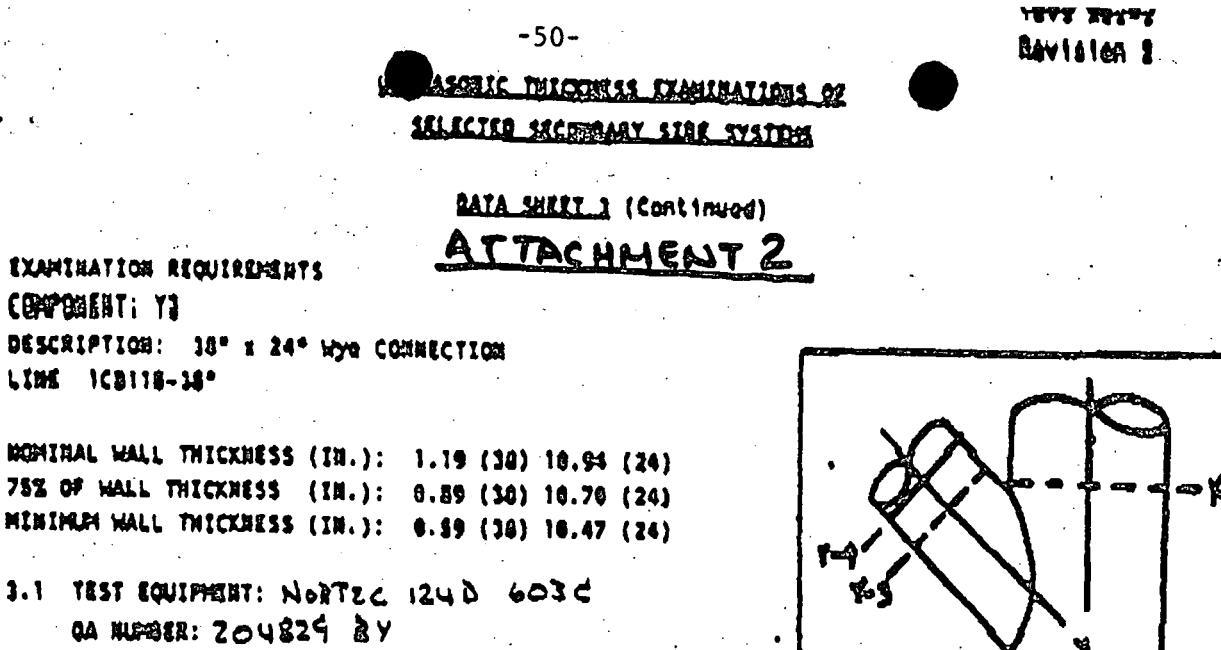
1.9 EXAMINATION REQUIREMENTS COPPOSENT: Y1 DESCRIPTION: 18" x 24" Wye COMMECTION LINE ICBIIS-18\*

Byron Station does not have a liquid phase system thickness measurement program to date. Since the Surry feedwater event, and inspection of the WYE connections on the feedwater pump suction lines was performed using a straight beam ultrasonic transducer. This inspection was performed during the Unit One refueling outage. The Wye connection examination data sheets summarizing the pertinent data are attached. (Attachments 1 & 2) The data is baseline data; however, results indicate that measurements exceeded nominal wall thickness and are found acceptable.

75% OF WALL THICKHESS (IN.): 0.89 (30) 10.70 (24) MENINUM WALL THICKHESS (IN.): 0.59 (30) 10.47 (24)
