Subject: License SUA-1341, Docket No. 40-8502 Willow Creek Project July 25, 2017 8S198-1 and 8S199-1 Release Christensen Ranch Mine Unit 8

Uranium One USA, Inc. - Willow Creek Project Spill Report Summary 8S198-1 (Injection) Fluid and 8S199-1 (Production) Fluid Releases

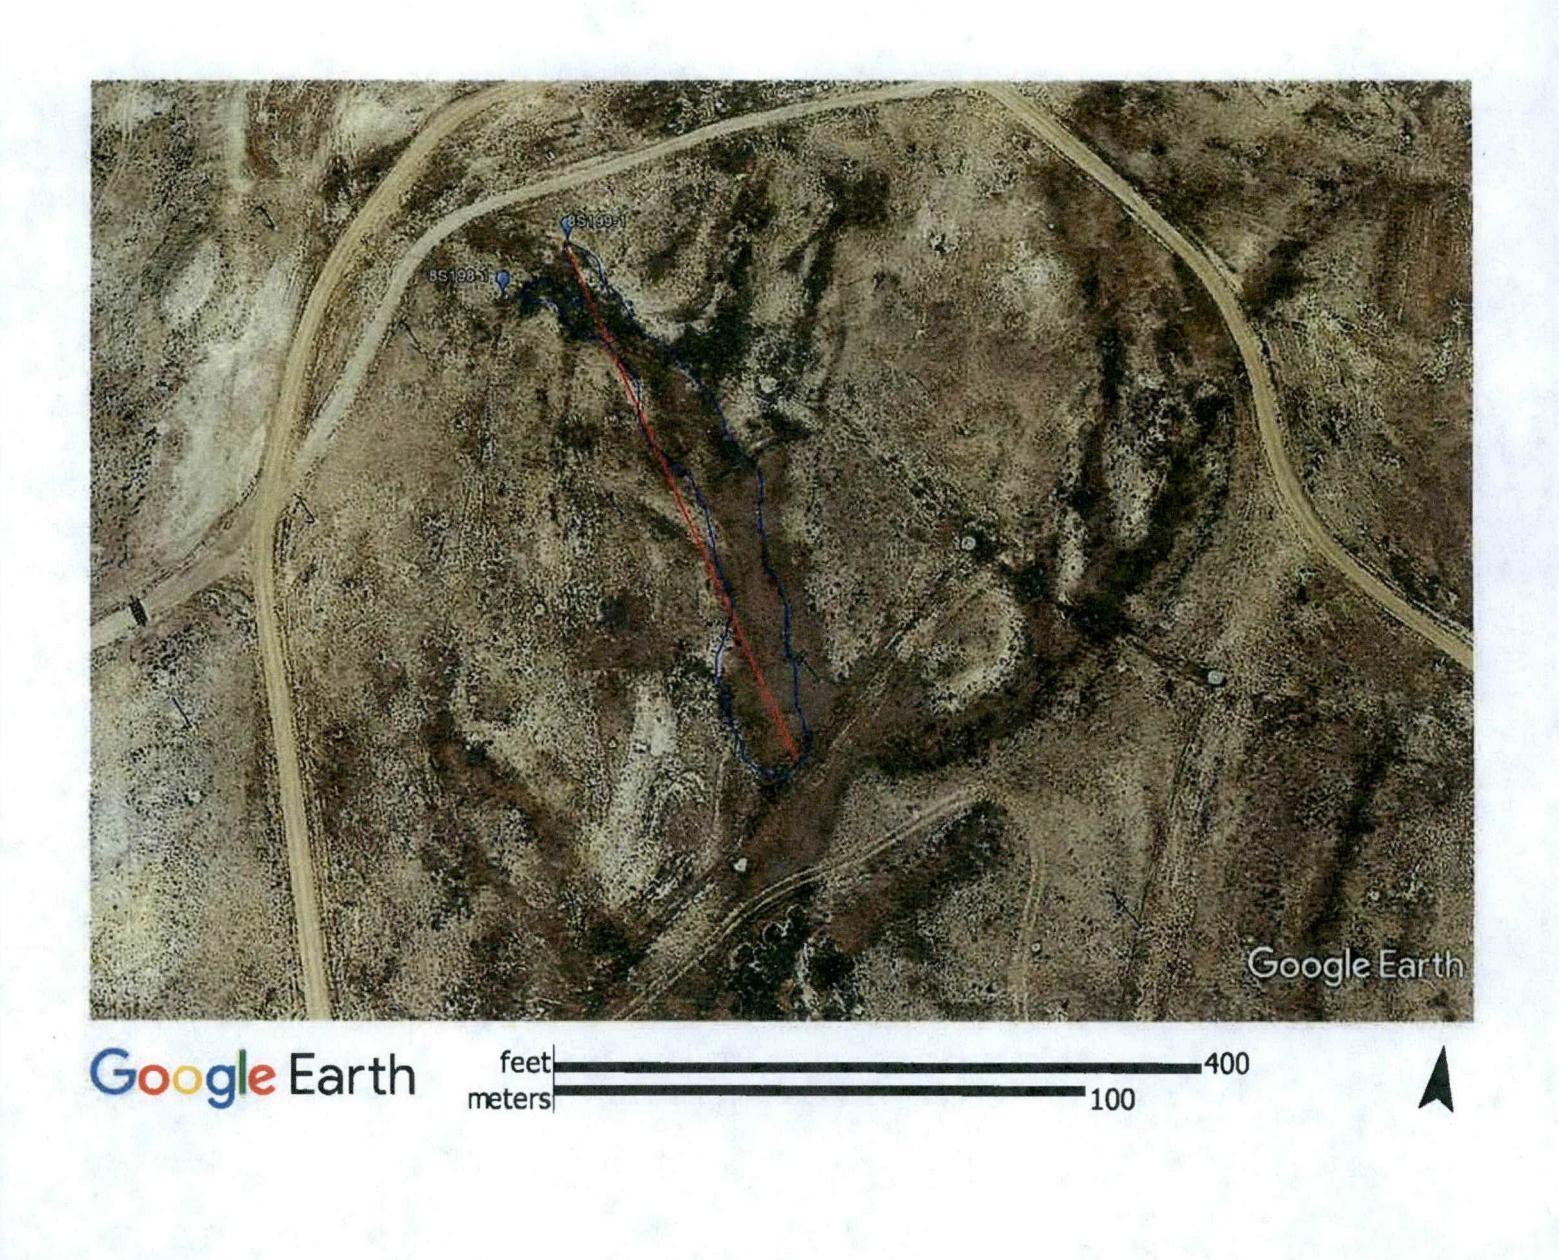
Spilled: Approximately 5,000 gallons of a combination of injection fluid and production fluid was released from ISR injection well 8S198-1 and production well 8S199-1into Mine Unit 8-6 and it overflowed onto the surrounding soil. Upon discovery and investigation of injection well 8S198-1, the source of the injection fluid release, it was determined a 1" steel union fitting had corroded and produced an approximate 1/8" hole on the thread portion of the union. The leak detect device was stuck and not operating properly. Upon discovery and investigation of production well 8S199-1, the source of the production fluid release, it was determined that the transition fitting located on the 1" poly pipe had developed a pin hole. The leak detect device was not operating properly as the float end on the device appeared to be busted. Proactive testing of both of these devices have been replaced and tested prior to putting the wells back into service. The union fitting on 8S198-1 has been replaced with a PVC union and the transition fitting on 8S199-1 has been replaced.

The release followed the existing grade, approximately 438' to the southeast of an ephemeral draw located in the north end of the 8-6 wellfield. No wildlife or livestock, nor did the spill reach surface water or the subsidiary to any waterways. No significant erosion resulted from the release.

Attachement: Google Earth Photo of 8S198-1 and 8S199-1 scaled spill area. (explinations); Light blue dots reflect the location of wells 8S198-1 and 8S199-1. The red line reflects the length of the release from start to finish. The dark blue is an approximate of the embodied area that was affected by the spill.
