SUBJECT: NRC SPECIAL INSPECTION REPORT 030-34866/2017-001

Docket:	030-34866
License:	11-27610-01
Report:	2017-001
EA No.:	EA-17-101
Licensee:	Qal-Tek Associates, LLC
Location Inspected:	3998 Commerce Circle Idaho Falls, ID 83401
Inspection Dates:	Onsite inspection - April 24-25, 2017 In-office Reviews through August 17, 2017
Exit Meeting Date:	August 17, 2017
Inspectors:	G. Michael Vasquez, Technical Assistant Division of Nuclear Materials Safety
	Jason E. vonEhr, Health Physicist Materials Licensing and Inspection Branch Division of Nuclear Materials Safety
Approved By:	Vivian H. Campbell, Chief Materials Licensing and Inspection Branch Division of Nuclear Materials Safety
Attachments:	 Supplemental Inspection Information Inspection Charter to Evaluate Transportation Event At Qal-Tek Associates, LLC in Idaho Falls, Idaho

Qal-Tek Associates, LLC NRC Inspection Report 030-34866/2017-001

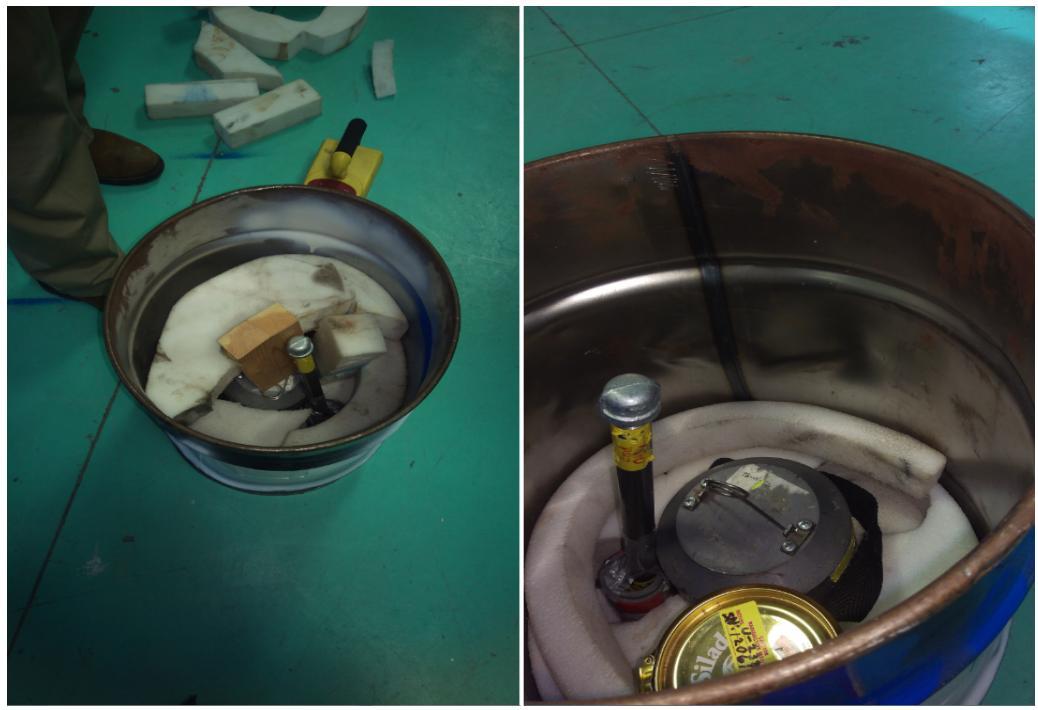
Figure 1 - Demonstration during on-site reactive inspection showing how the package was likely packed on departure from the Idaho Falls facility and New York City. Also visible are the lead containment system actually used, wooden board acting as a wedge, as well as the radium rod and uranium puck.

The inspectors noted that the lid of the containment system had an approximately ¼ inch lip. Therefore, the lid needed to open less than 1 inch for the small sources to come out of the containment system. It was possible that the miscellaneous sizes and shapes of the high-density foam pieces allowed the internal void spaces in the drum to form a larger void space above the lid of the containment system such that the lid was able to lift off the containment system enough for the radioactive sources to fall out but simultaneously small enough to allow the lid to re-seat itself once the package and the containment system were placed right side up.

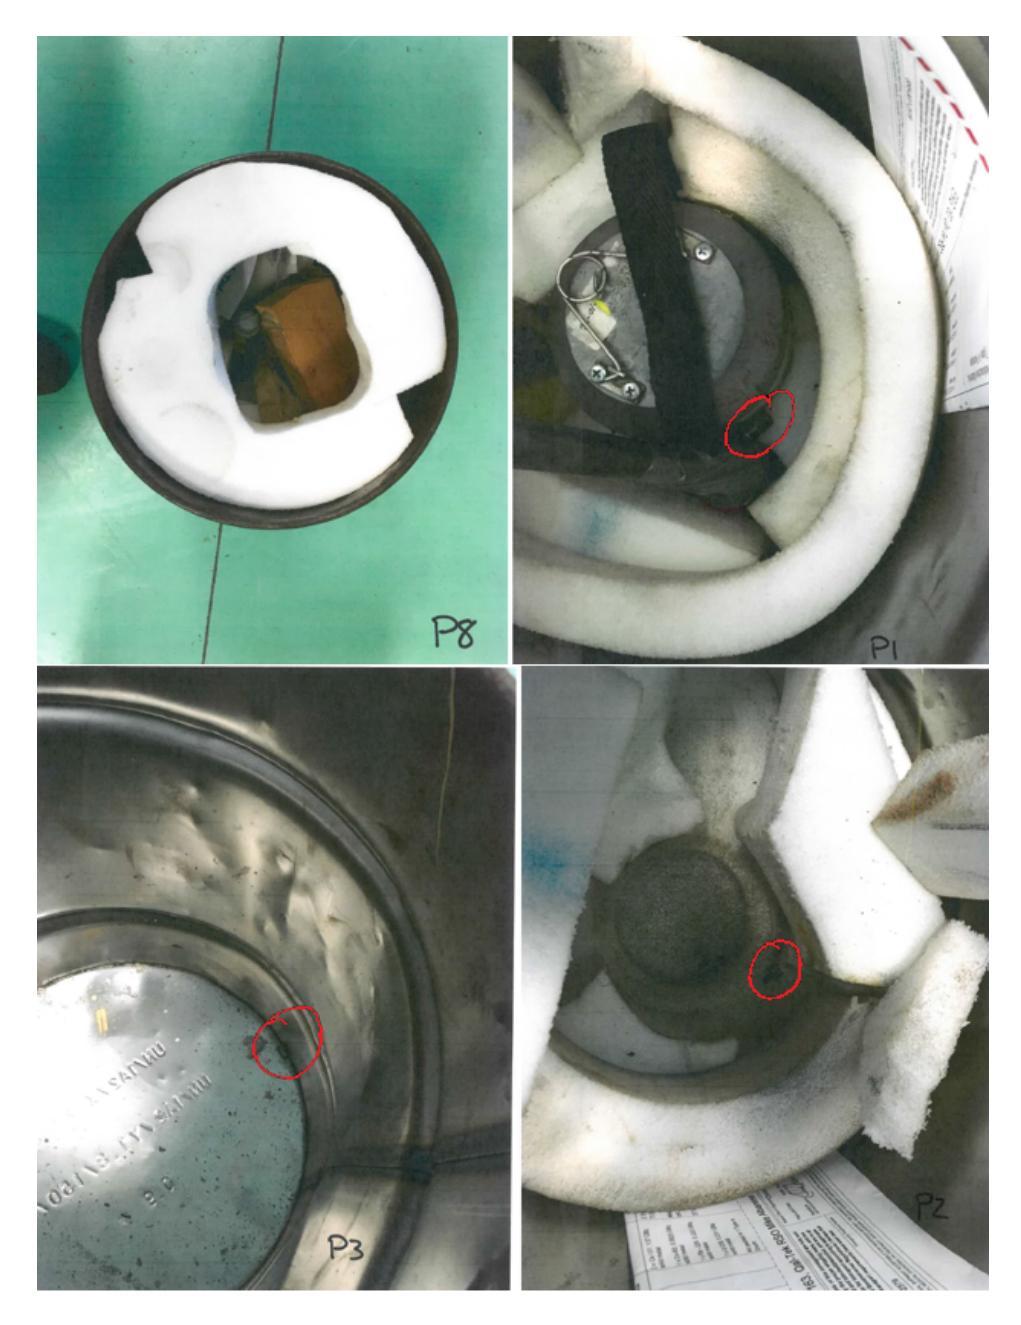
Upon arrival in Idaho Falls at the QTA facility, the package was surveyed by a QTA employee and determined to have external radiation levels in excess of regulatory limits. No contamination on the external surface of the drum was found. After notifying the corporate RSO, the package was transferred to a separate building for unpacking. Licensee employees found the serialized tamper seal was intact. They documented a detailed dose profile of external radiation levels for the package and, after opening the package, they found the lid of the Cs-137/Co-60 containment system was seated on the body of the containment system as normal, but the sources were outside of it.

Since the sources were not shielded inside the lead containment system, the dose rates exceeded NRC and DOT limits (see Figure 2). The highest measured dose rate on the package was 1.4 R/hour on contact and the transport index was 15 (10 CFR 71.4 defines the transport index as the dimensionless number representing the dose rate in mR/hour at 1 meter). The highest dose rate was found on the bottom of the package where one of the Cs-137 sources was located against the wall on the bottom of the drum. The second Cs-137 source and the Co-60 source were found near the drum's centerline just outside the Cs-137/Co-60 containment system and higher up in the drum on top of a section of high density foam.

Figure 2 - Clockwise from the top left, in order of the licensee's unpacking of the drum: (1) Top-down view of how the licensee found the package on arrival in Idaho, with the drum's lid removed, (2) the discovery of the first Cs-137 source found outside the containment system; (3) the location of the Co-60 source (containment system was removed); and (4) the second Cs-137 source outside the containment system. Note the first image where the 2 inch by 4 inch wooden board is now diagonal, not vertical, and beneath the top layer of foam, and the last picture of the drum wall: the second Cs-137 source rested against the bottom corner of the steel drum.

On June 6, 2017, the inspectors were informed that the QTA RSC approved the updated shipping procedure OP-PRO-152, "Licensed Material Receipt, Accountability, Storage, Handling, & Shipping." The inspectors reviewed the enhanced transportation procedure instructions and found they contained packaging instructions including a description and pictures of acceptable containment systems with positive fastening devices that must be used. In addition, the licensee required the use of a secondary physical inner packaging to ensure containment of sources. The procedure changes provided guidance on selecting appropriate containment systems for various weight limits when shipping by ground transportation and by overnight air transport.

The inspectors were also informed that the licensee's corrective actions included oneon-one function-specific training of all QTA-authorized shippers to ensure a complete understanding of packaging instructions. The licensee lifted the ban and workers were allowed to resume packaging and shipping of radioactive sources after satisfactory completion of the training.
