# **DRAFT COMPLETION REVIEW REPORT**

Hecla Mining Company Durita Facility Montrose County, Colorado Colorado Radioactive Materials License No. 317-02

March 30, 2015

The Colorado Department of Public Health and Environment Radiation Program

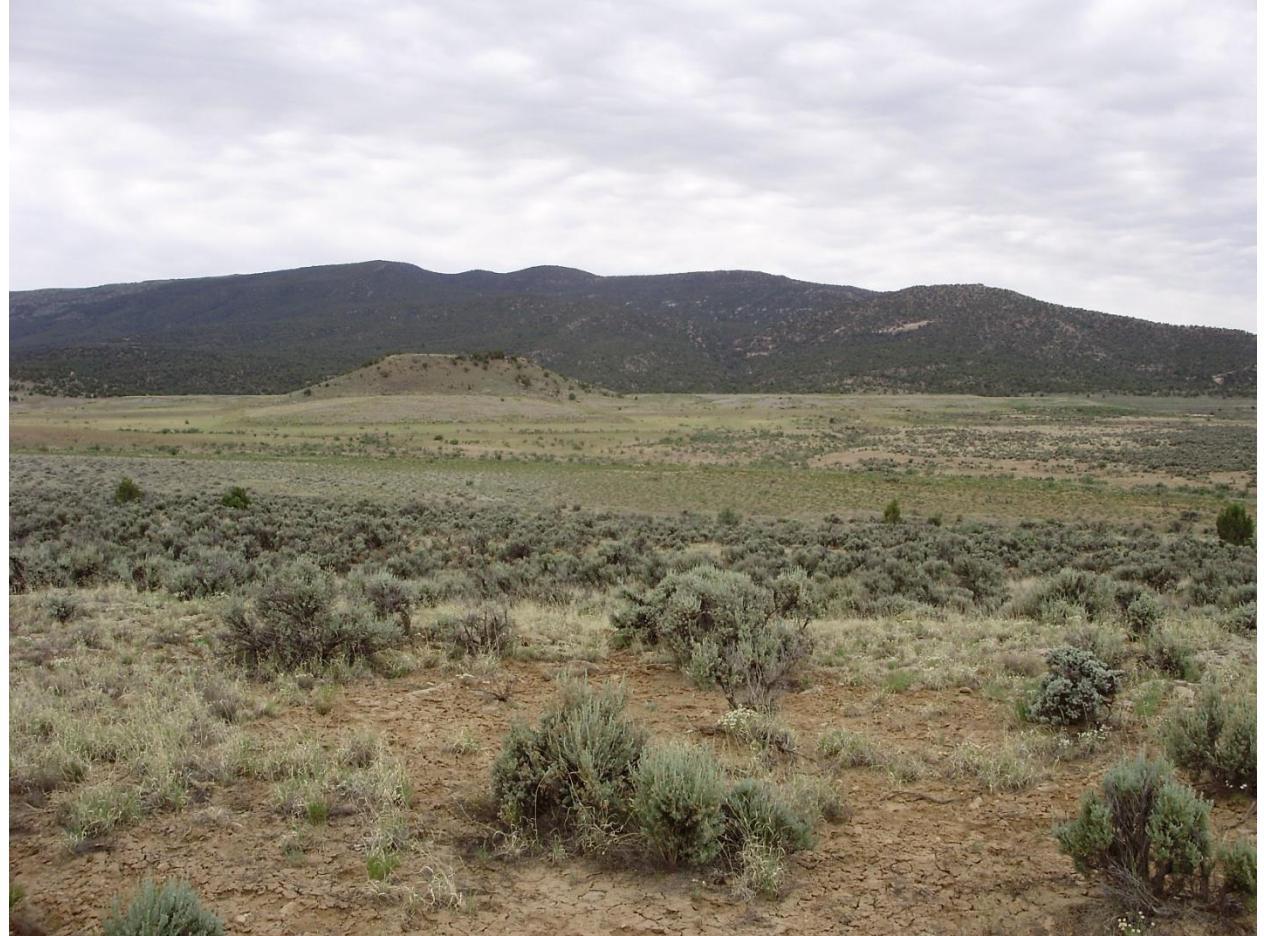
Photograph 1: View of the Durita site looking southwest. Mancos Hill is visible in the middle distance. The disposal cell is between the viewer and Mancos Hill. Leach pads LT-201 and LT-202 are to the right of Mancos Hill and leach pad LT203 is to the left and behind Mancos Hill.

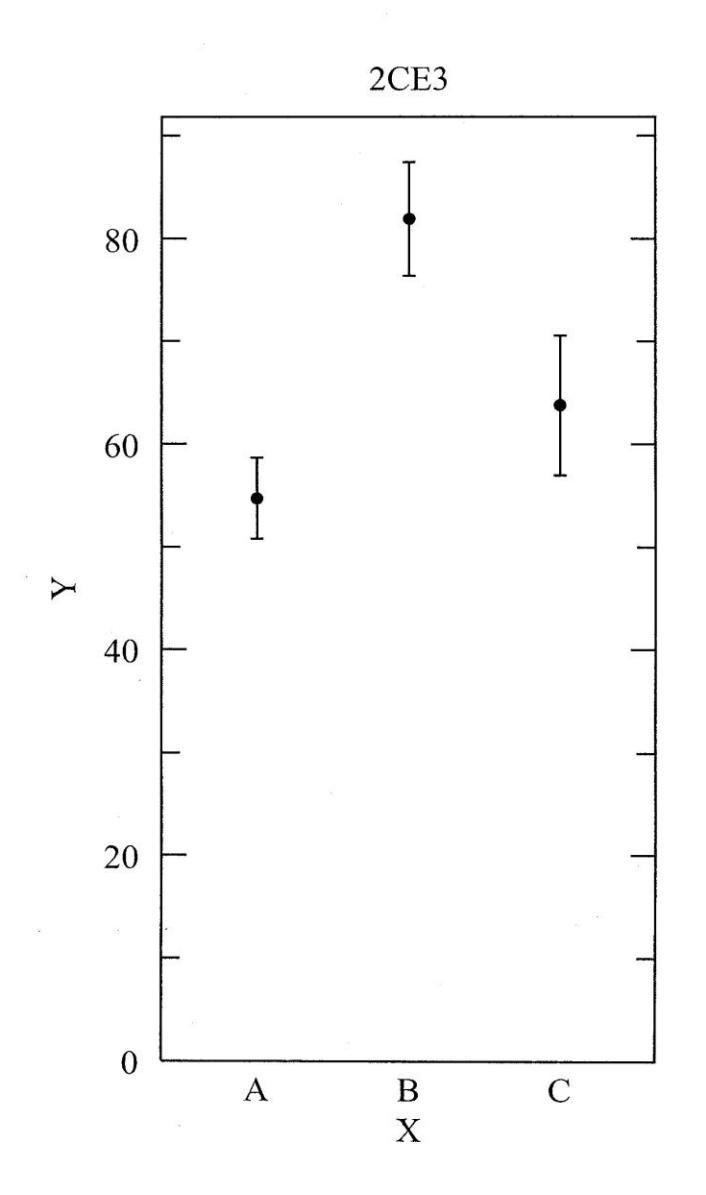
Plot of means with 95% confidence interval of the chloride content populations for monitor well MW-4. Population A is the analyses from April 1977 to August 1986. Population B is the analyses from November 1986 to October 1989. Population C is the chloride analyses from December 1989 to November 1991. Population B shows a distinct statistical character from population A and C.

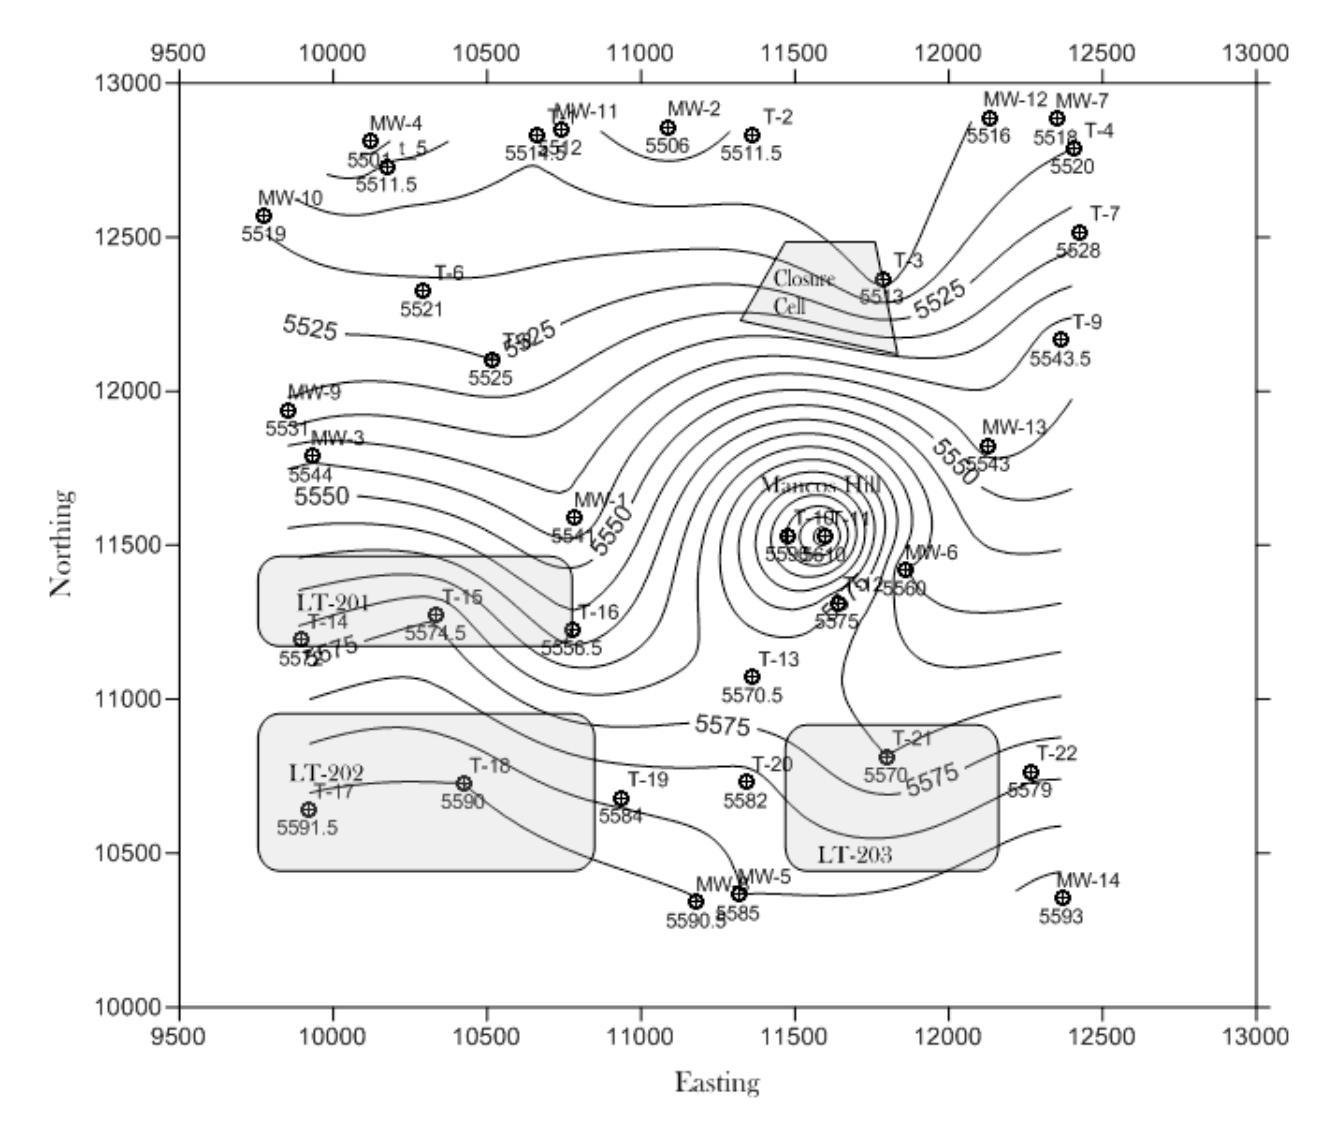
Figure 7.3. The drilling description of MW-1 shows the presence of unconfined ground water at this interface. MW-1 appears to be in the channel of this aquitard surface. This aquitard-surface channel appears to go from the vicinity of MW-8 through MW-1 to the vicinity of MW-4 and MW-10. This channel collects the unconfined flow from the area between T-22 and T-15. Water in the low point of the aquitard surface was seen during the drilling program conducted in Four Corners Environmental Research and reported in 1977. Because of the location of test holes, the prominent positive feature associated with Mancos Hill is displaced to the south.
