Subject: Review of Operating Experience R. E. Ginna Nuclear Power Plant Docket No. 50-244

### Investigation of DB50 Breaker Failures

### SUBJECT: Results of Analyses and Testing Performed to Determine Cause of Failure of Certain W "DB-50" Circuit Breakers at Ginna Station (EWR 3073)

SUBJECT: Close out of ENR 3073 DB-50 & DB-75 Circuit Breaker Failures

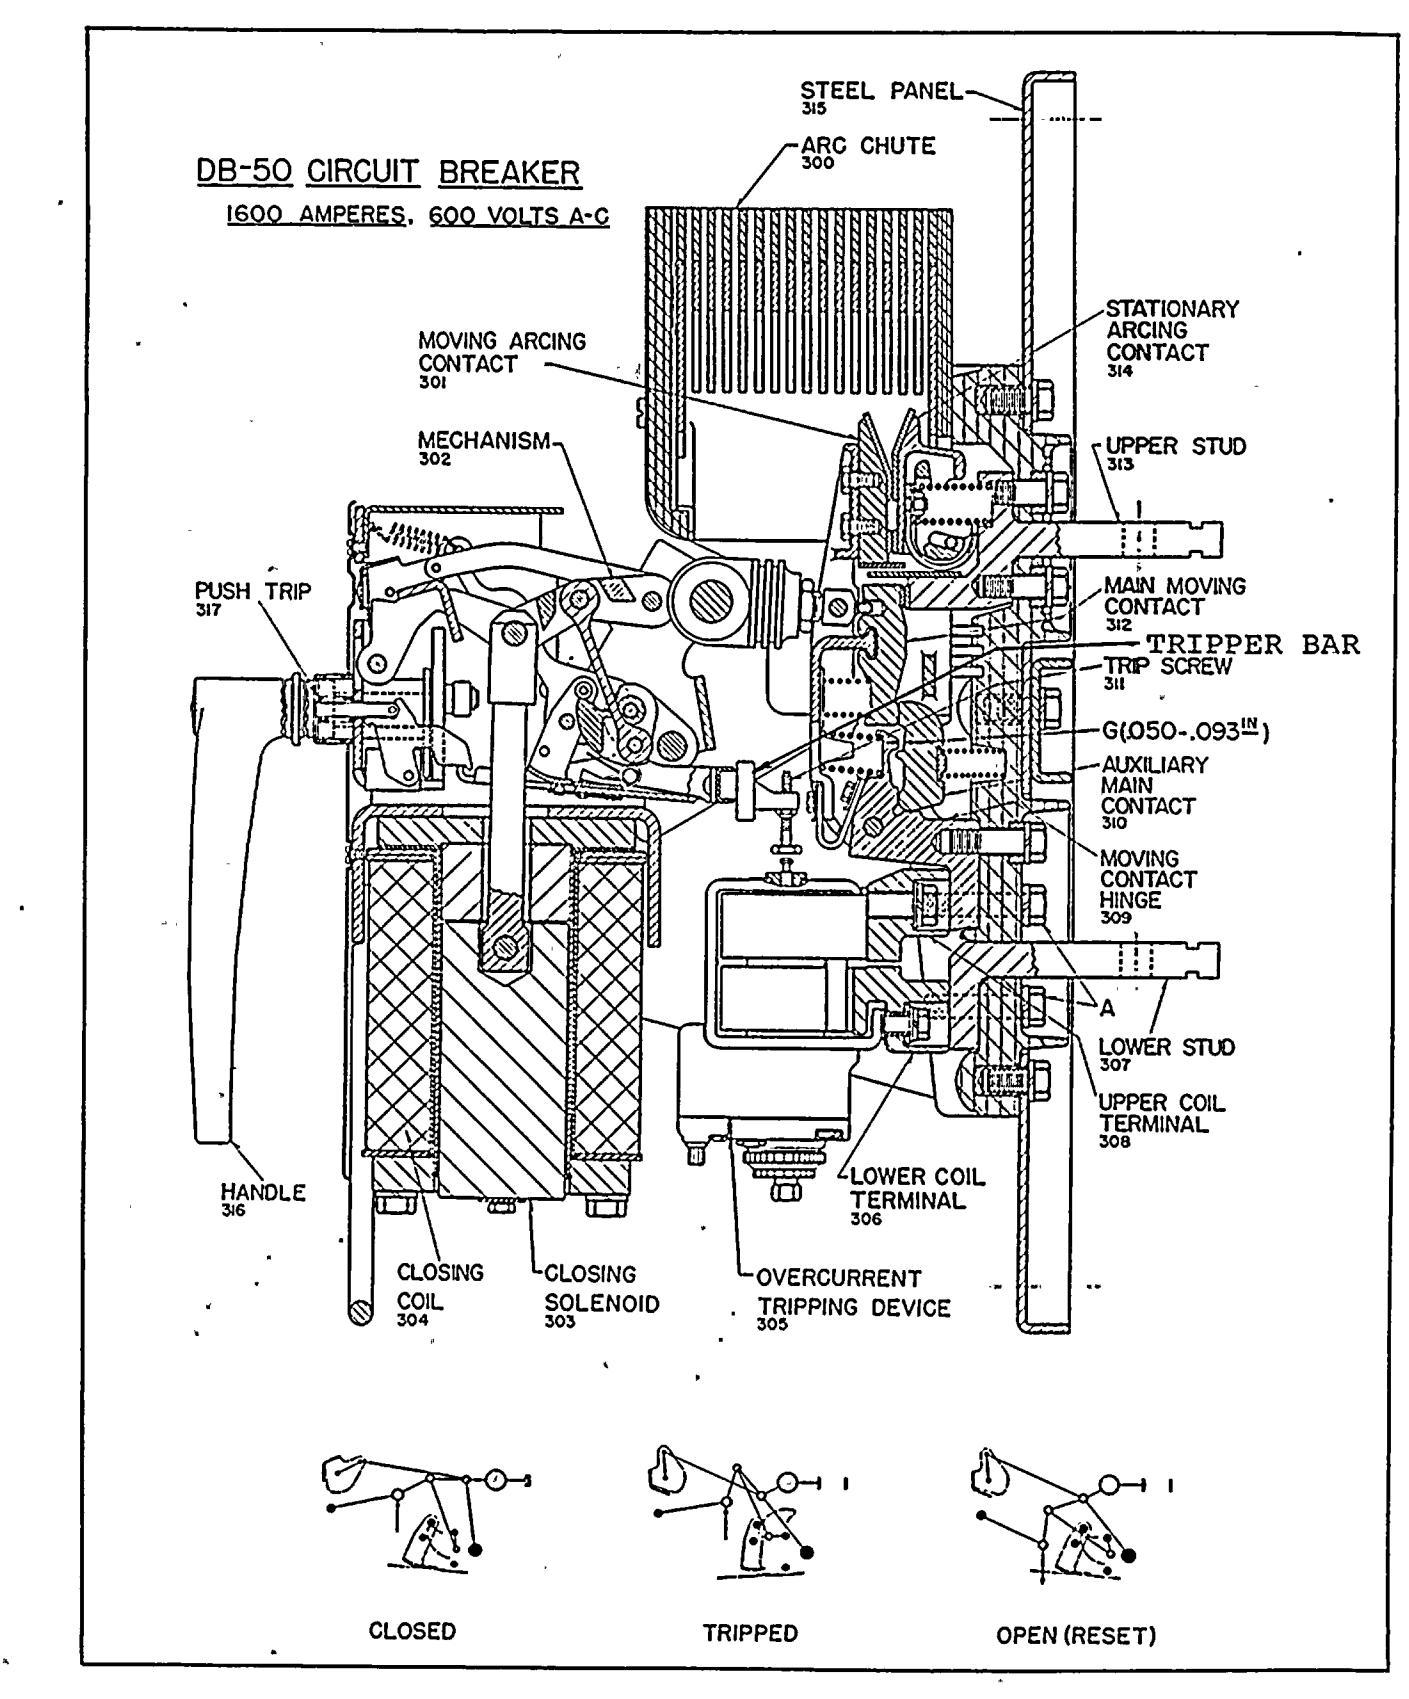
Fig. 1 - Cross-Sectional View of Type DB-50 Circuit Breaker

The failure of Circuit Breaker SIPIC1 to close upon receipt of a close signal was determined to be due to inadequate clearance between the lockout assembly and the "tripper bar" which prevented the tripper bar from locking into the closed position, and therefore simulated an overcurrent condition in the breaker. It should be noted that the principal function of the tripper bar is to open the breaker when the overcurrent coil internal to the DB-50 breaker actuates (See figure 1). Existing instruction books for the "DB" breakers with the lockout attachment state there are no adjstments for this clearance, however, Westinghouse has since developed an adjustment method. By loosening the locknut, the elastic stop nut can be turned to adjust the clearance between the lockout assembly and the tripper bar. The clearance should be 1/32"-1/16" with the lockout coil in the energized position (See figure 2). Results of Analyses and Testing Performed to Determine Cause of Failure of Certain W "DB-50" Circuit Breakers at Ginna Station (EWR 3073)

It is recommended that plant maintenance procedures be modified to check, and adjust if needed, clearance of the lockout assembly on "DB" breakers that have this lockout feature in accordance with the <u>W</u> procedure. This is in addition to any existing maintenance procedures that may apply. When maintenance procedures have been modified, reliability and availability of the breakers will be acceptable.

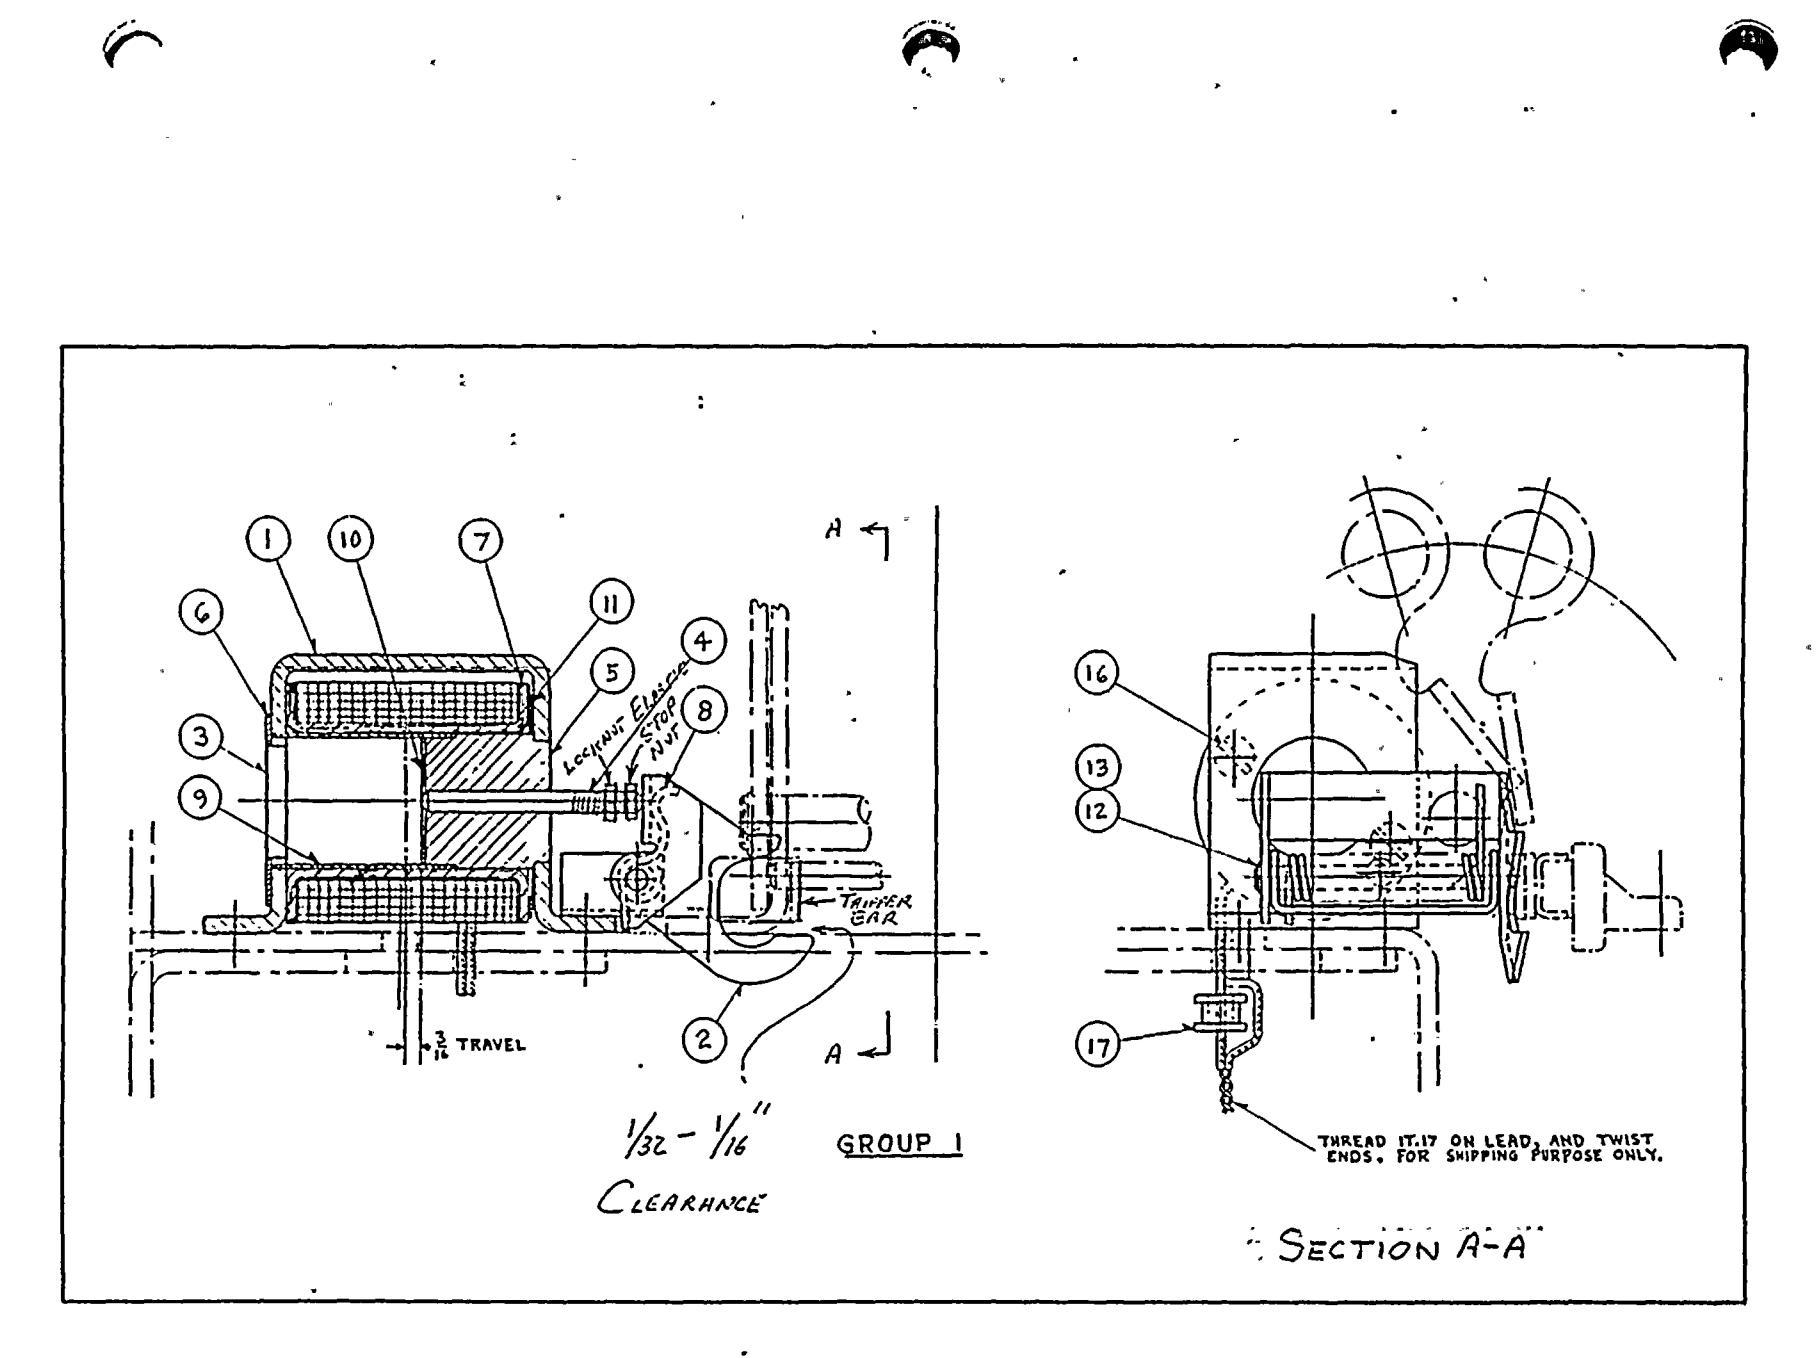
Fig. 2 - Electric Lockout Attachment - Construction Details

This letter is to summarize our findings at East Pittsburgh on April 22, 1981. We found that when the electrical lockout was energized there was no clearance between the electric lockout arm and the trip bar. This caused the breaker to fail to close reliably. There is a screw and locknut adjustment that should be set for 1/32-1/16" clearance between the electric lockout arm and the trip bar when the lockout is energized. We corrected this adjustment and the breaker subsequently closed reliably. This is a breaker manufacturing assembly adjustment that is not normally adjusted in the field.
