UNITED STATES  
NUCLEAR REGULATORY COMMISSION

SUBJECT: REQUEST FOR ADDITIONAL INFORMATION REGARDING RISK-INFORMED INSERVICE TESTING FOR PALO VERDE NUCLEAR GENERATING STATION (TAC NOS. M94139, M94140, AND M94141)

**An Examination of Motor-Operated Valve Failures With Application  
to Increasing the Surveillance Testing Period at  
Arizona Public Service Company**

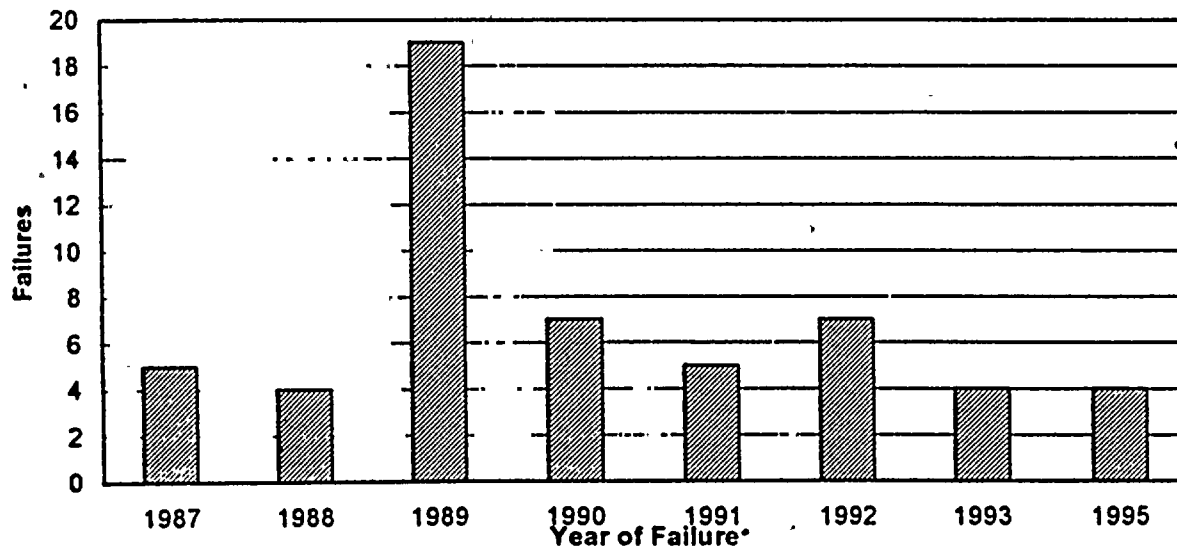
Figure 1 - Distribution of Failures by Year

The 523 failures are distributed among 159 MOVs and 11 years, from 1986 to 1996. The distribution of failures by year of occurrence is shown in Figure 1. This list of valves was compared to the list of valves for which an extension of the inspection period is requested. This resulted in a total of 91 failures among 28 valves. The failure narratives for these failures were analyzed and data grouped by the following categories.

The reader may wish to observe that 14 of the 21 components identified have multiple failures, and only two of these have a time period of six years between failures. The distribution of these failures is shown in Figure 1.

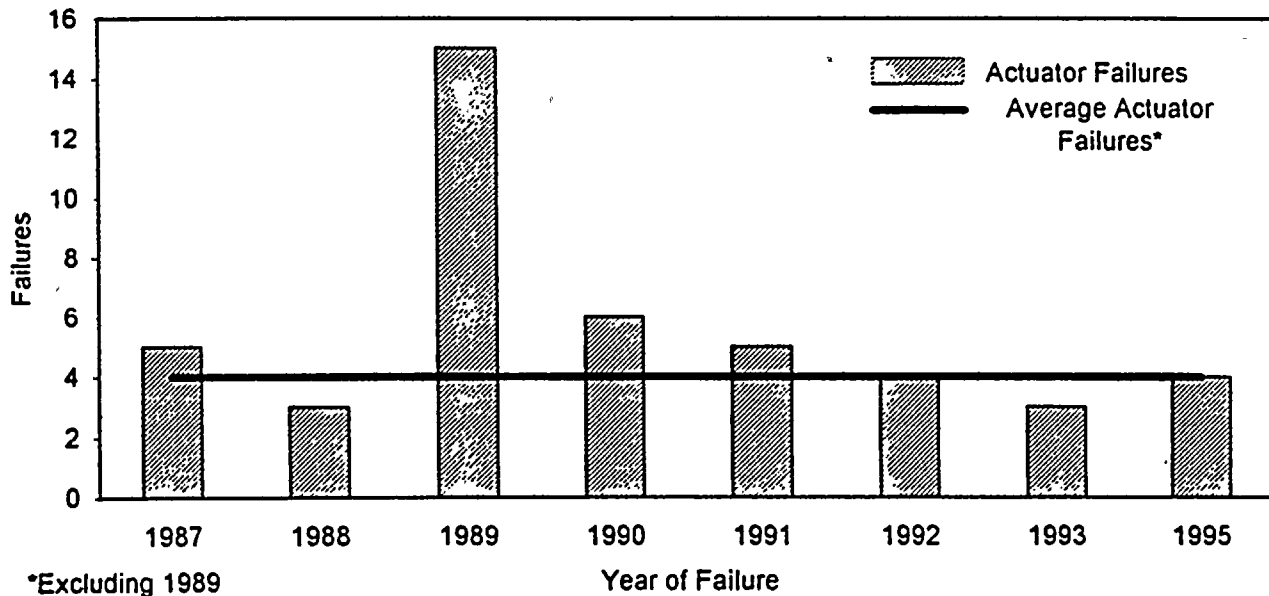
**Figure 2 - Distribution of actuator failures by year**

Examination of these failures identifies the actuator as the component area with the largest percentage of failures (82%). This is shown below in Table 2. It should be noted that units 1 and 2 at Palo Verde started commercial operation in 1986, and unit 3 started commercial operation in 1988. Aging of valve components in contact with the fluid may not see aging related failures without additional service wear.

As can be seen in Figure 2, if data for 1989 is not averaged then actuator failures are relatively constant in number.
