INDIANA & MICHIGAN ELECTRIC COMPANY DONALD C. COOK NUCLEAR PLANT UNIT 2

# STEAM GENERATOR TUBE INTEGRITY - APRIL 1987 An Assessment of the Next Operating Interval Length Attachment 1 to AEP:NRC:0936J

American Electric Power Service Corporation One Riverside Plaza Columbus, Ohio 43216

May 18, 1987

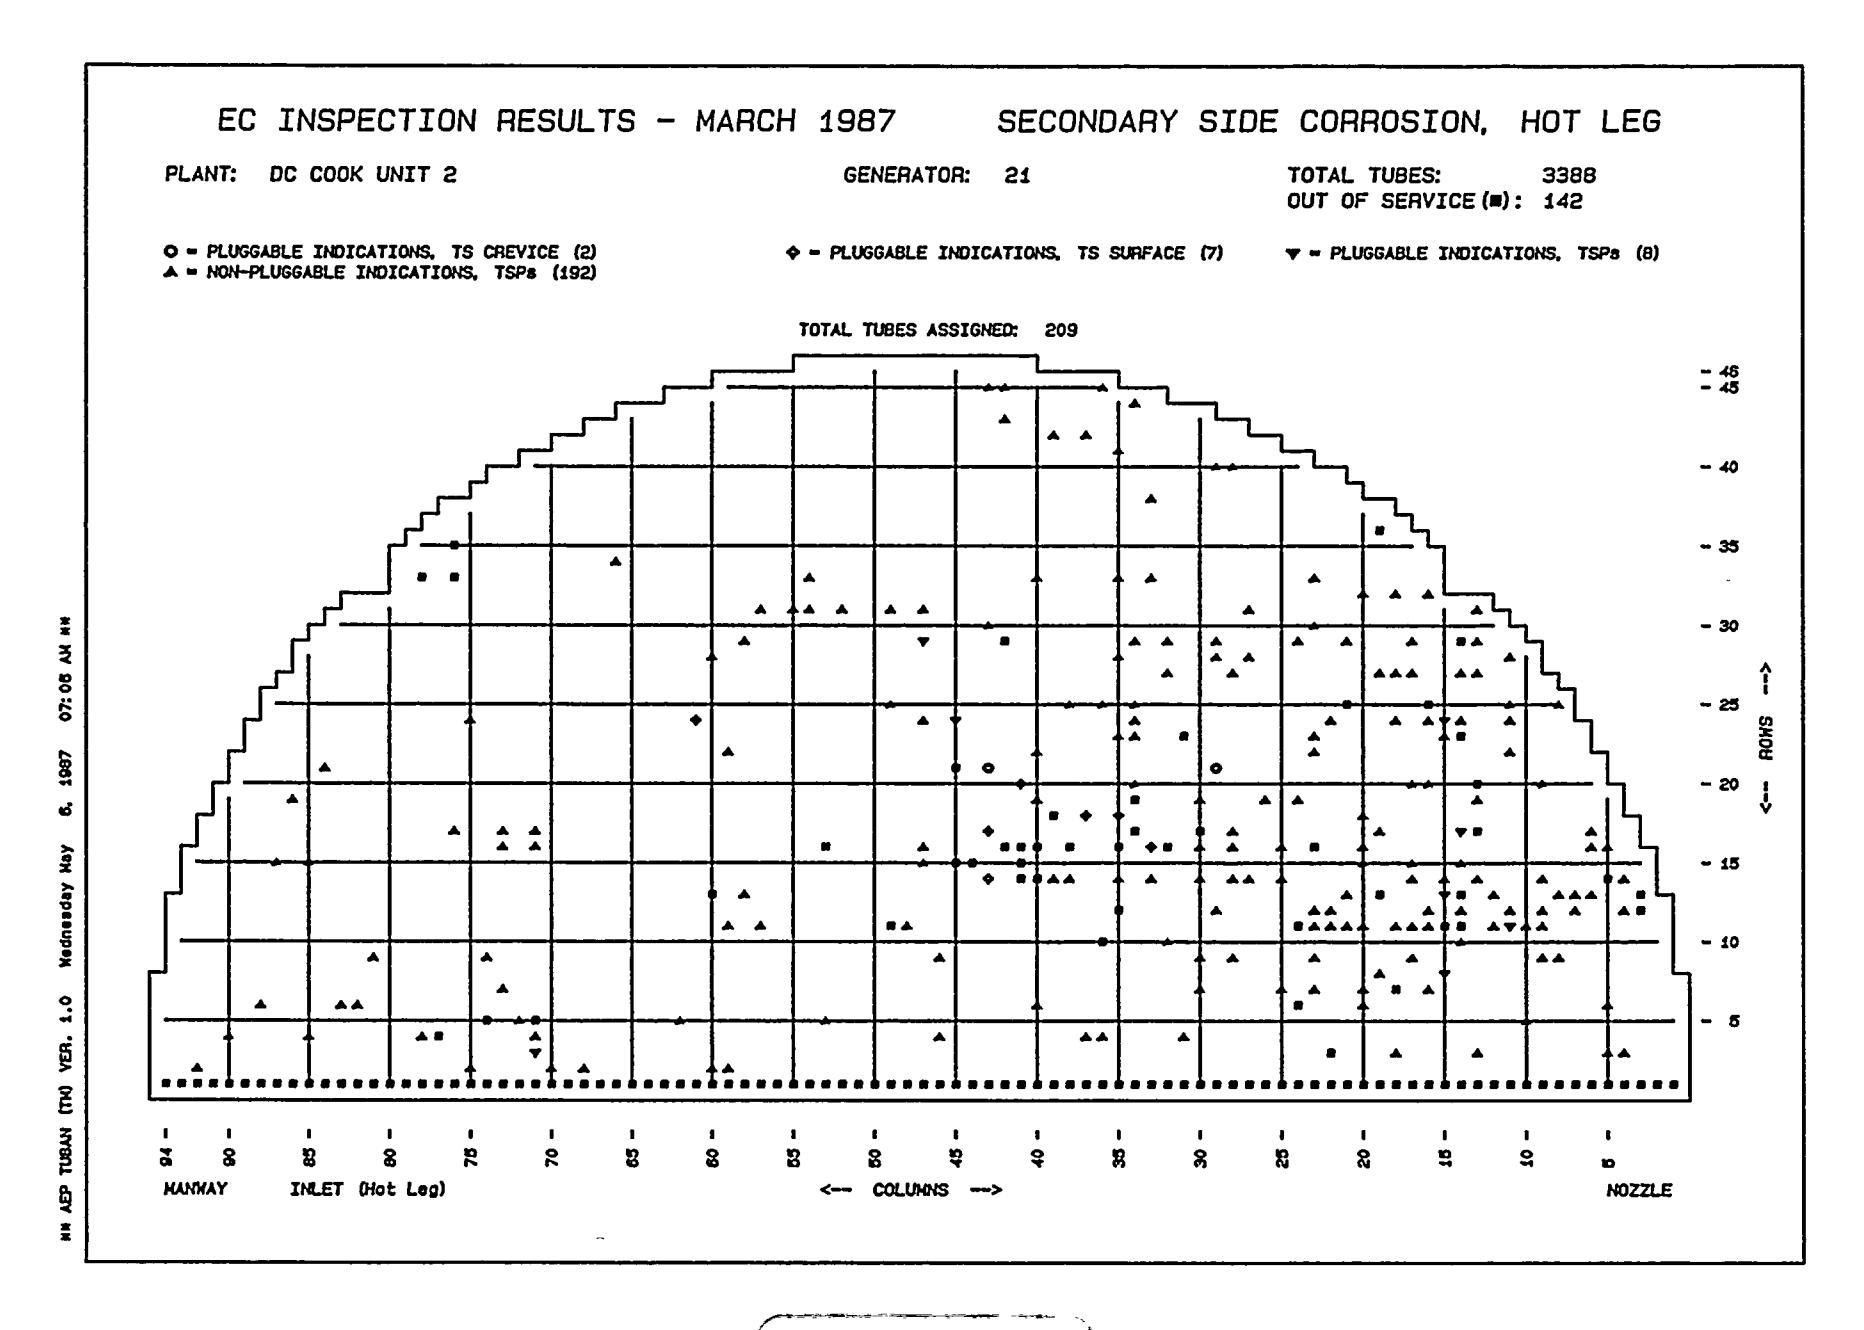
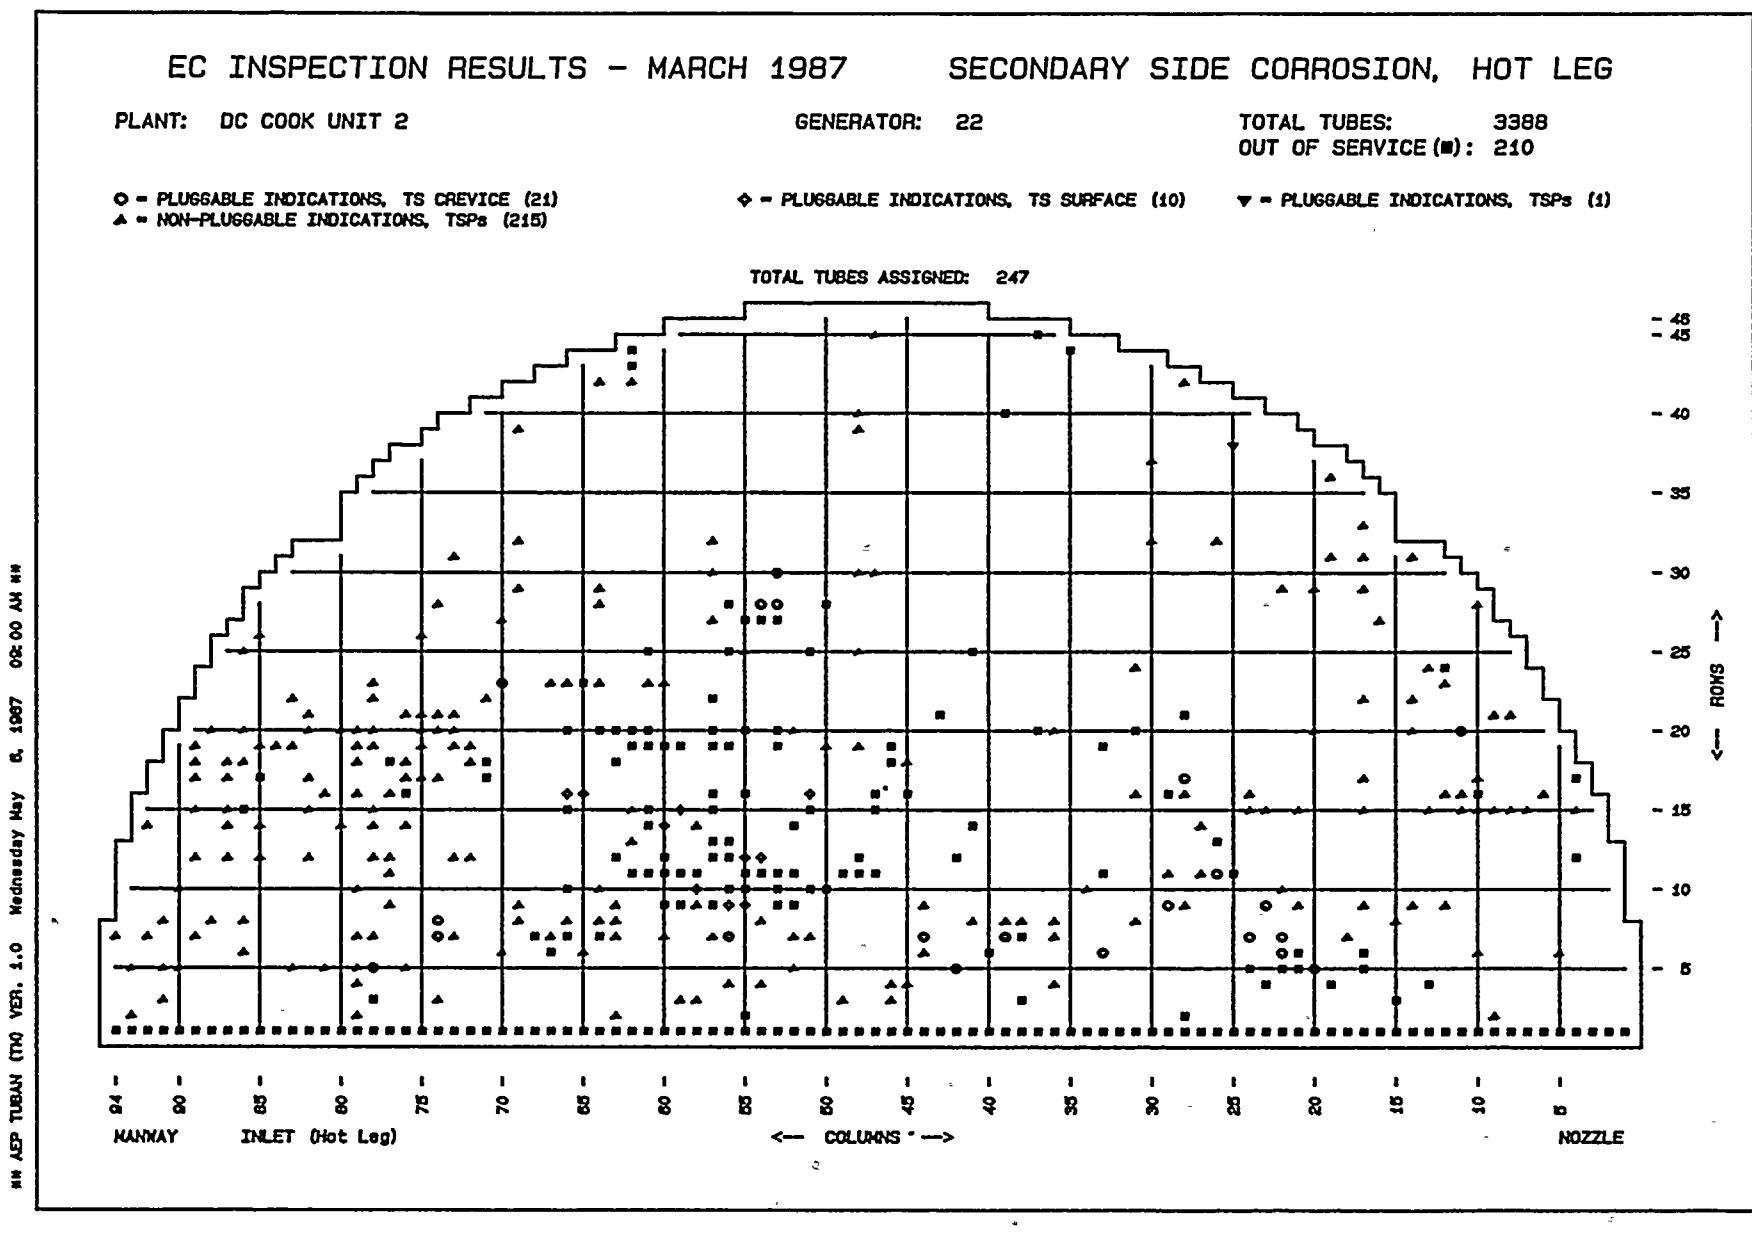
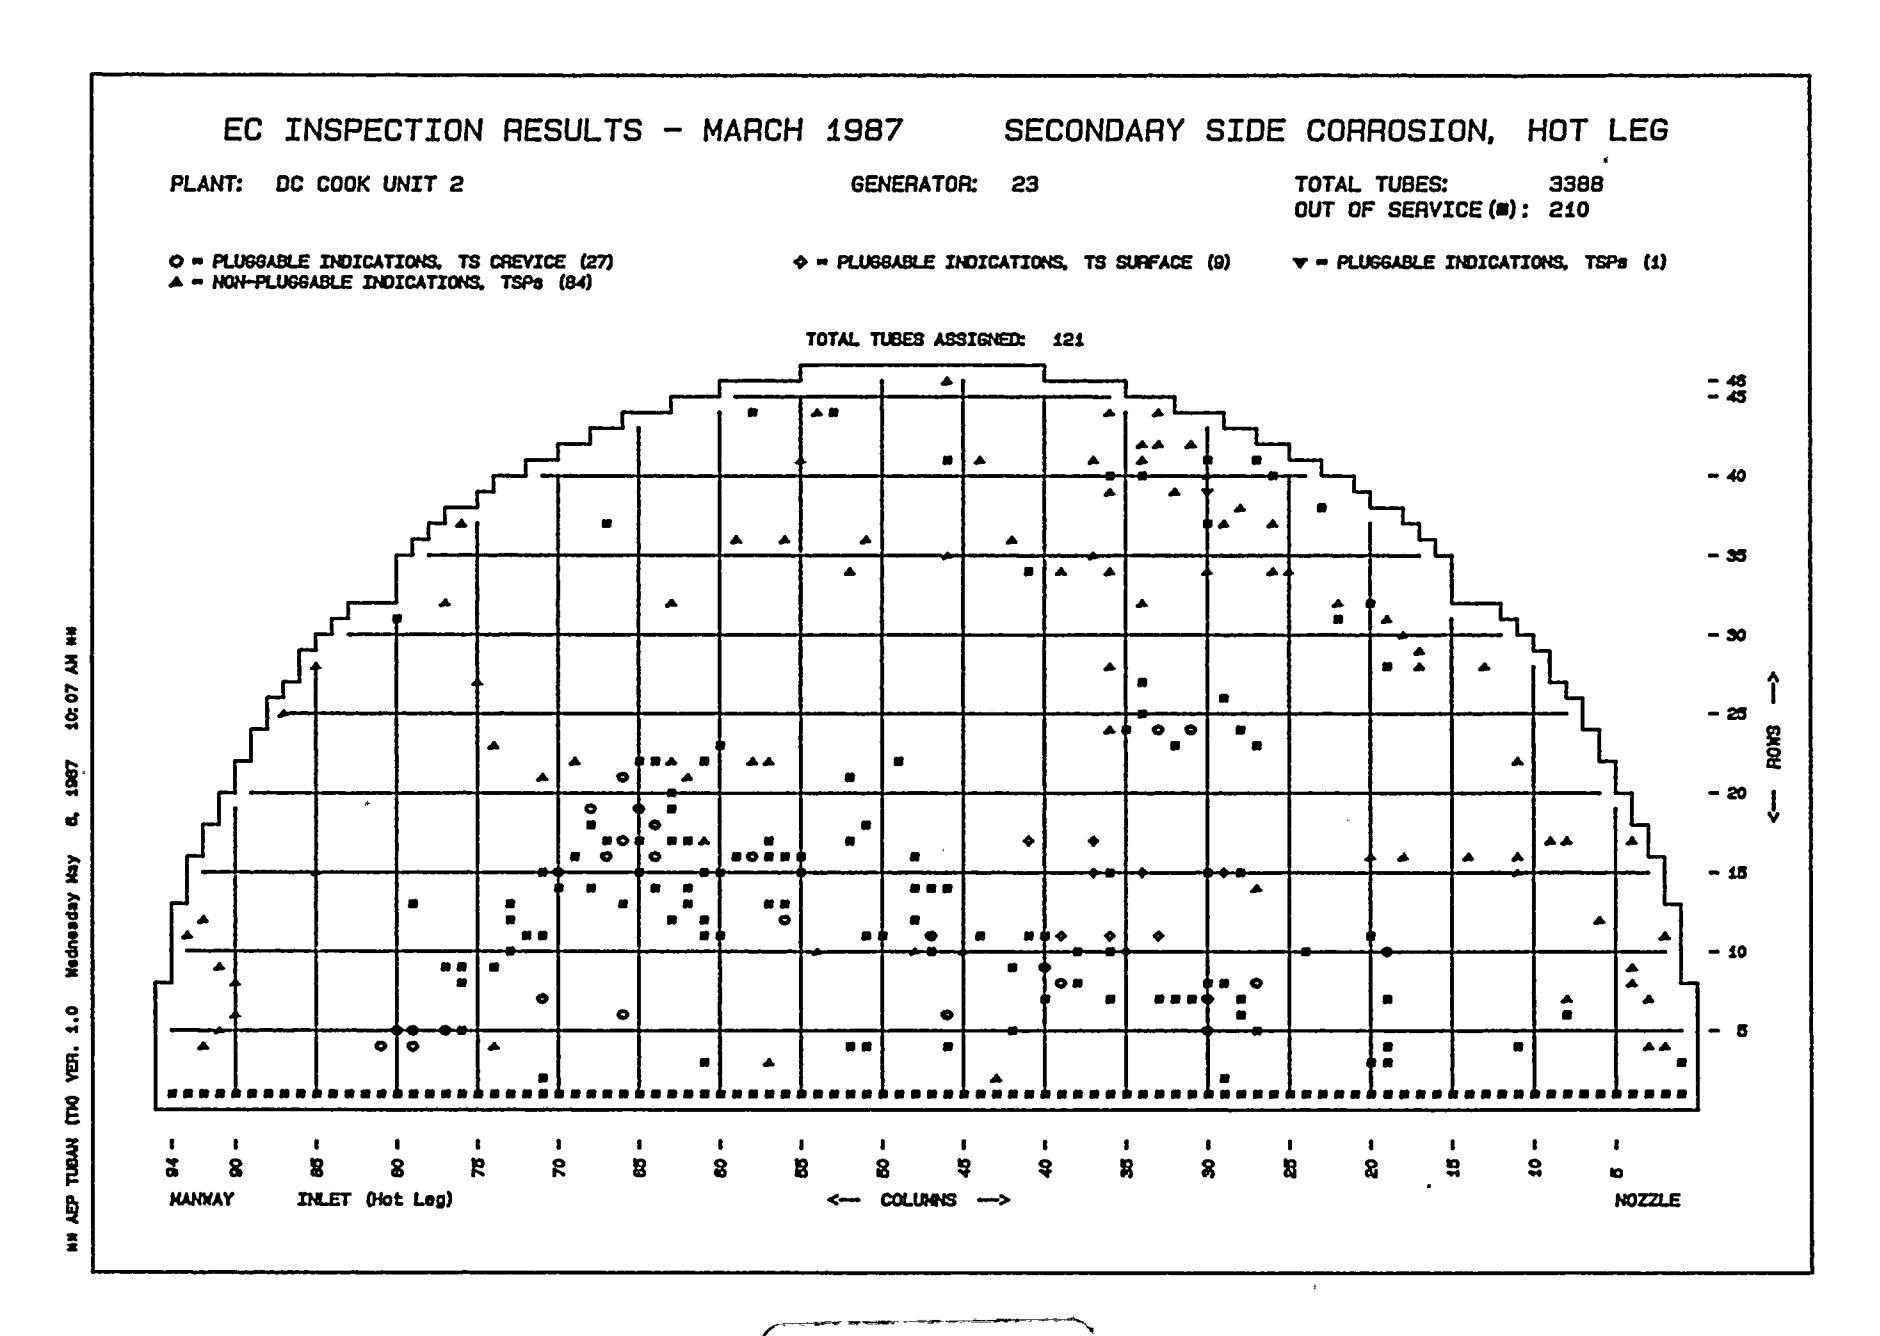
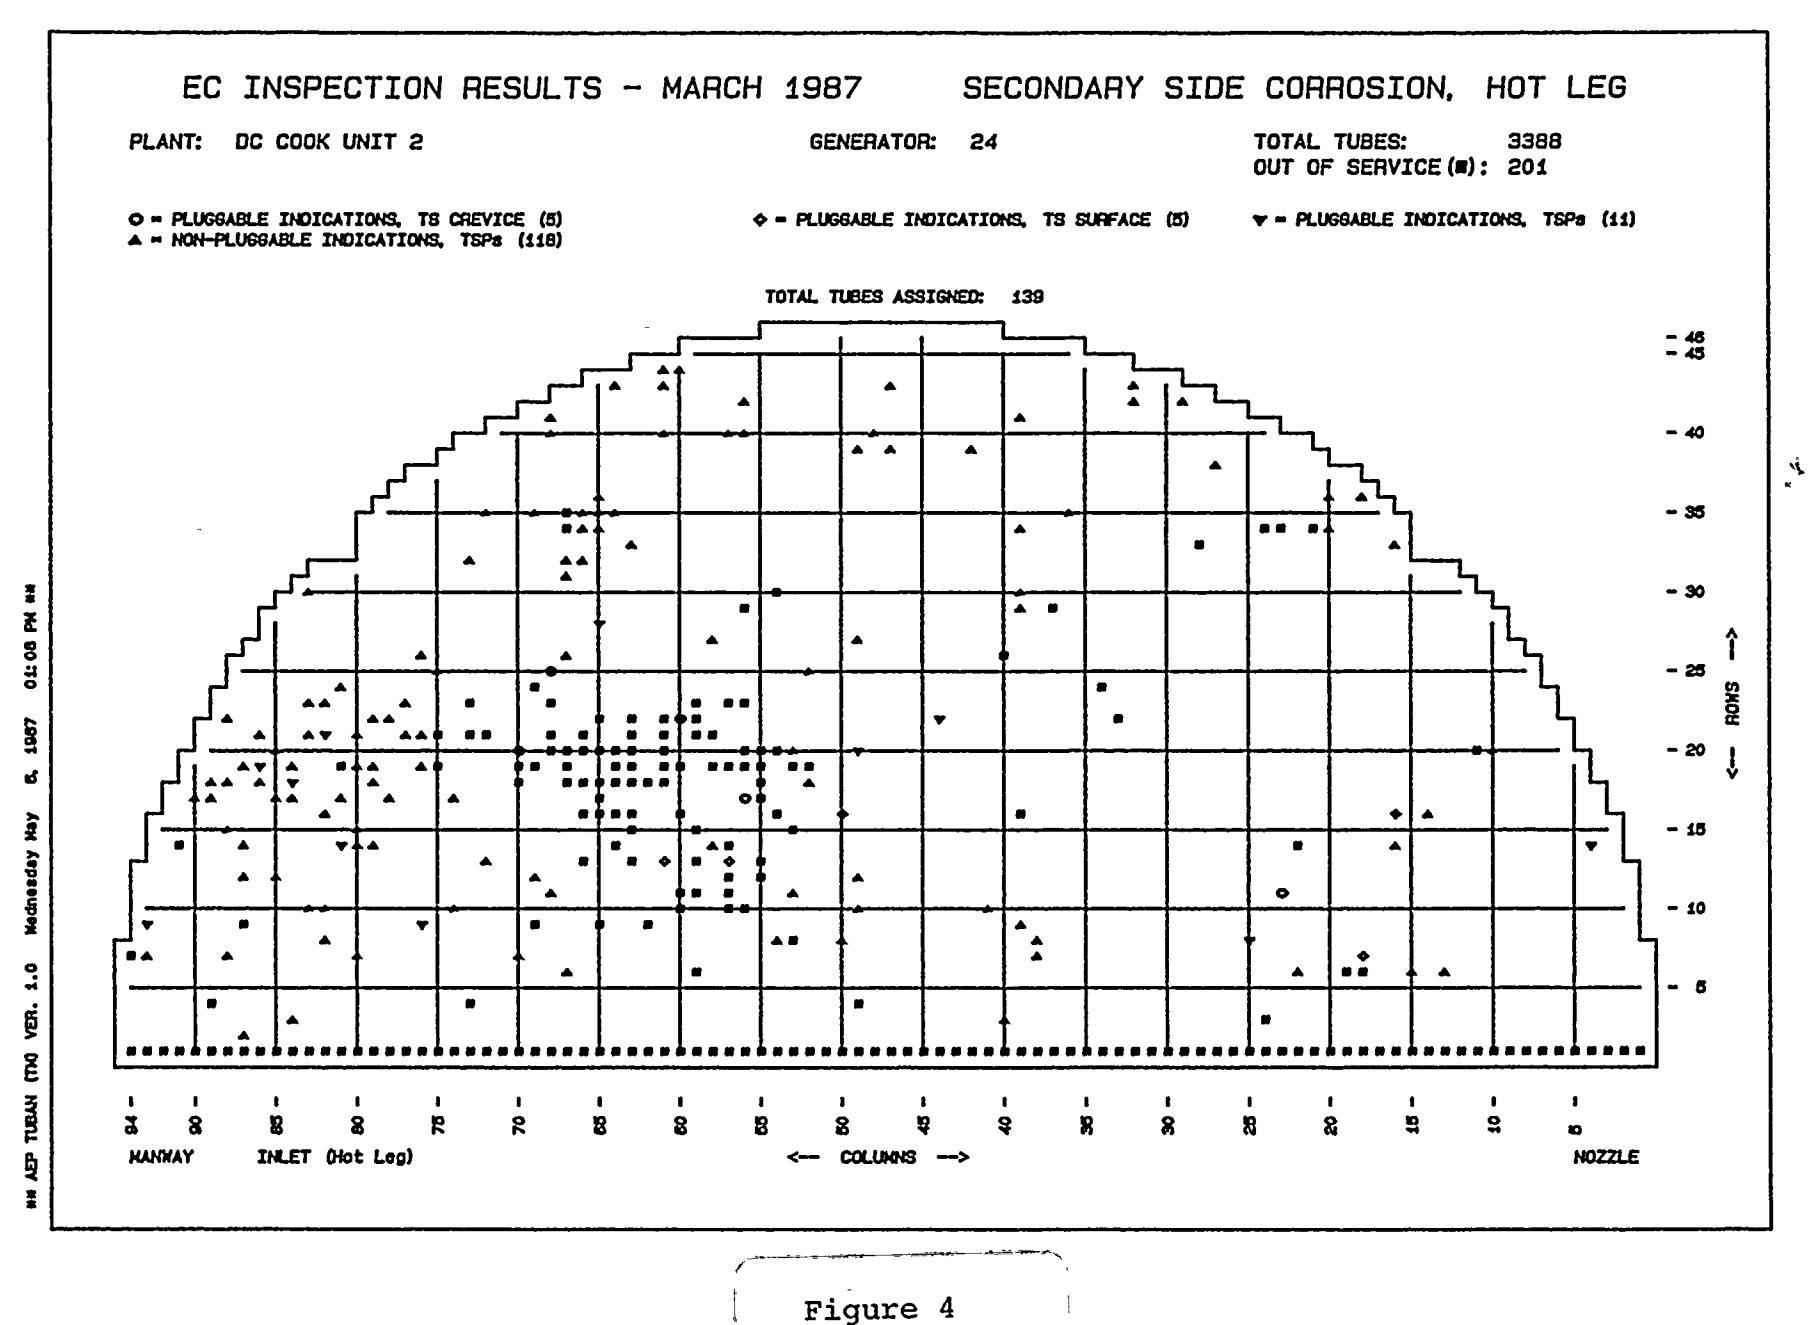
Figures 1, 2, 3, and 4 are tubesheet maps for each Cook 2 steam generator showing the location and extent of wall degradation in the steam generator tubing. Indications plotted are those contained in Table 1-A.

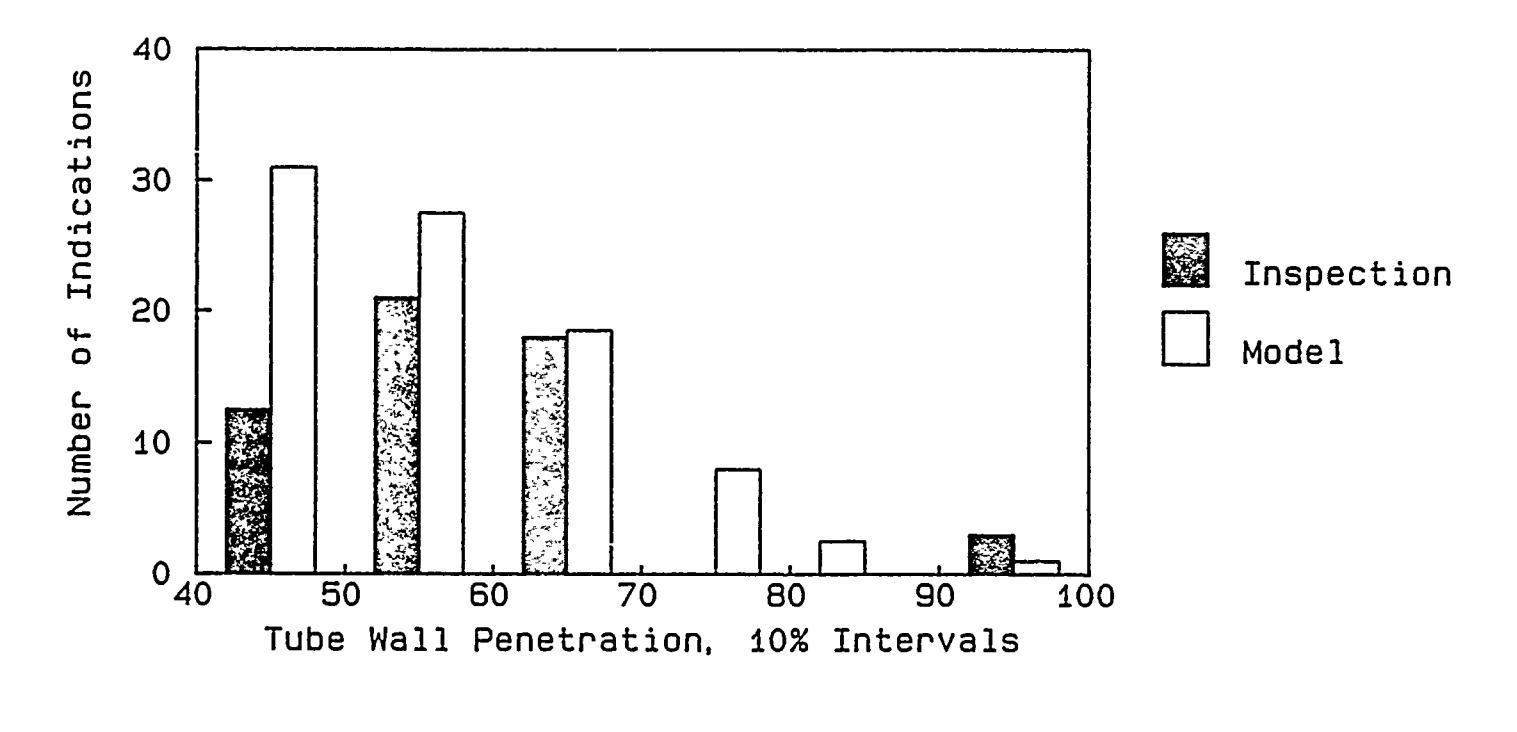
Figure 7 Comparison of Model Prediction to Actual EC Inspection Results, Tubesheet Crevice Region

The end results of the above-described comparison are shown in Figure 7 for the tubesheet crevice region, Figure 8 for the tubesheet surface region, and Figures 9-A and 9-B for tube support plate intersections. In the tubesheet surface region and at tube support plate intersections, the model data was fit with a "best estimate" curve. In the tubesheet crevice region, the model data was fit with a more conservative "over-prediction" curve in recognition of the fact that crevice corrosion has been the limiting factor for continued operation.
