REGULATORY INFORMATION DISTRIBUTION SYSTEM (RIDS)

SUBJECT: LER 88-002-00:on 880326,ice buildup in ice condenser flow passages due to sublimation. W/8 ltr.

NRC Form 366A (9-83) LICENSE	E EVENT REPORT (LER) TEXT CONTIN	U.S. NUCLEAR RE	U.S. NUCLEAR REGULATORY COMMISSION APPROVED OMB NO. 3150-0104 EXPIRES: 8/31/88					
FACILITY NAME (1)	DOCKET NUMBER (2)	LER NUMBER (6)	PAGE (3)					
D. C. Cook Nuclear Plan Unit 1	nt : 0 5 0 0 0 3 1 5	ÝFAR SEQUENTIAL REVISIOI 5 8 8 0 0 2 0 0	0 2 OF 1 0					
TEXT (If more space is required, use additional NRC Form S	186A's/ (17)	Þ	ę

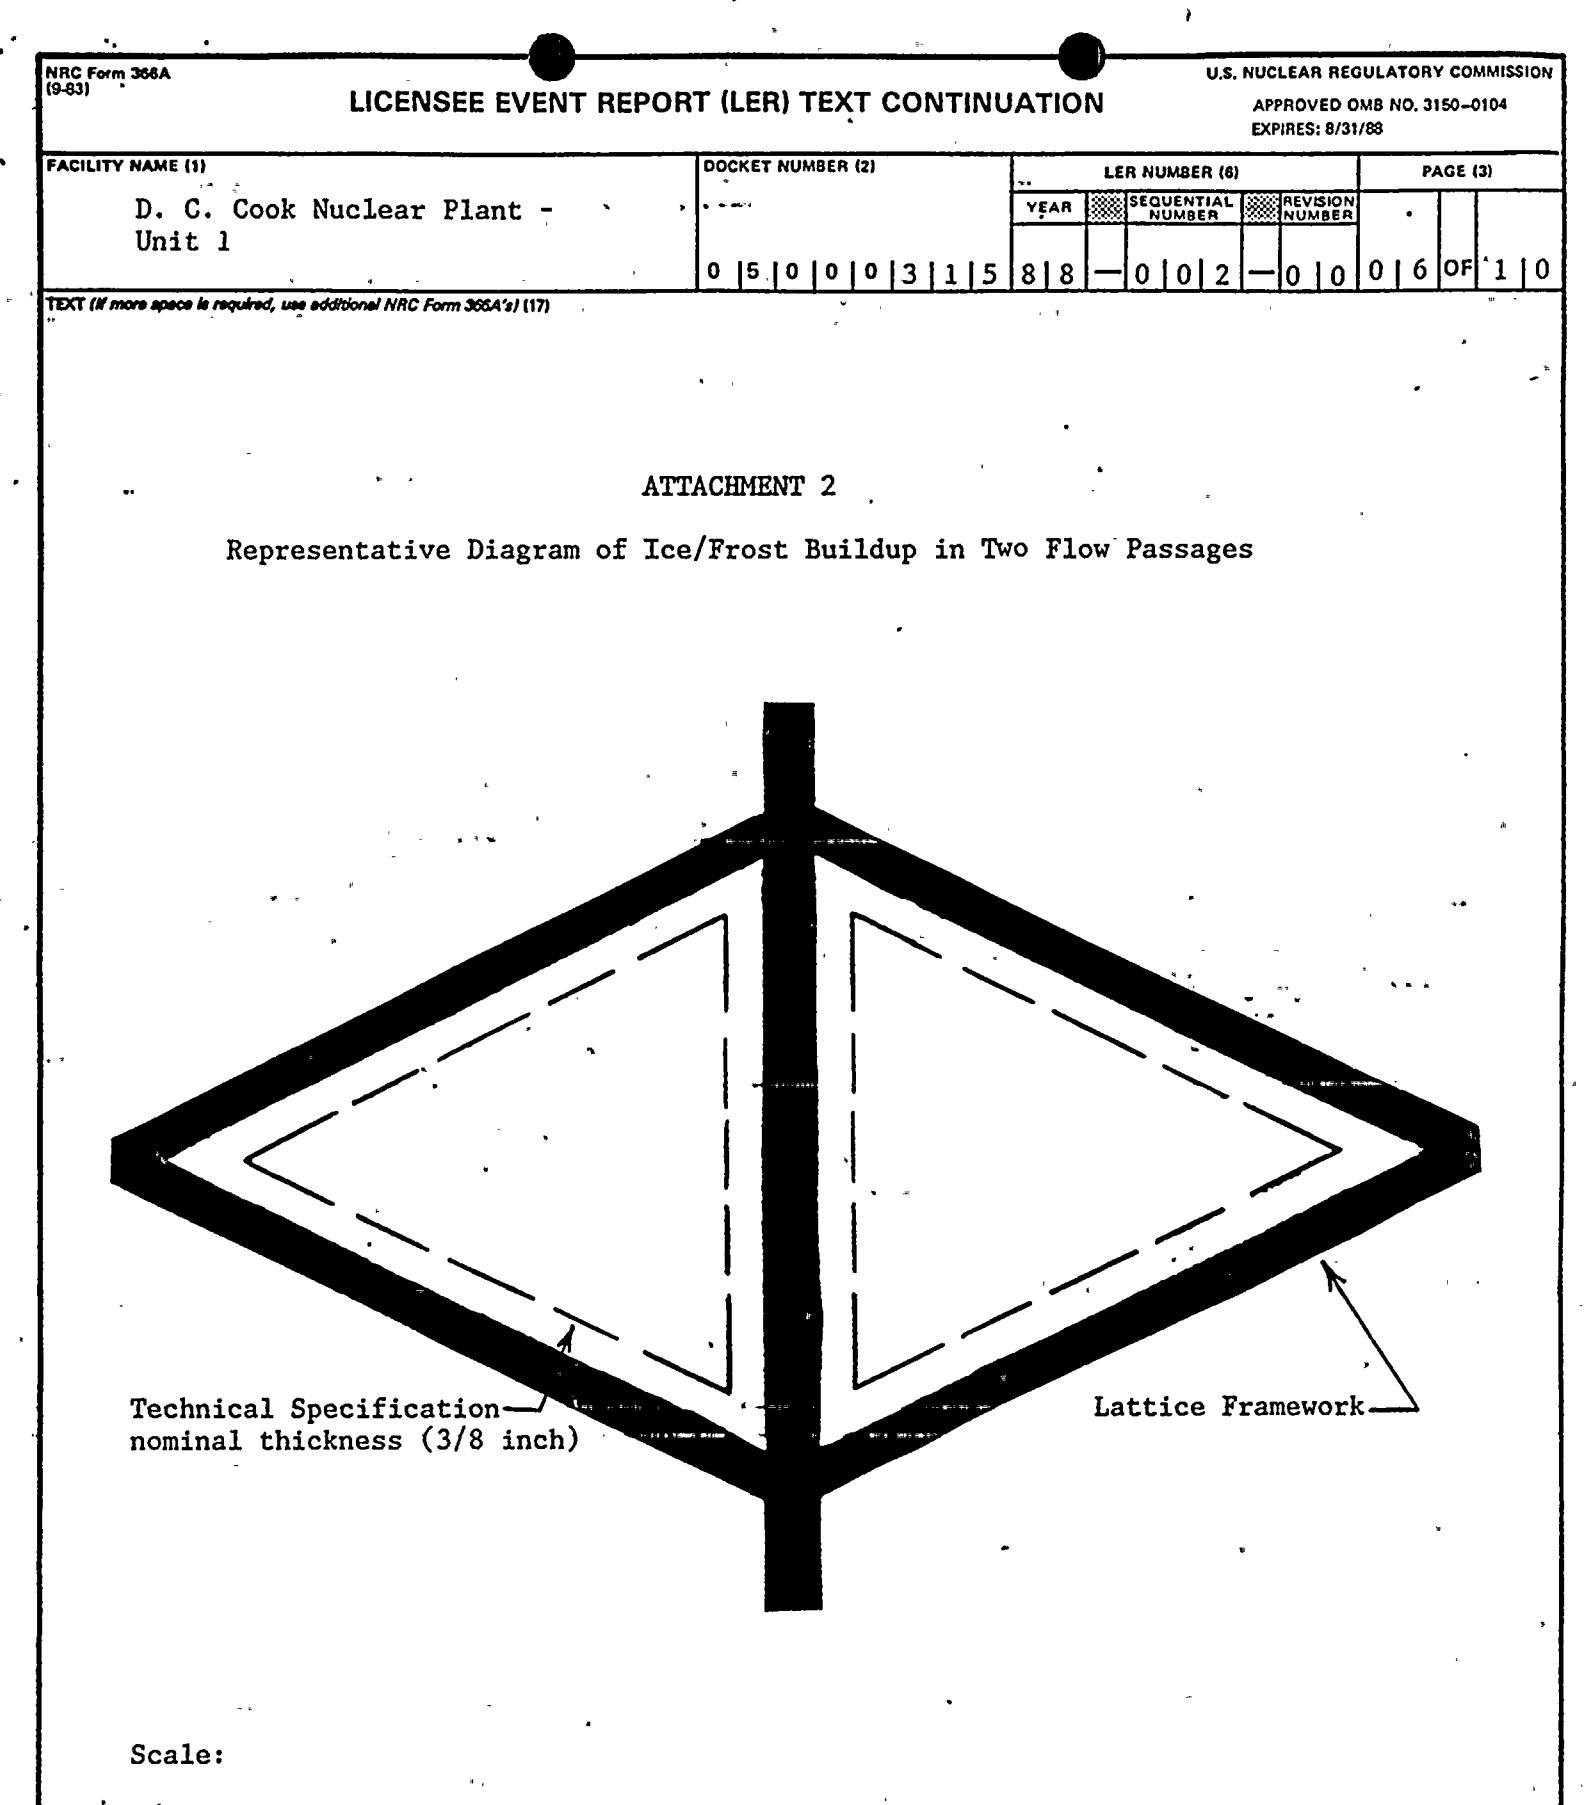
Description of Flow Passage Blockage by Category (affected Flow Passages are indicated by the boxed areas on the following attachments).

Category	Description*
А	Maximum Flow Passage Ice/Frost Blockage greater than 75 percent.
В	Maximum Flow Passage Ice/Frost Blockage between 50 and 75 percent.
C .	Maximum Flow Passage Ice/Frost Blockage between 25 and 50 percent.
D	Maximum Flow Passage Ice/Frost Blockage less than 25 percent (but greater than 3/8" buildup).
.")	concratigod estegaries which reflect the maximum

* NOTE: These are generalized categories which reflect the maximum ice/frost blockage found in a particular flow passage and in general was limited to one or two lattice frameworks in the flow passage. This does not indicate that the flow passage was blocked it's entire length. Lattice Framework is located at the positions of cruciforms in the ice basket. Cruciforms are installed every six feet within the 48 foot ice basket (for convention the "top" lattice framework is referred to as number 1, etc.). The specific lattice frameworks affected are indicated on the individual Bay drawings (Attachments 3 thru 6).

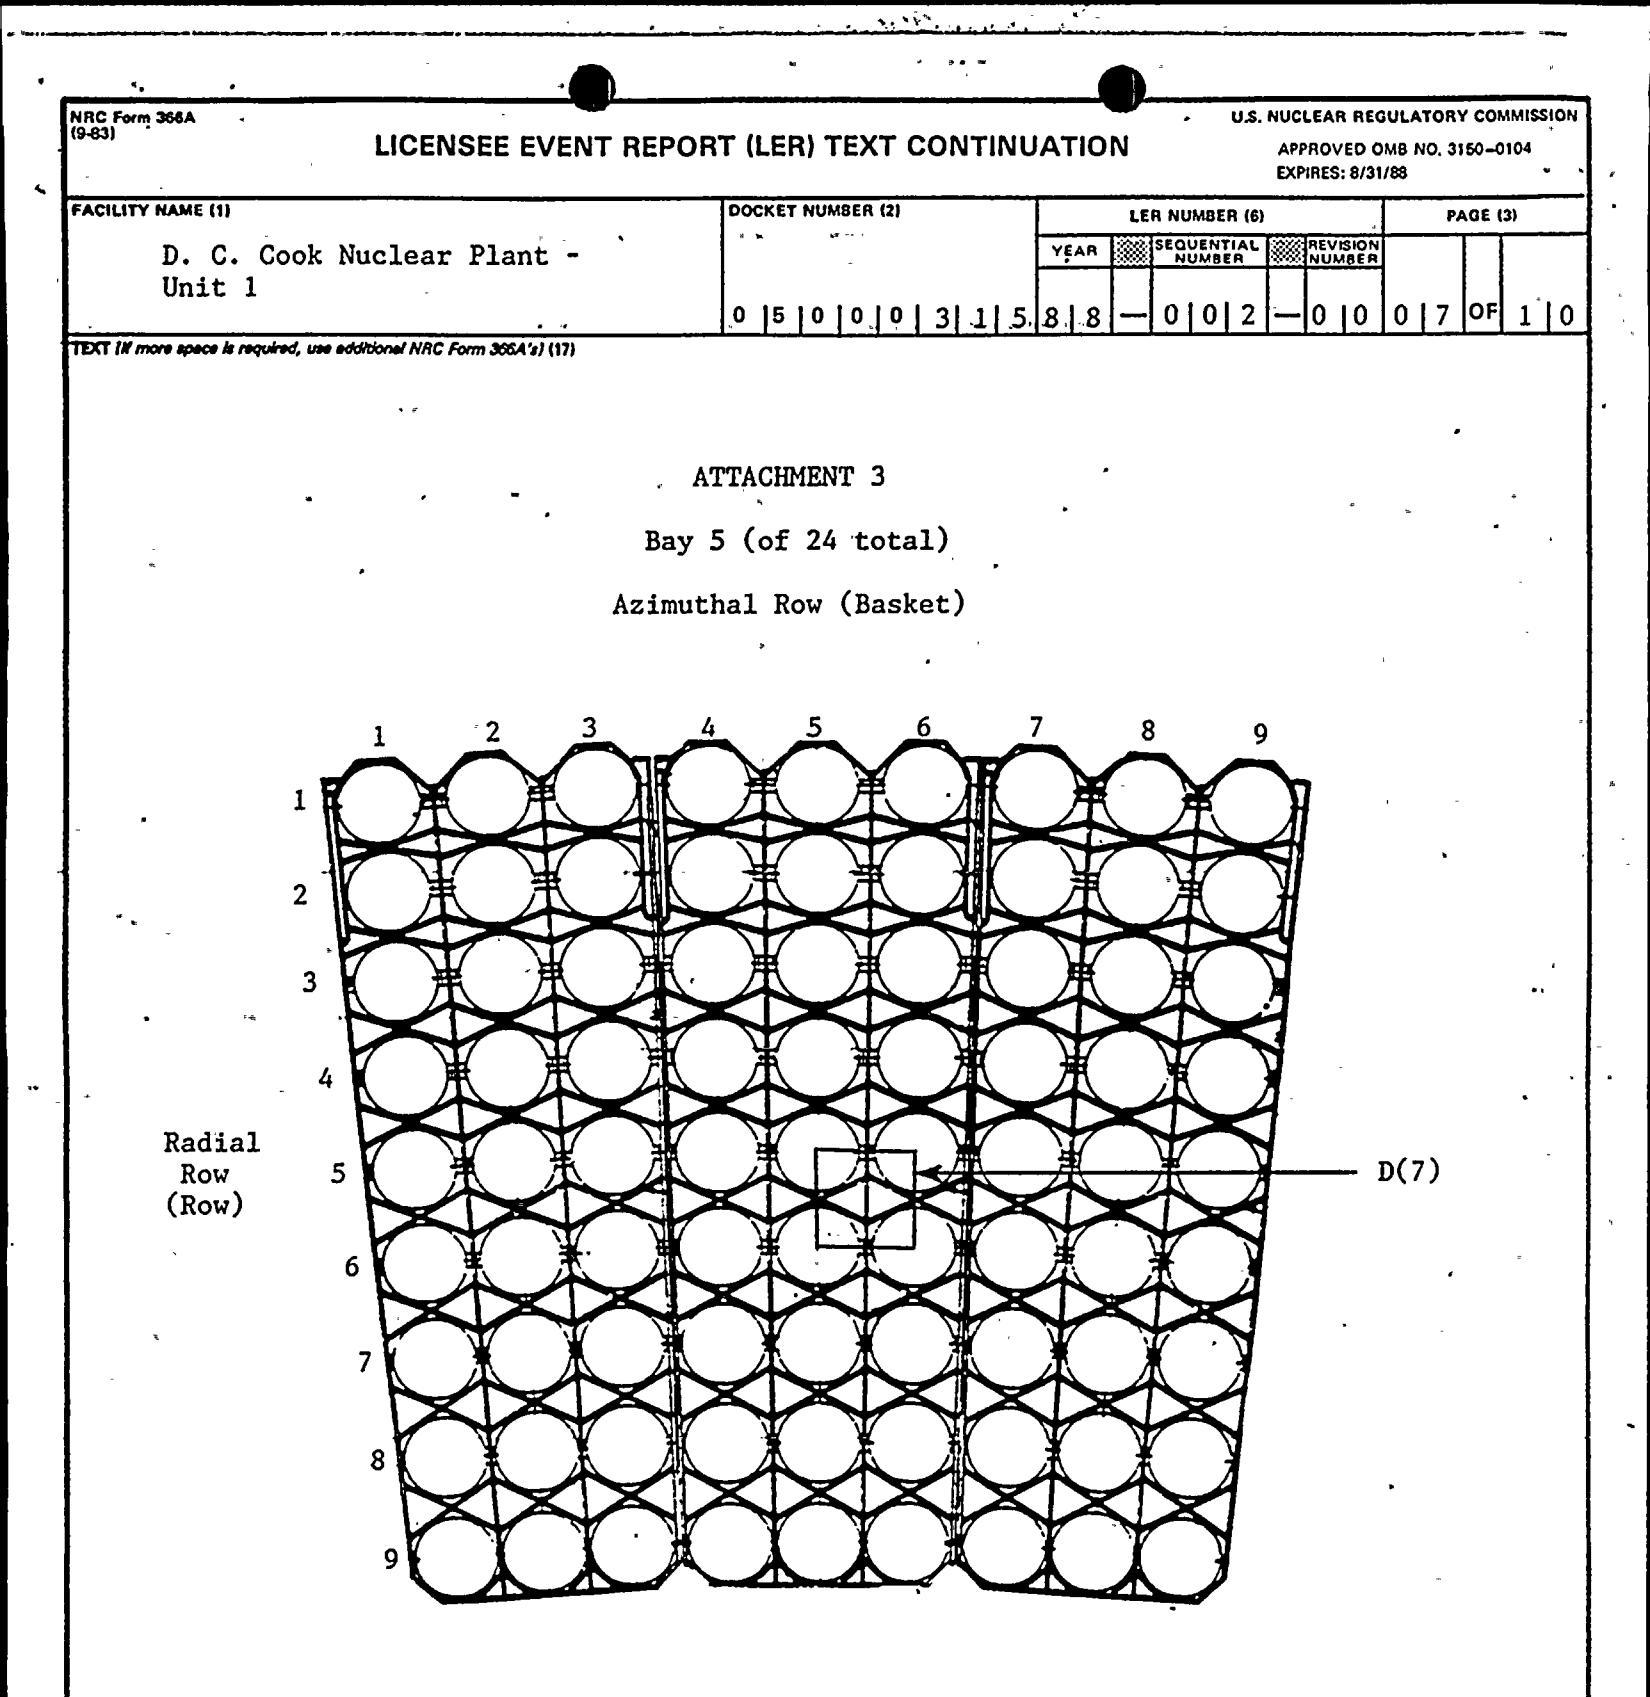
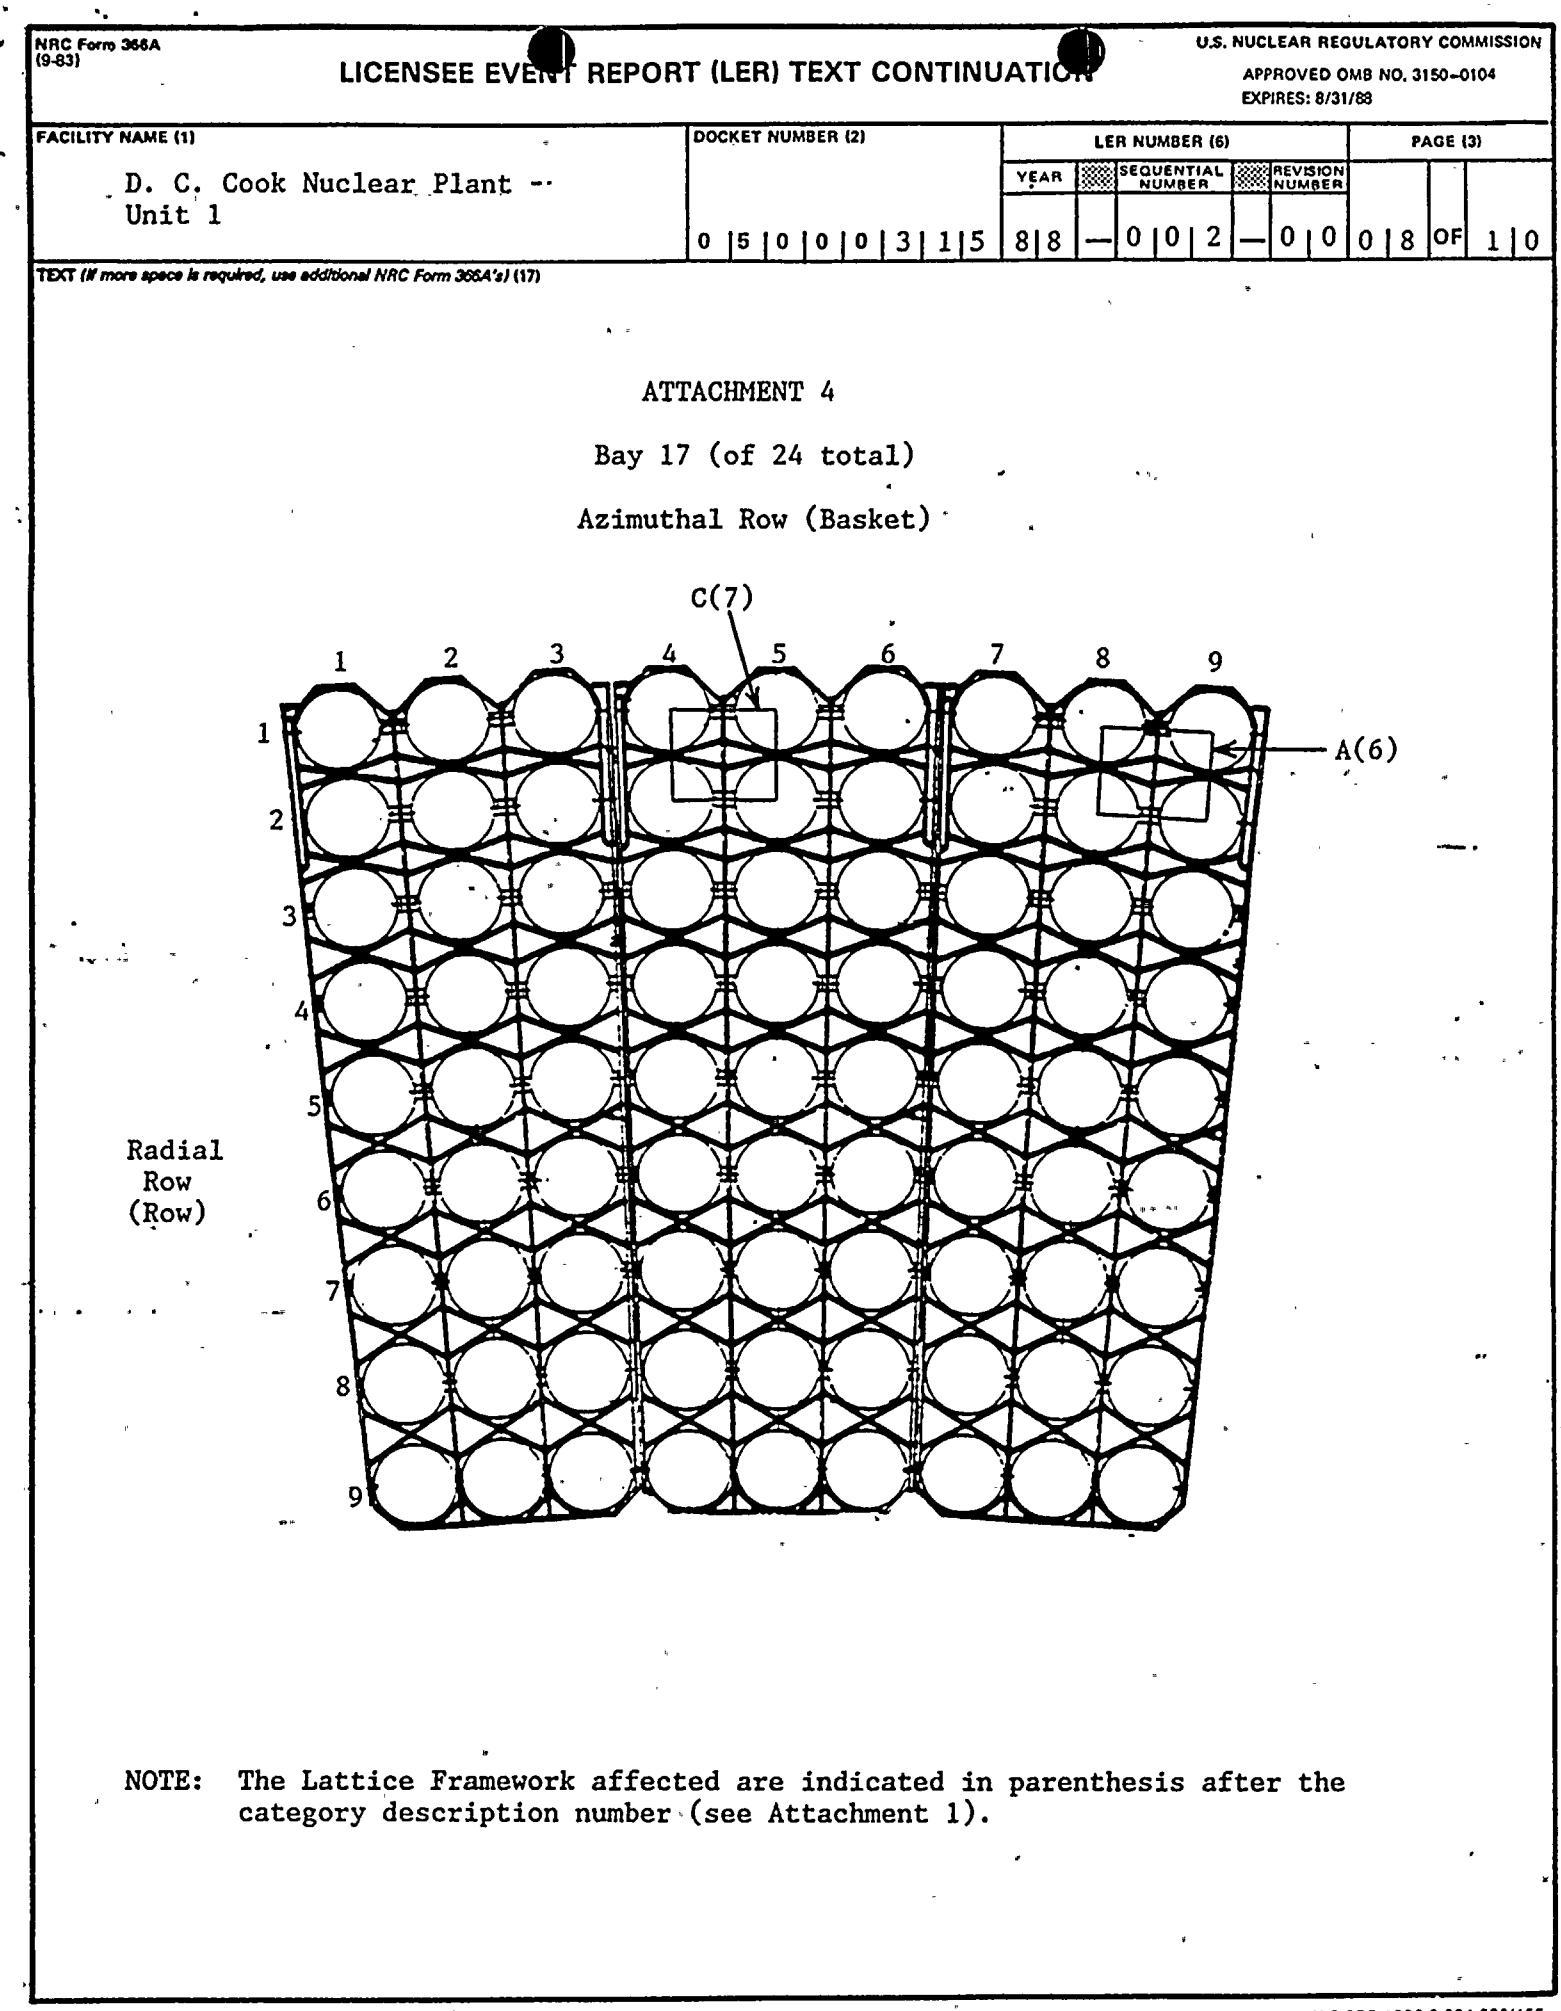
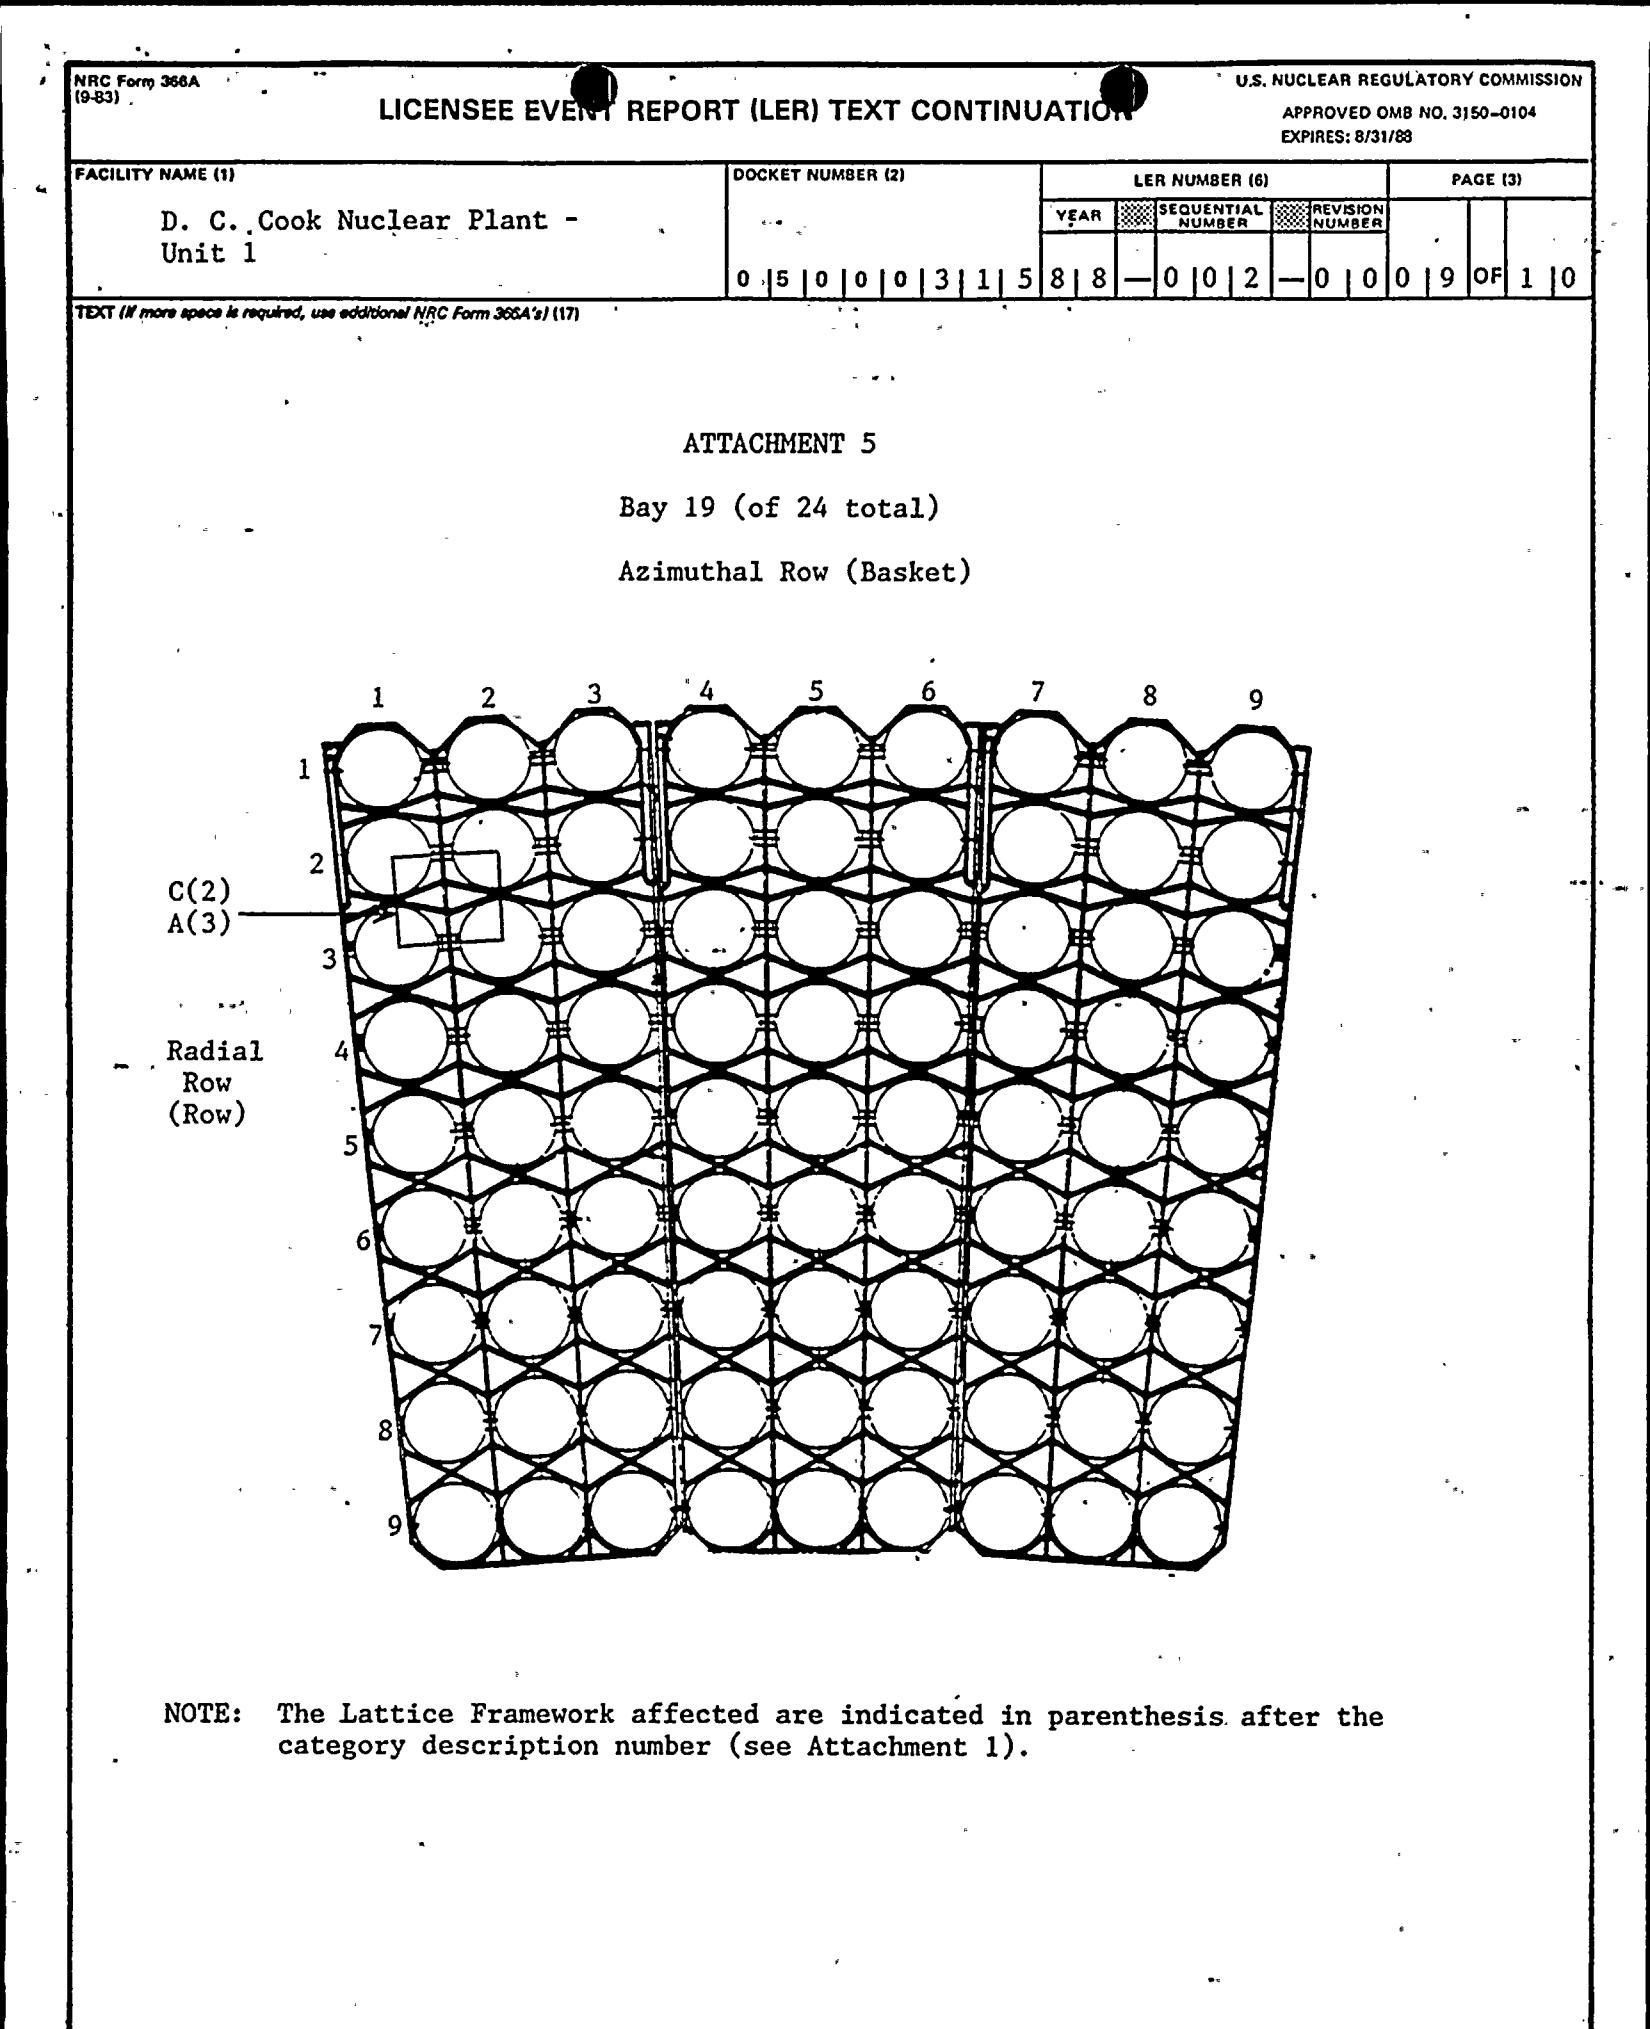
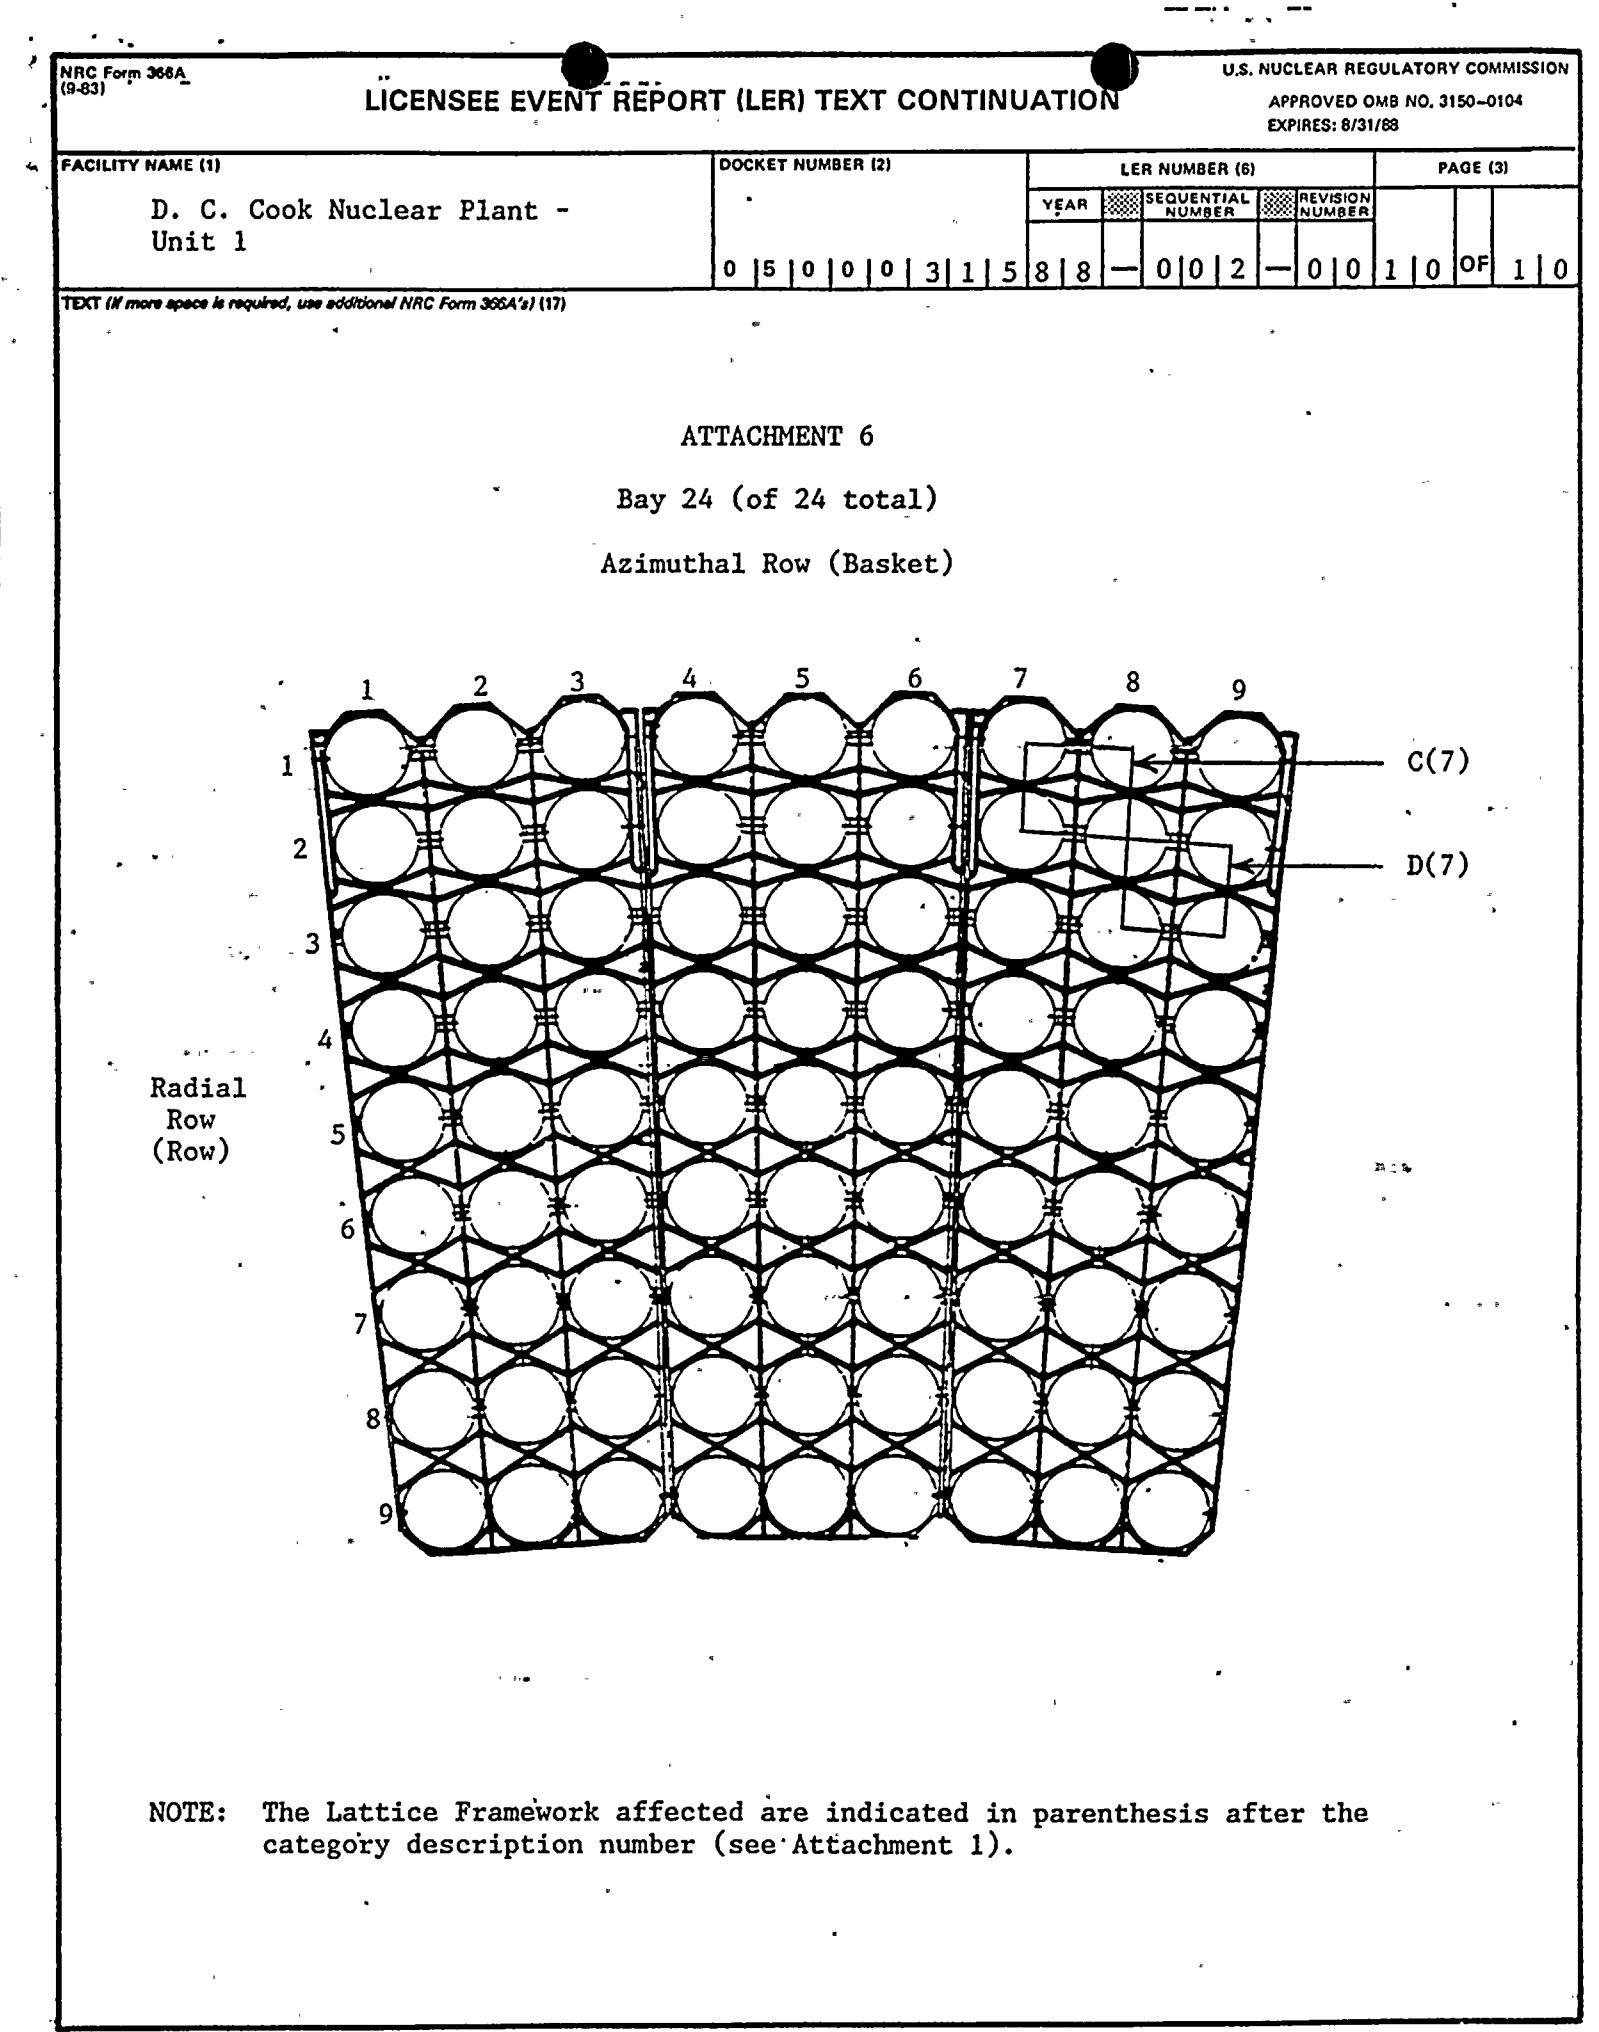
The as-found visual inspection ice condenser (EIIS/COND) flow passages conducted on March 26, 1988, indicating frost and ice accumulation greater than 3/8 inch in two flow passages in Bay 5, four flow passages in Bay 17, two flow passages in Bay 19 and four flow passages in Bay 24. Subsequently, the inspection was expanded to include at least twenty additional flow passages in each of these bays. This inspection revealed no additional frost or ice buildup in any of the additional flow passages inspected. A total of 12 flow passages were affected. There are a total of 3072 flow passages in the Ice Condenser. Attachments 1 through 6 graphically describe the geometry of the flow passages were declared inoperable at 1530 hours on March 26, 1988.

NOTE: The Lattice Frameworks affected are indicated in parenthesis after the category description number (see Attachment 1).

The corrective action was to manually clean the flow passages to remove the accessible frost and ice buildup. The AHU with the clogged drain line was turned off and the drain line has been cleaned. Operations performs tours of the ice condenser at least three times per week. The tour includes a check for proper operation of the air handling units and initiation of required corrective actions for malfunctioning units. To address future indications of AHU overflow, administrative controls will be developed and put in place by October 1, 1988, to evaluate any effect(s) of AHU overflow on flow passages and to implement appropriate corrective actions.
