SUBJECT: LER 88-007-00:on 880908, ice build-up in ice condenser flow passages due to sublimation. ltr.

D. C. Cook Nuclear Plant - Unit 1					
Too Build-Up in Too Condenser Flow Passages Due to Sub	limation				
EVENT DATE (5) (50 NUMBED (6) DEPORT DATE (7) OTHER	FACILITIES INVOLVED (8)				
MONTH DAY YEAR YEAR WEAR SEQUENTIAL WEAR REVISION MONTH DAY YEAR FACILITY NA	MES DOCKET NUMBER(S)				
NUMBER NUMBER	0 15 10 10 10 1 1				
0 9 0 8 8 8 8 8 0 0 7 0 0 9 3 0 8 8	0 5 0 0 0 1				
OPERATING THIS REPORT IS SUBMITTED PURSUANT TO THE REQUIREMENTS OF 10 CFR 'S: (Check one or more	of the following) (11)				
MODE (9) 4 20.402(b) 20.405(c) 50.73(a)(2)(iv)	73.71(5)				
POWER 20.405(a)(1)(i) 50.38(c)(1) 50.73(a)(2)(v)	73.71(e)

> D. C. Cook Nuclear Plant -Unit 1

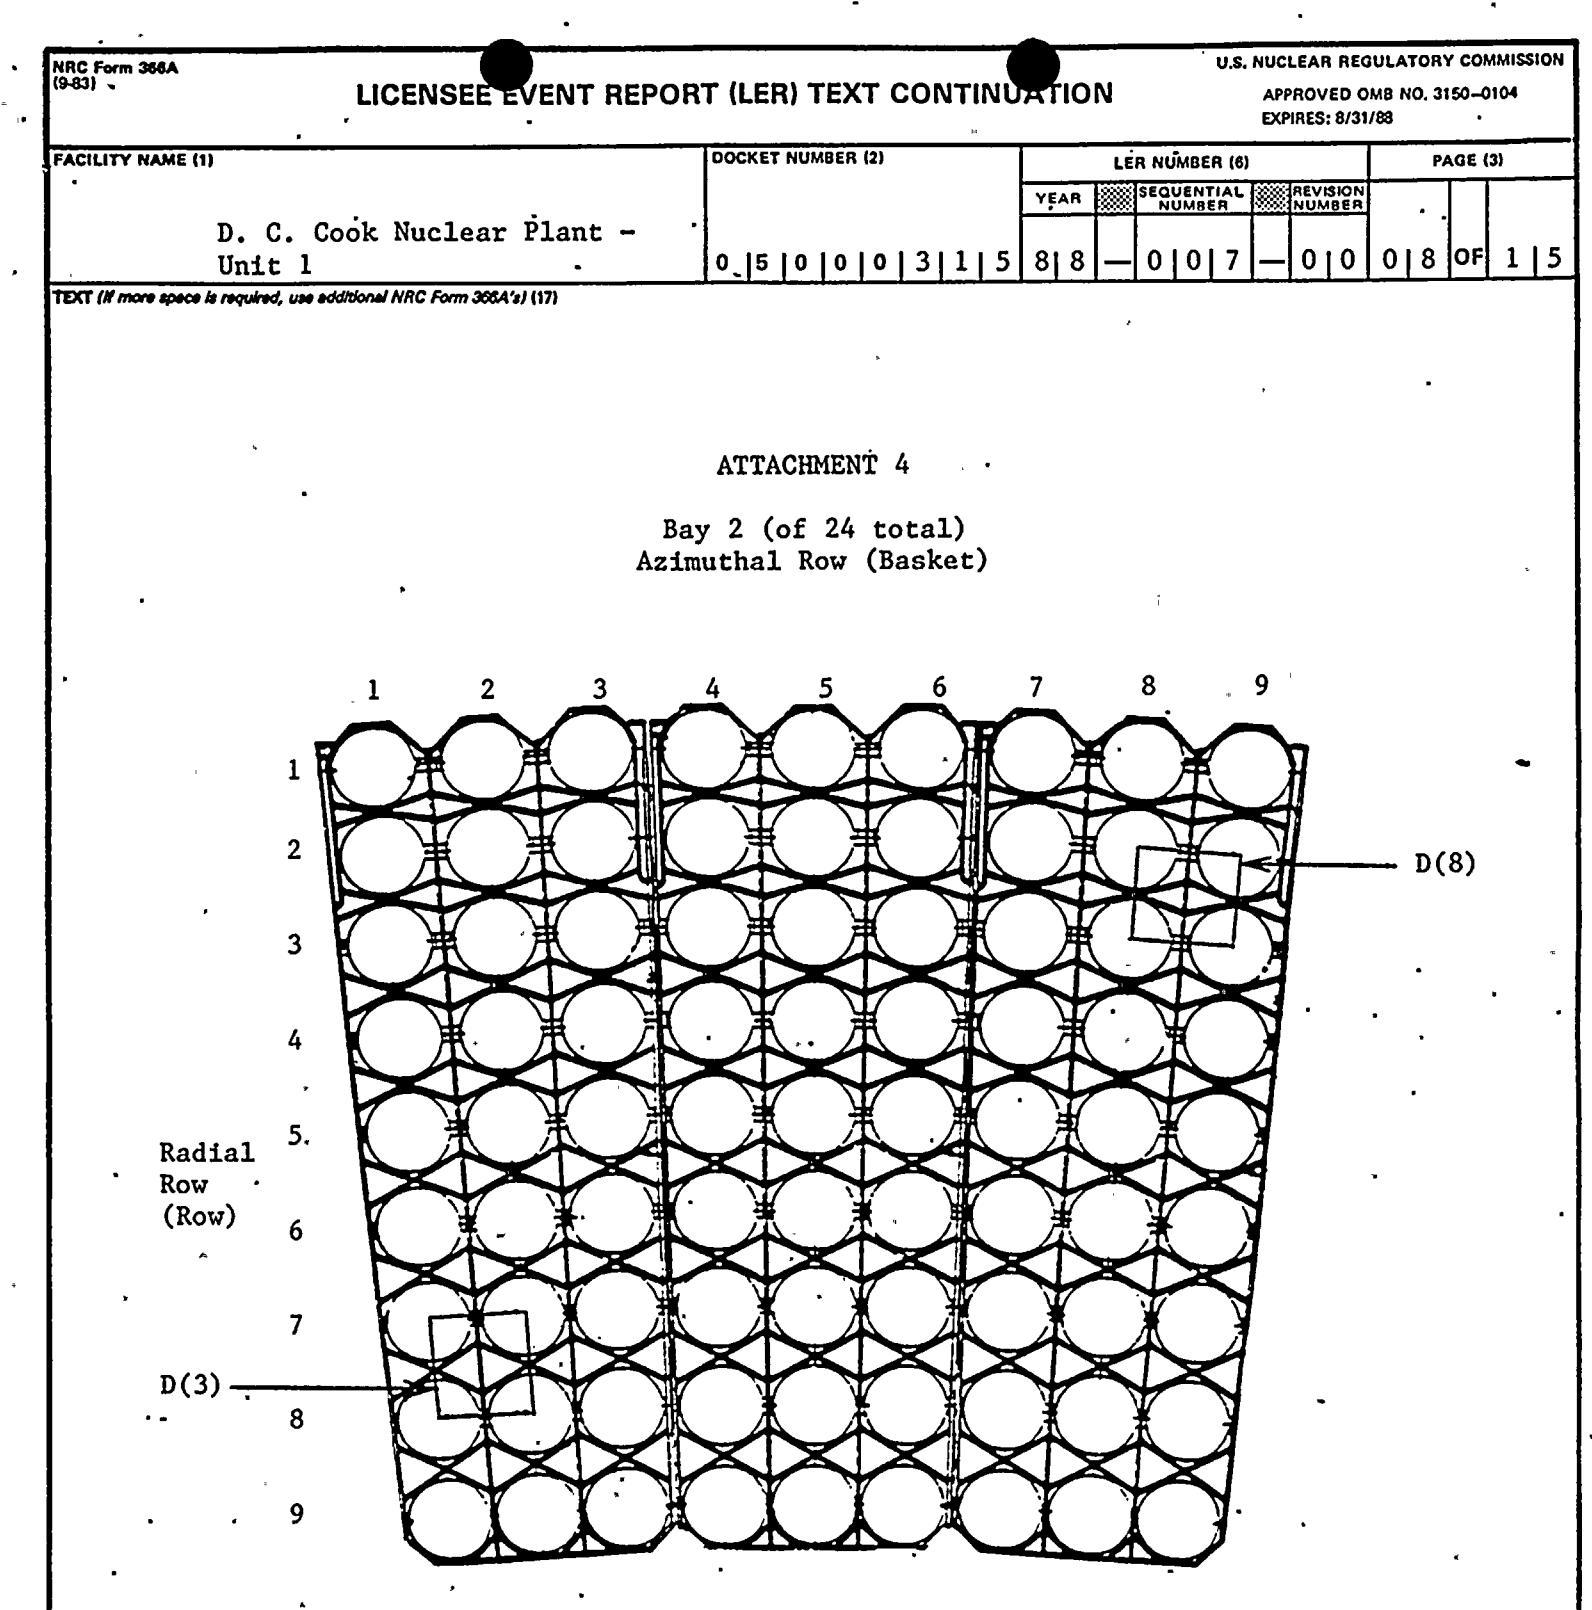
Note: The lattice frameworks affected are indicated in parenthesis after the category description number (see Attachment 1).

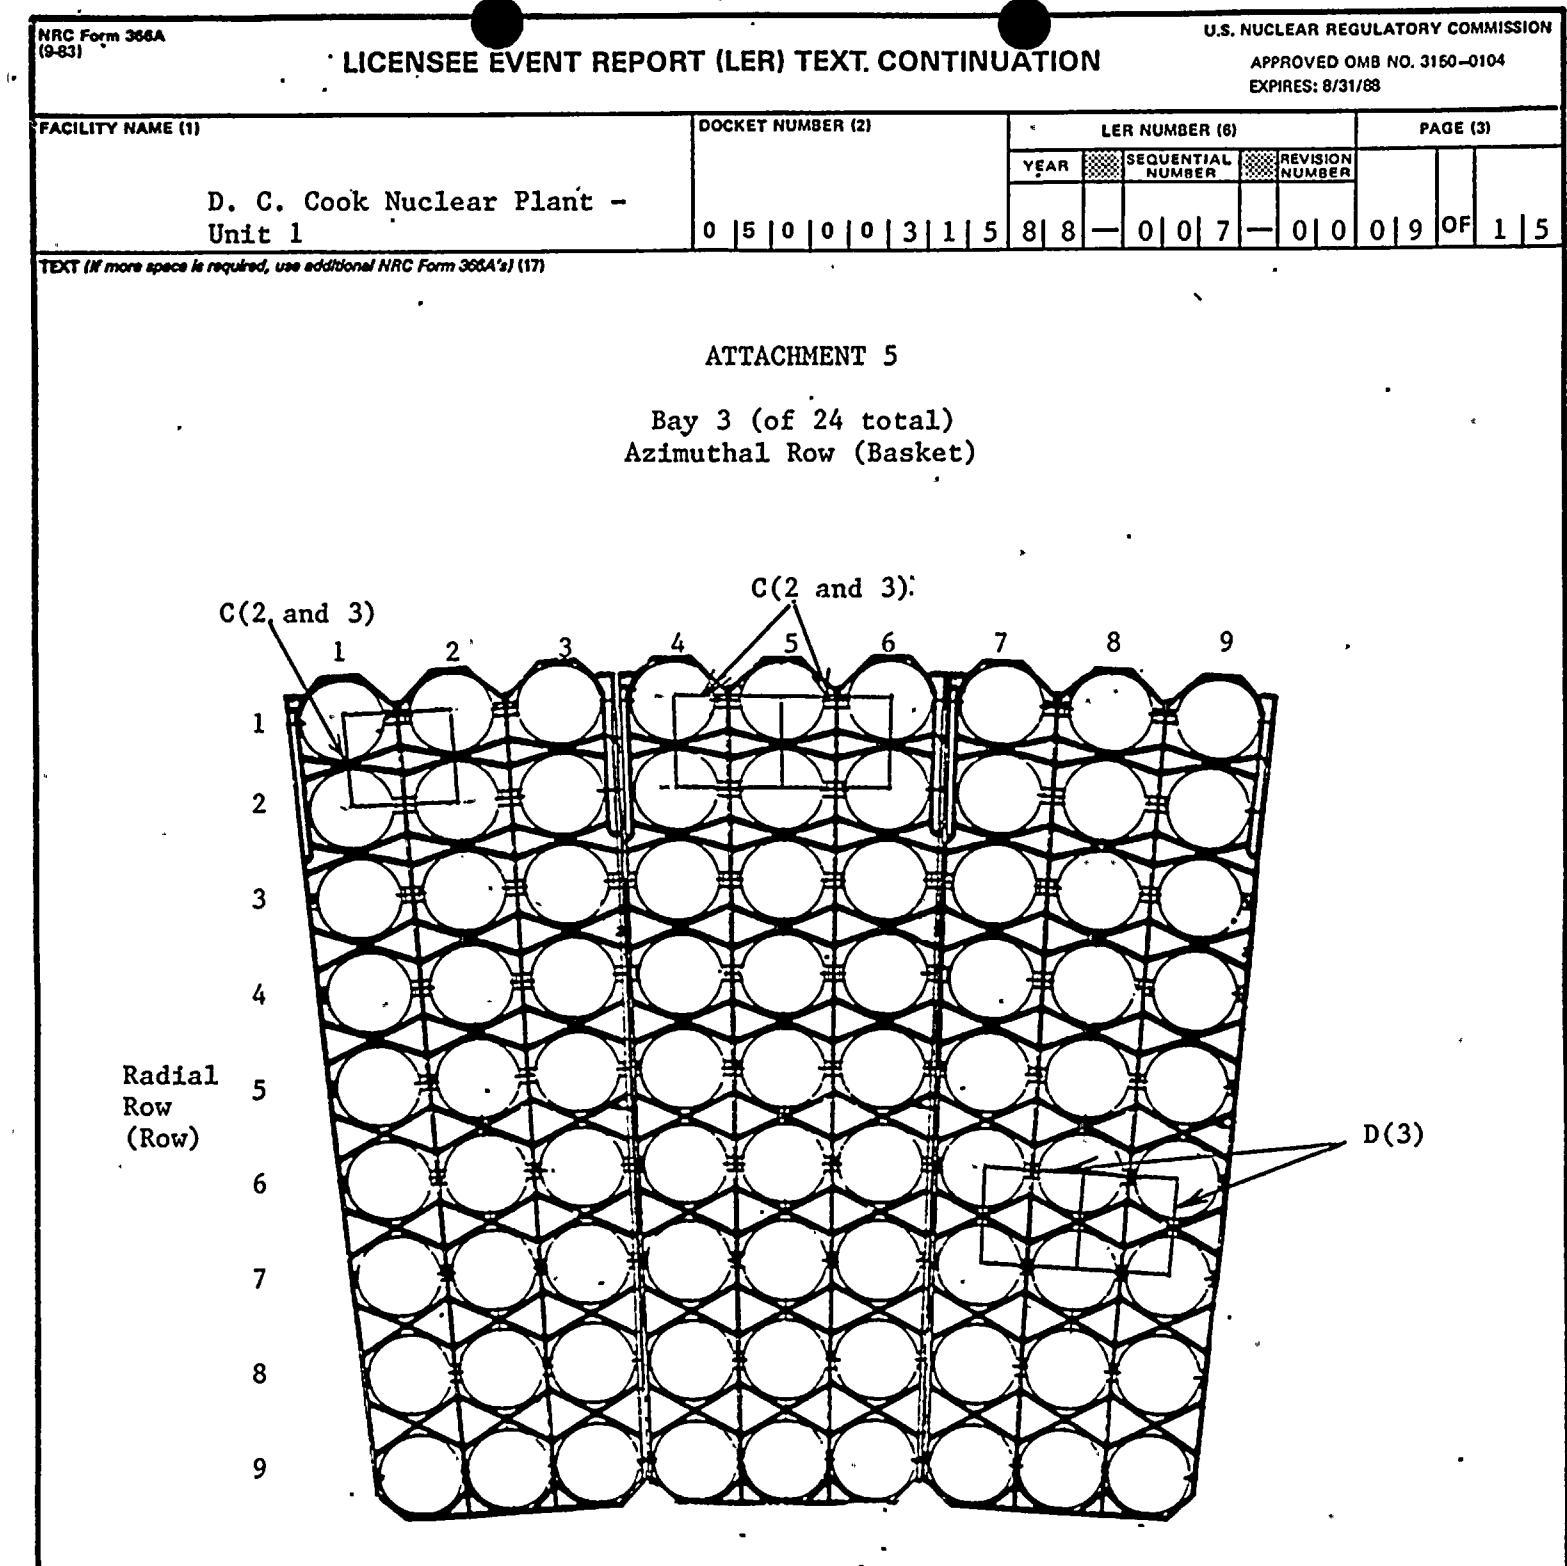
Note: The lattice frameworks affected are indicated in parenthesis after the category description number (see Attachment 1).

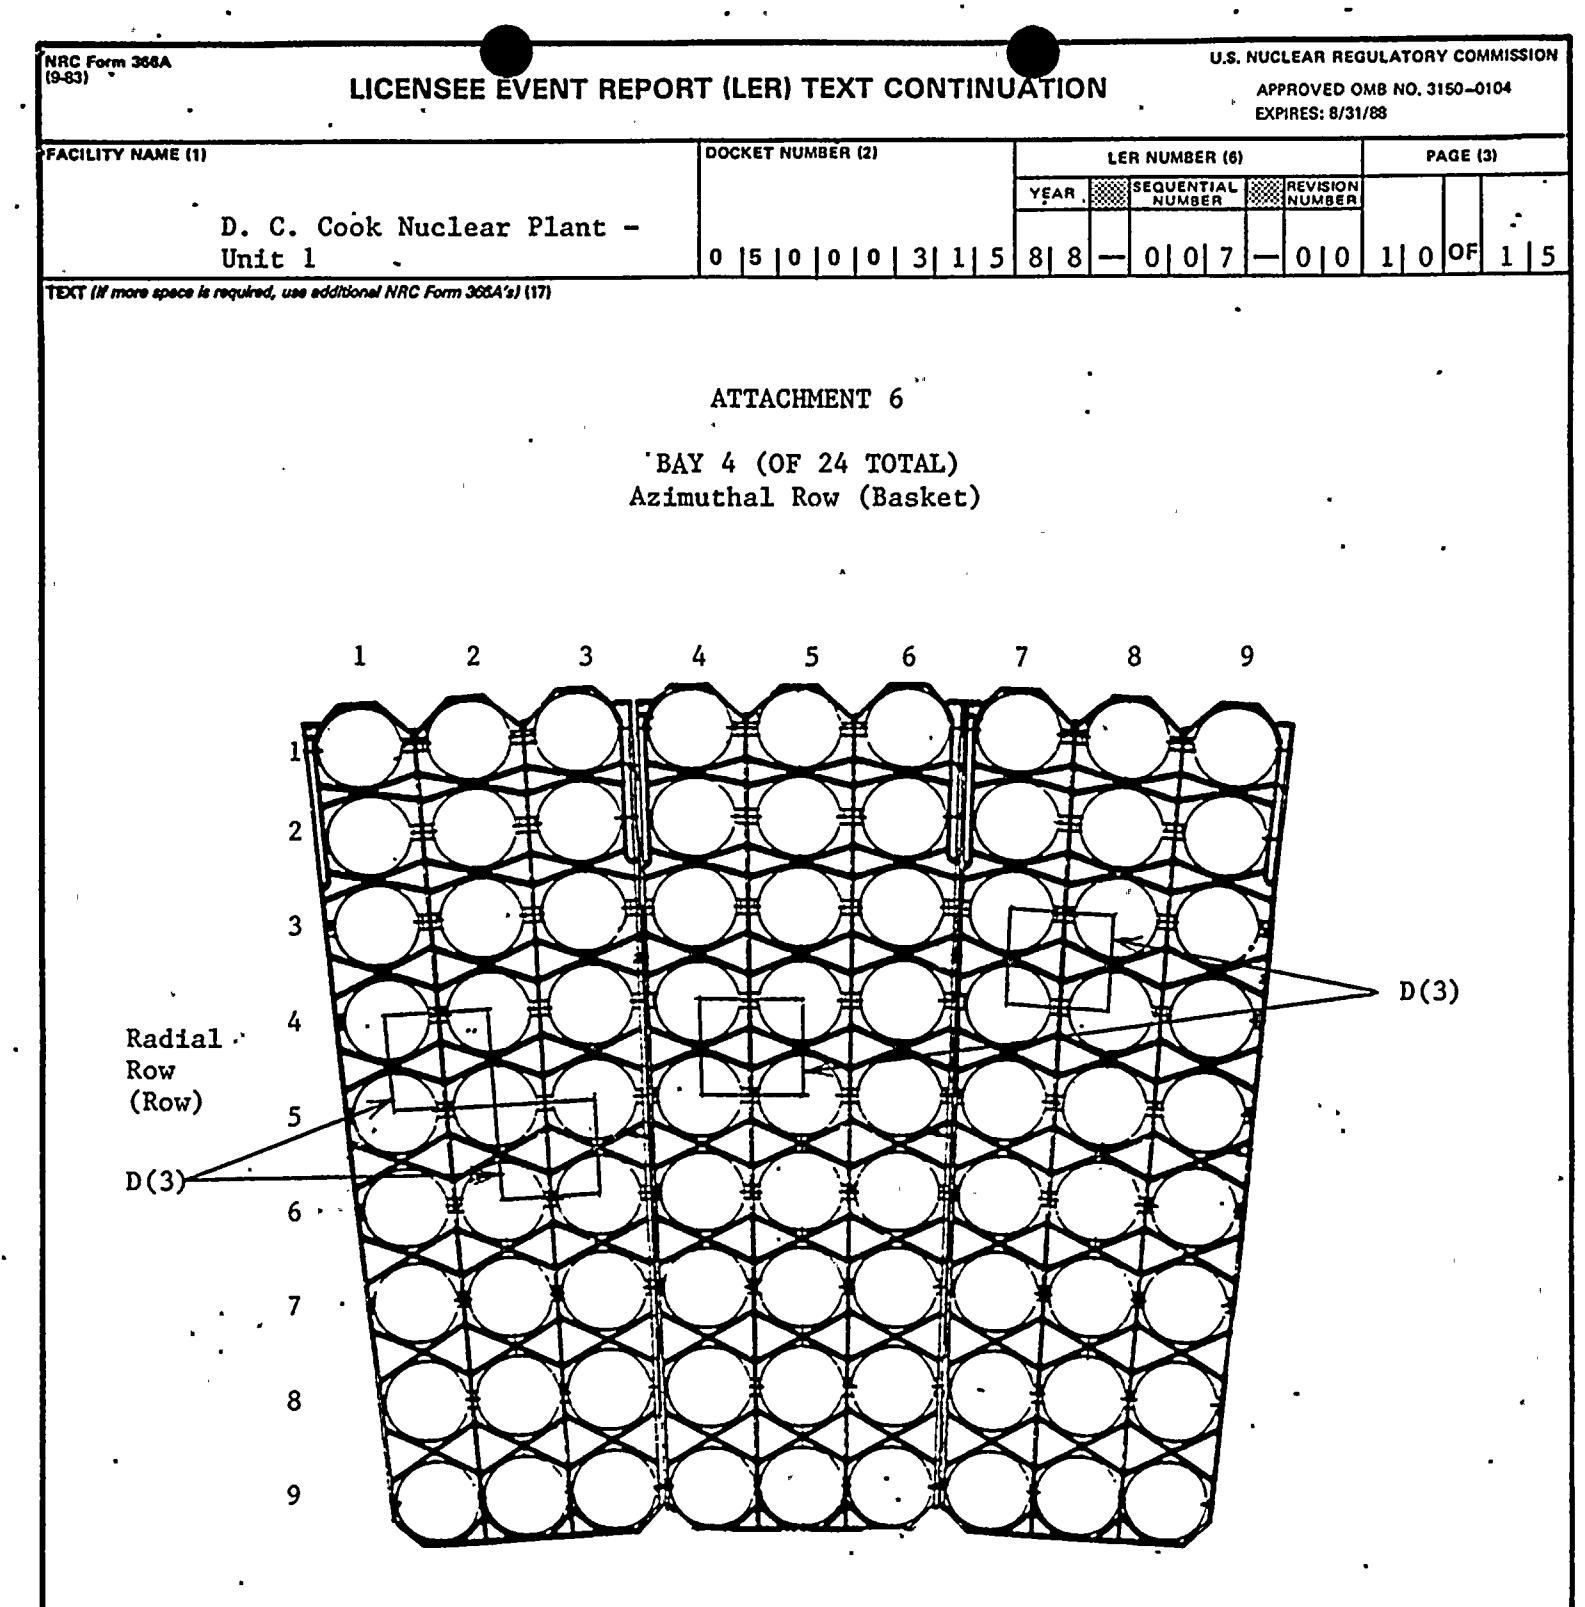
Note: The lattice frameworks affected are indicated in parenthsis after the category description number (see Attachment 1).
