SUBJECT: Forwards response to NRC RAI to support technical review of
 util 920225 proposed license amends re OL expiration date.

Re: Turkey Point Units 3 and 4
Docket Nos. 50-250 and 50-251
Request for Additional Information (RAI) -
Proposed License Amendments
Operating License Expiration Date

TURKEY POINT UNITS 3 AND 4

PROPOSED LICENSE AMENDMENTS:
OPERATING LICENSE EXPIRATION DATE

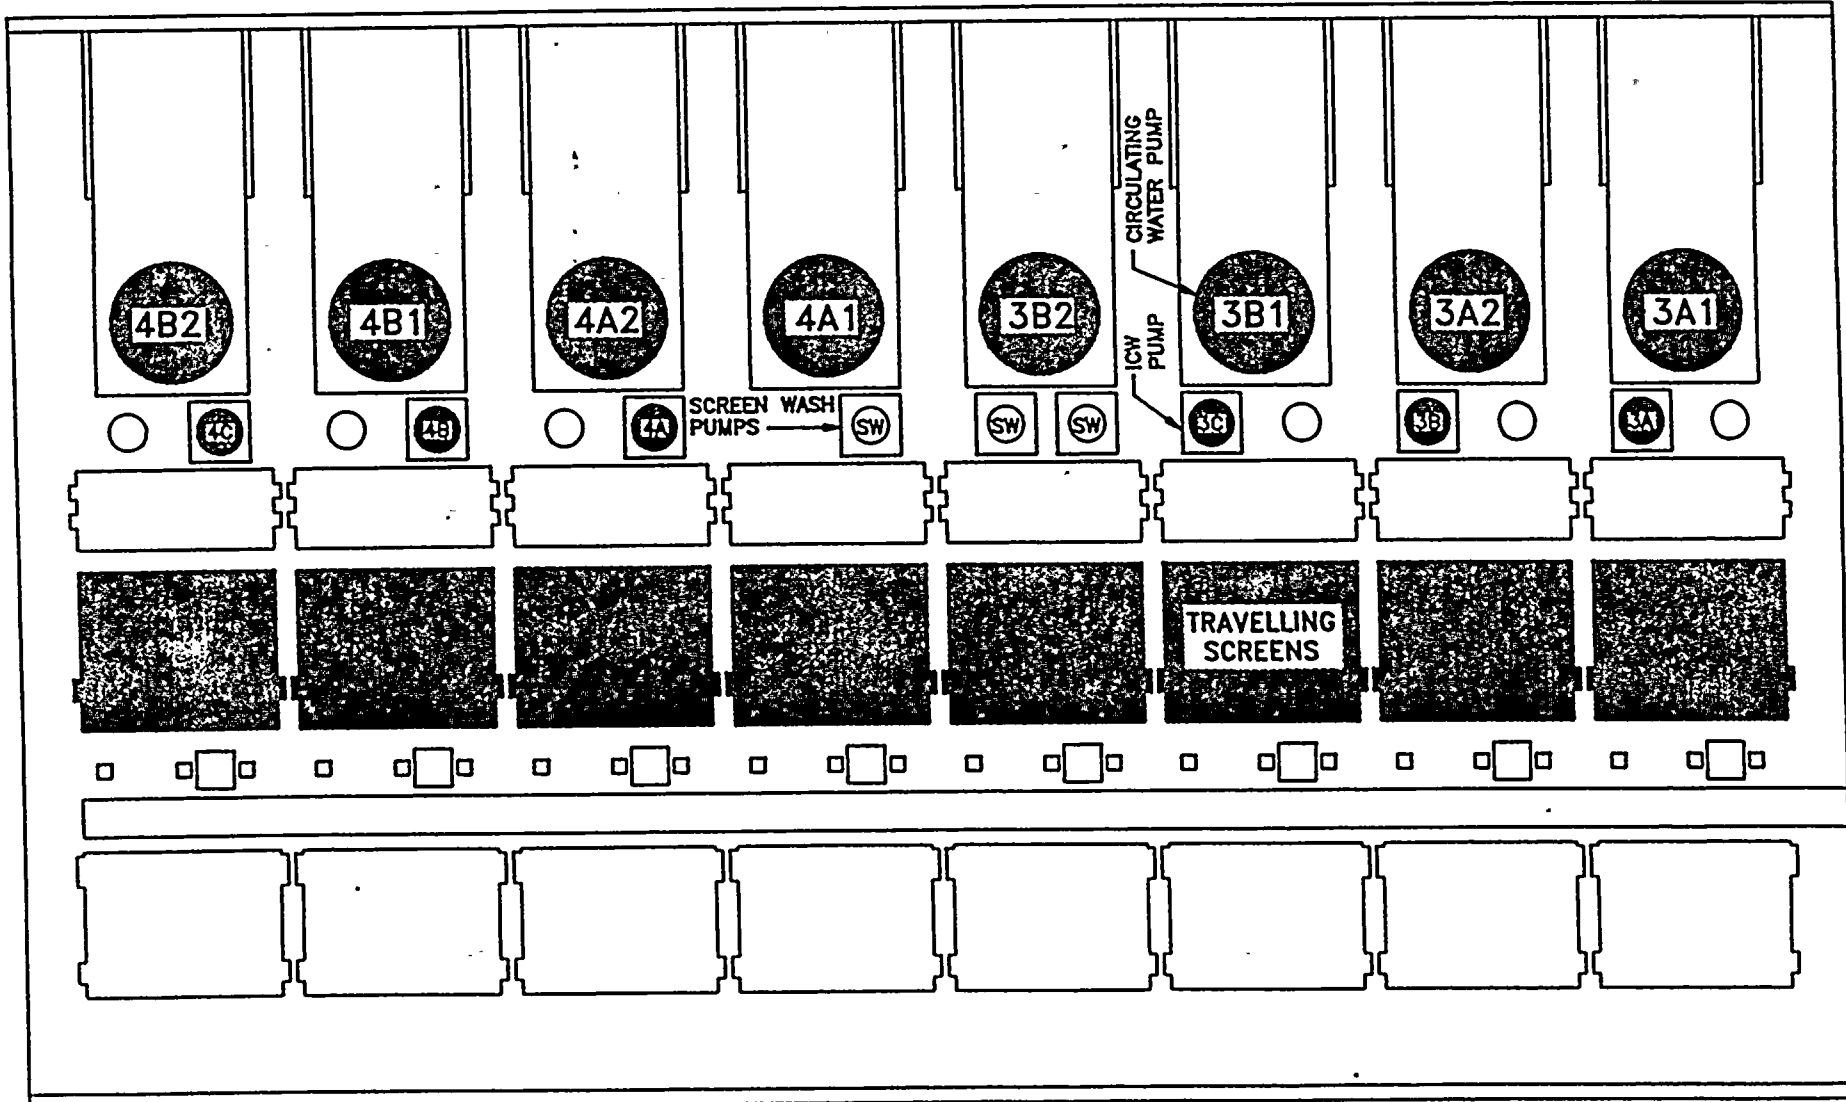
GENERAL ARRANGEMENT
INTAKE STRUCTURE
(PLAN VIEW @ EL 16'-0")

The main structural components of the intake structure, which are composed of reinforced concrete, are depicted in Attachment 1. They consist of the foundation, bay walls, horizontal struts including Circulating Water (CW) pump thrust beams, and deck support beams for the Intake Cooling Water (ICW) pumps, CW pumps, and travelling screen equipment.

In 1985/1986, inspections of the structure by FPL identified erosion/corrosion of the CW pump thrust beams, horizontal struts at the 1'-9" elevation, and the deck support beams for the ICW pumps. The most significant degradation was present on the CW pump thrust beams. Due to the degree of damage, the beams were replaced. Repairs were also made to the strut beams at elevation 1' - 9" and to the ICW pump support beams. These members reside in the wet/dry zone which is heavily oxygenated, are exposed directly to intake canal water which has a high chloride ion concentration, and have 3 inches of concrete cover over the reinforcement (as required by the American Concrete Institute (ACI) code of record at the time of construction). Other
