SUBJECT: LER 97-003-00:on 970227, steam generator low level protection circuitry outside design basis occurred. Caused by inadequate failure modes & effects analysis performed as-built piping configuration for S/G level. Review performed. W/970331 ltr.

# SHEARON HARRIS NUCLEAR POWER PLANT UNIT 1 DOCKET NO. 50-400 LICENSE NO. NPF-63 <u>LICENSEE EVENT REPORT 97-003-00</u>

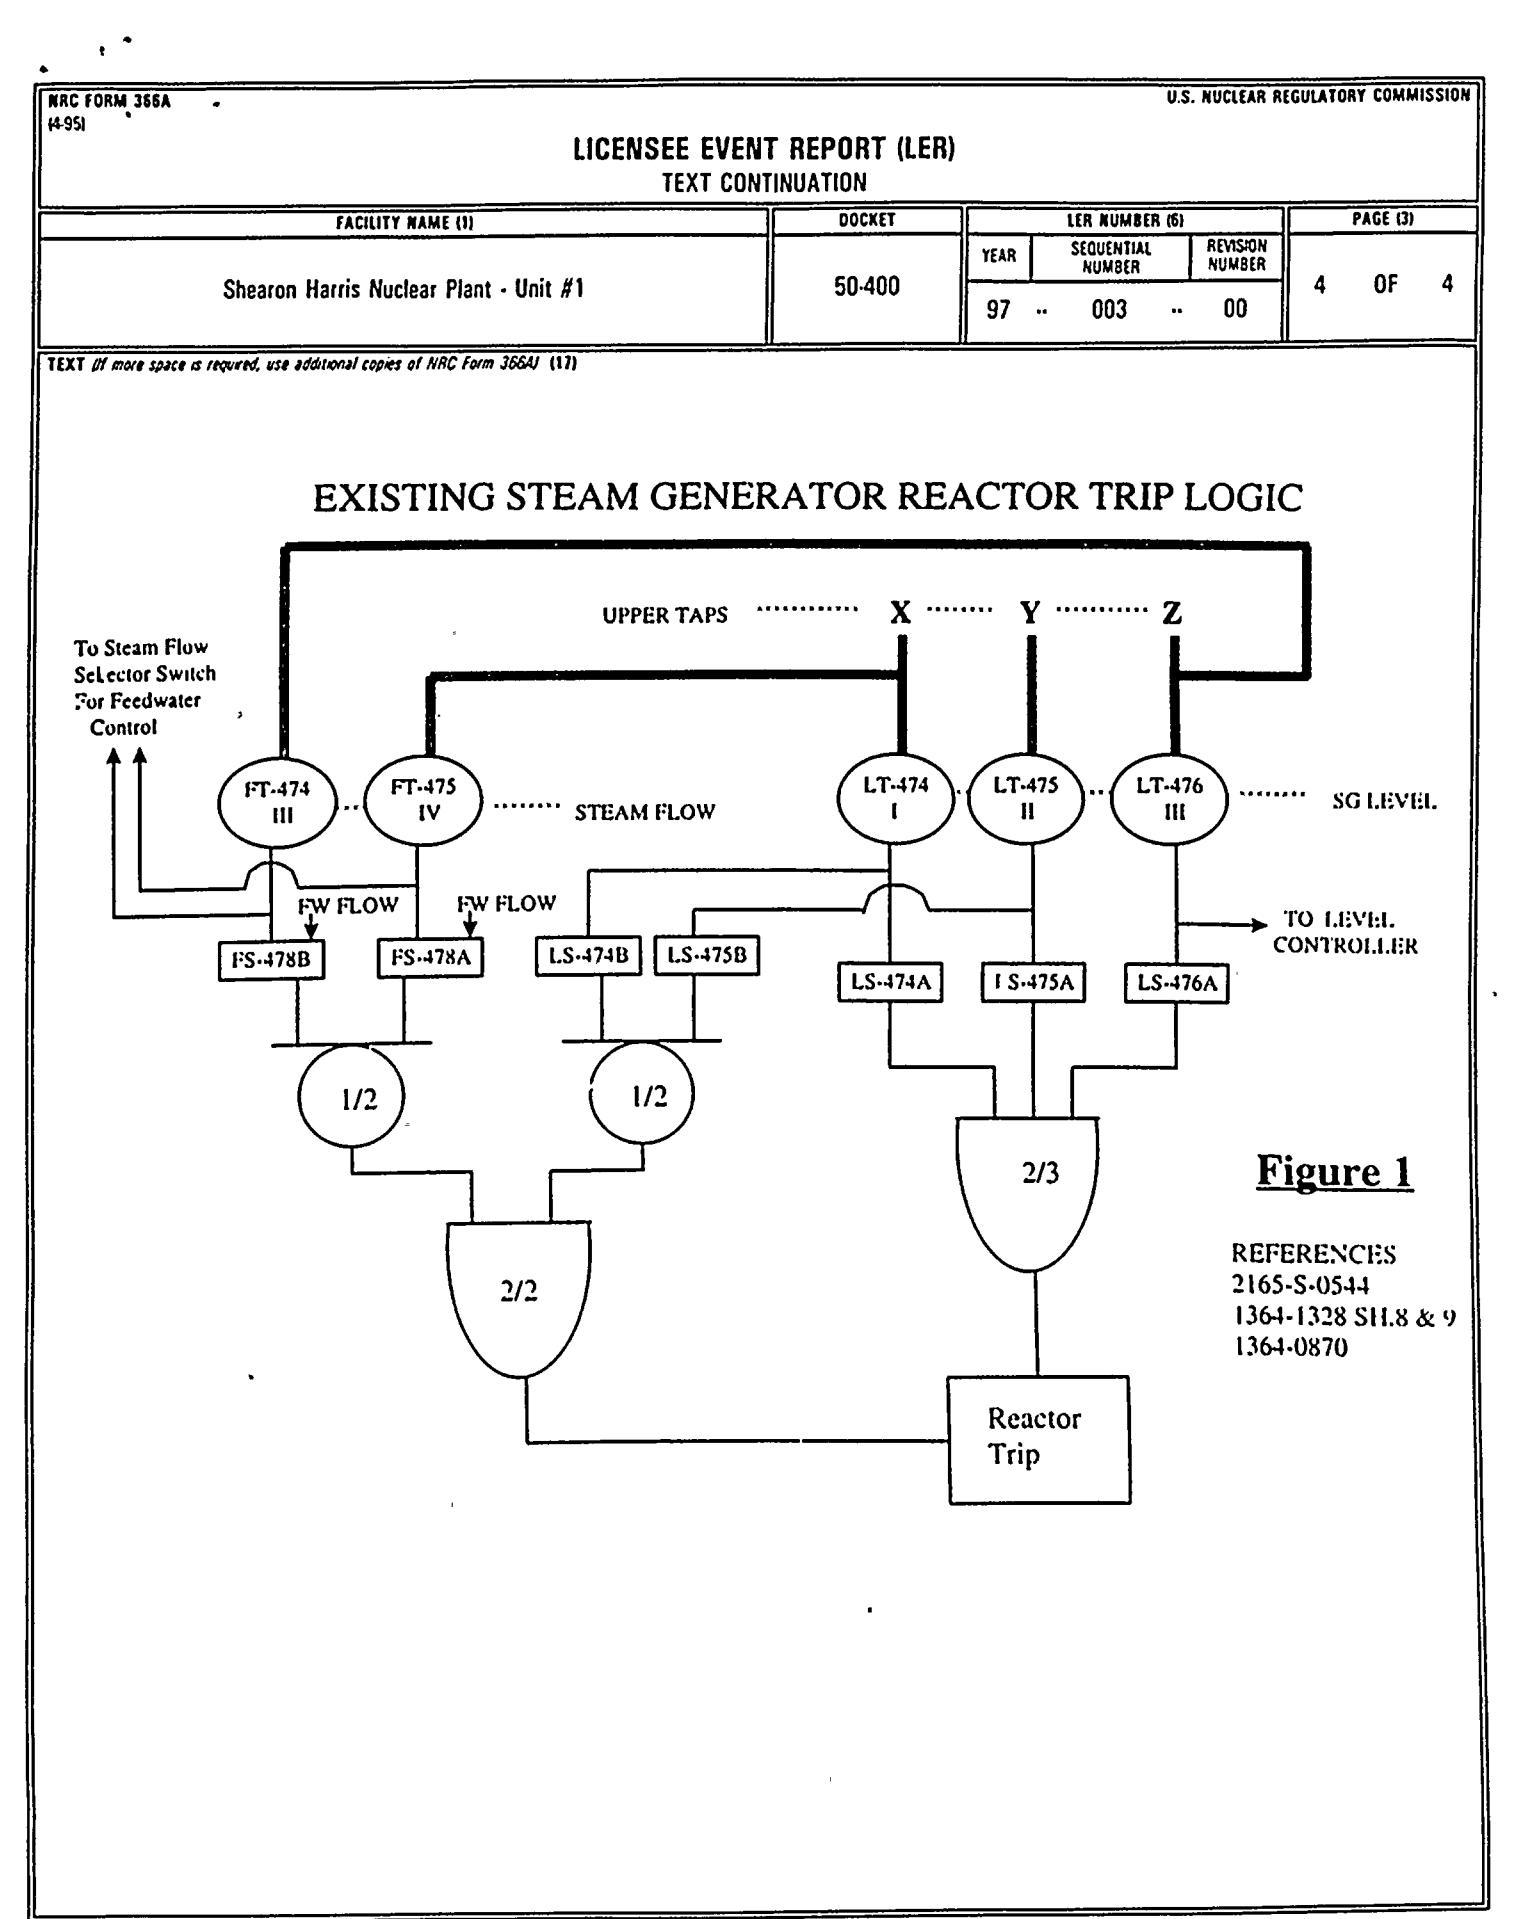
At HNP, each S/G has four narrow range level channels which provide input to a 2 out of 3 logic for the S/G low-low level reactor trip signal. (reference attached drawing) Each S/G also has two steam flow transmitters that share a common tap with two of the narrow range level channels. These two steam flow transmitters provide input to the steam flow-feedwater flow mismatch logic and can be selected to provide input to the S/G Water Level Control System. The Technical Evaluation contained in NSAL 96-004 specifically states that "two steam flow channels are provided for each loop, only one of which shares a tap connection with a narrow range steam generator level channel in a three level channel system." IEEE Standard 279-1971, section 4.7.3, requires that "where a single random failure can cause a control system action that results in a generating station condition requiring protective action and can also prevent proper action of a protection system channel designed to protect against the condition, the remaining redundant protection channels shall be capable of providing the protective action even when degraded by a second random failure"

Investigation concluded that, due to the arrangement of the S/G upper instrument line tap connection for the two S/G steam flow channels, which share a common tap connection with a S/G narrow range level channel, if the steam flow selector switch is placed in channel IV, the coincidence logic will not cause a S/G low-low level reactor trip during the following scenario:

- Ø Steam Generator upper tap or impulse line used by Channel I Steam Generator Level and the Channel IV Steam Flow channel ruptures causing the level signal to fail high.
- 0 A second random failure occurs on Channel II or Channel III.

In this scenario only one S/G low-low level reactor trip channel is available, which is not sufficient to actuate the 2 of 3 reactor trip logic. During this postulated scenario, the rupture causes a false high S/G level signal and a false low steam flow signal. If this steam flow signal is selected as input to the S/G water level control system on the steam flow selector switch, the feed regulating valve will start to shut to match feedwater flow to the apparent steam flow signal. The actual level in the affected SG will start to decrease and the reactor trip will not be received as required when the SG level drops.

- 1. The Steam Flow Selector Switch on the main control board was taken to Channel III, which eliminates the potential failure scenario. Caution tags have been placed on the Steam Flow Selector switch as an interim administrative control to ensure that Operations personnel maintain the switch in channel III or control feedwater flow in manual.
- 2. A review was performed during the investigation of this condition for other protection channels, to ensure that protection and control interaction requirements were met. No additional discrepancies were identified during this review.

1. A permanent resolution for the identified design deficiency will be implemented by July 15, 1997.
