# FIRE ENDURANCE TEST OF A WALL ASSEMBLY CLAD WITH THERMO-LAG® 330-1

Project No. 14980-98207

May 23, 1995

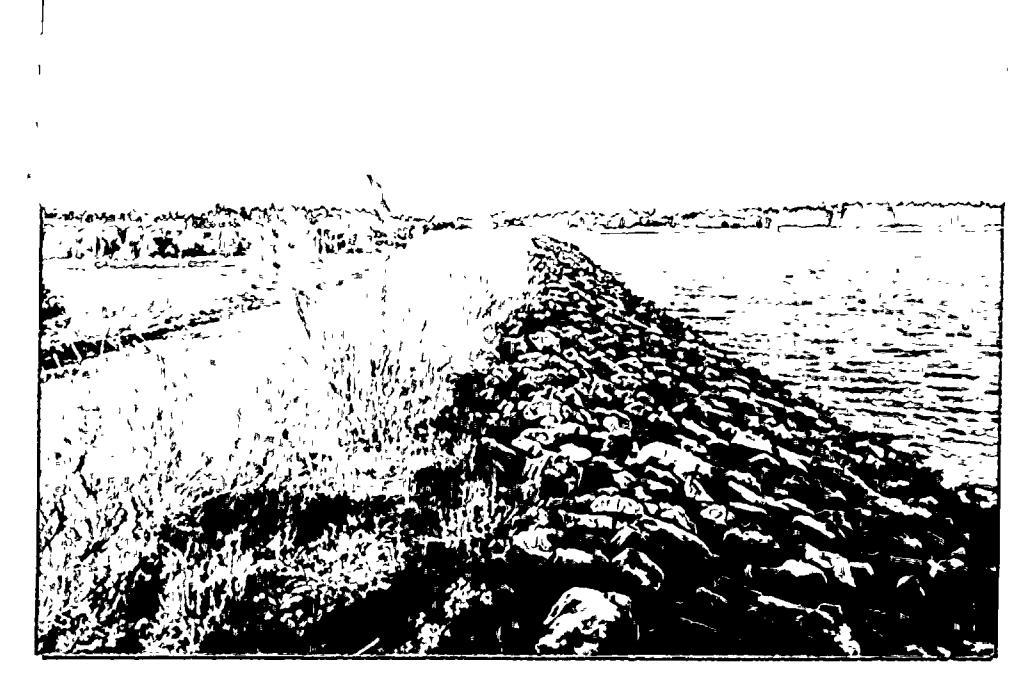
Upstream slope of dam as seen from near the left abutment. Note undesirable vegetation along the crest of the dam.

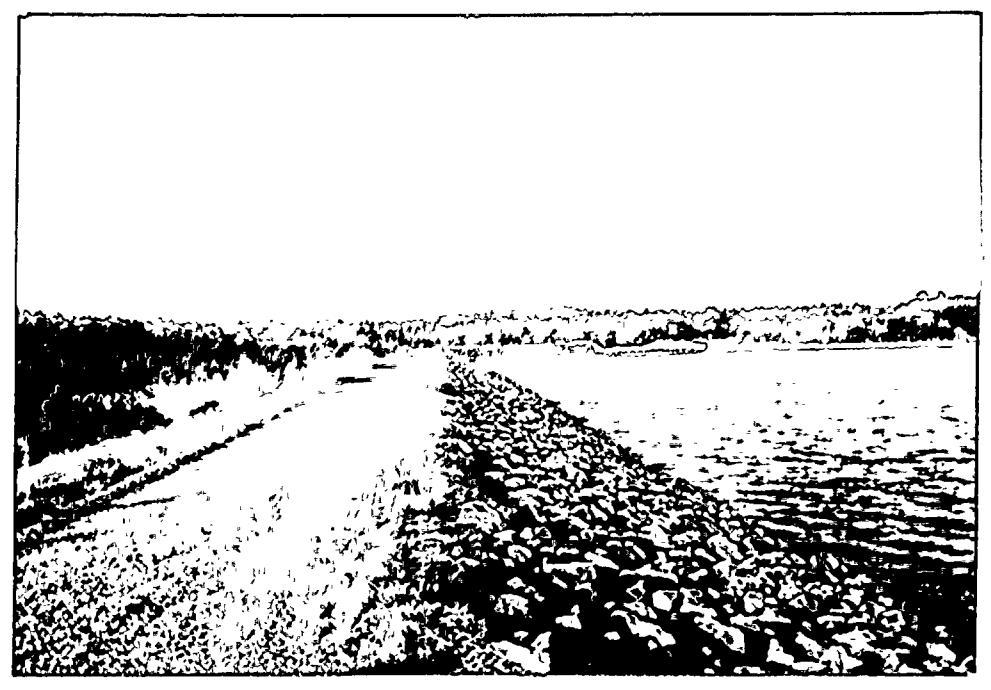
Photograph No. 2

Crest and upstream slope of the central portion of the dam.

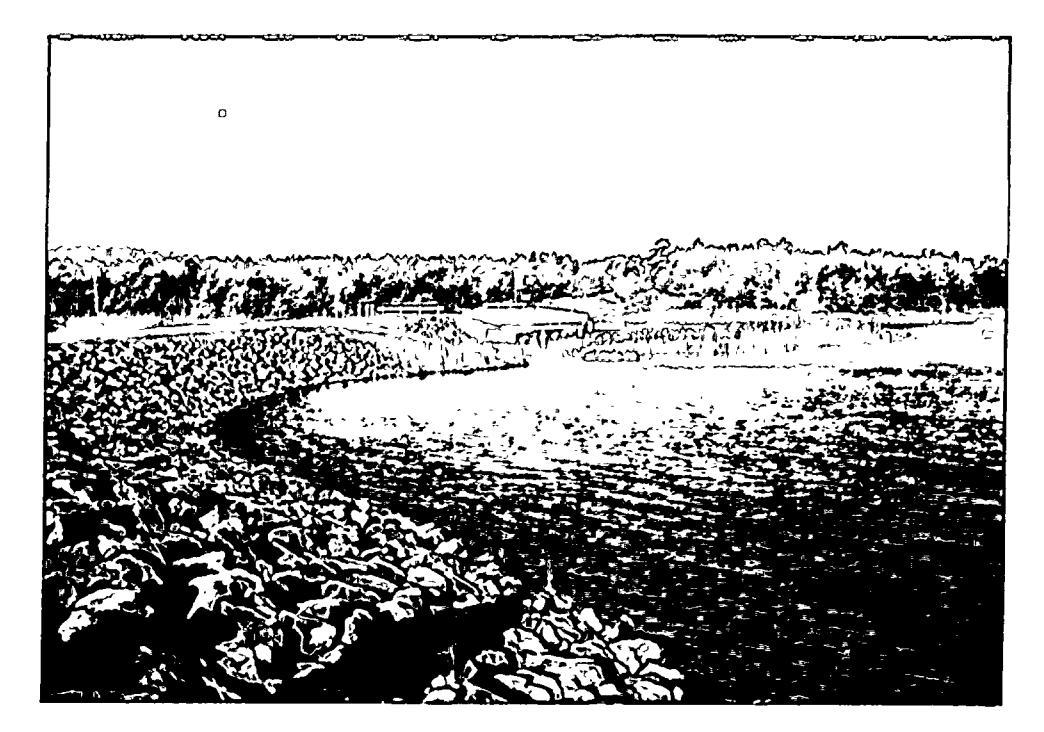
Upstream slope showing the spillway and the right (west) abutment.

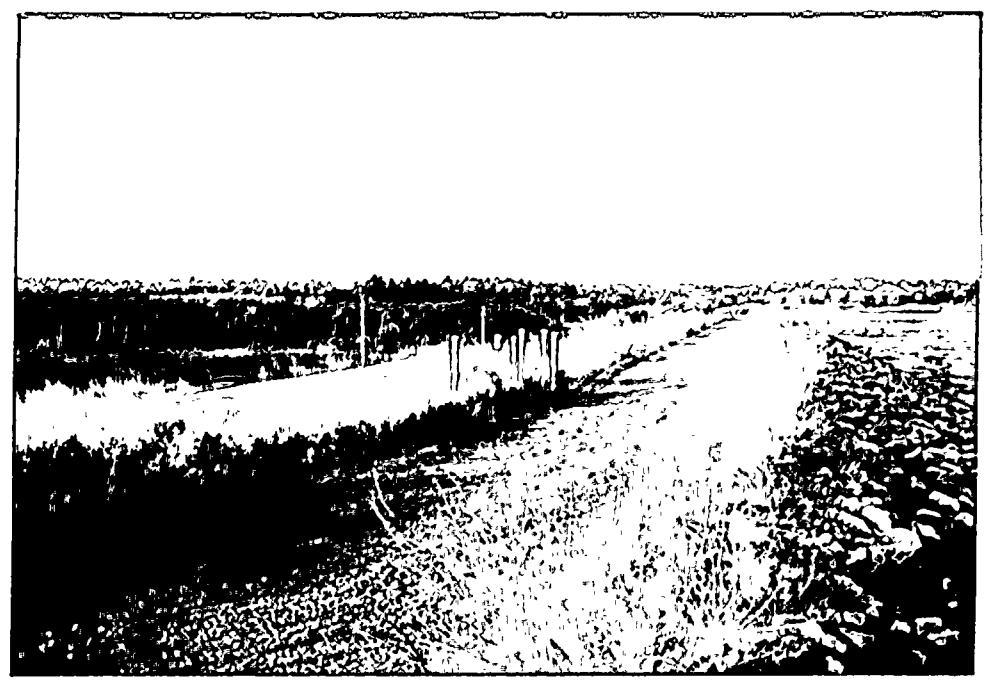
Photograph No. 4

Crest road, piezometers 5 & 12, monument AM9. Note undesirable vegetation.
