File NC505-12 Project 84NK29824

FACT-FINDING REPORT

# AIR DUCT PENETRATIONS THROUGH ONE HOUR FIRE RESISTIVE WALL ASSEMBLY

American Iron and Steel Institute Washington, D.C.

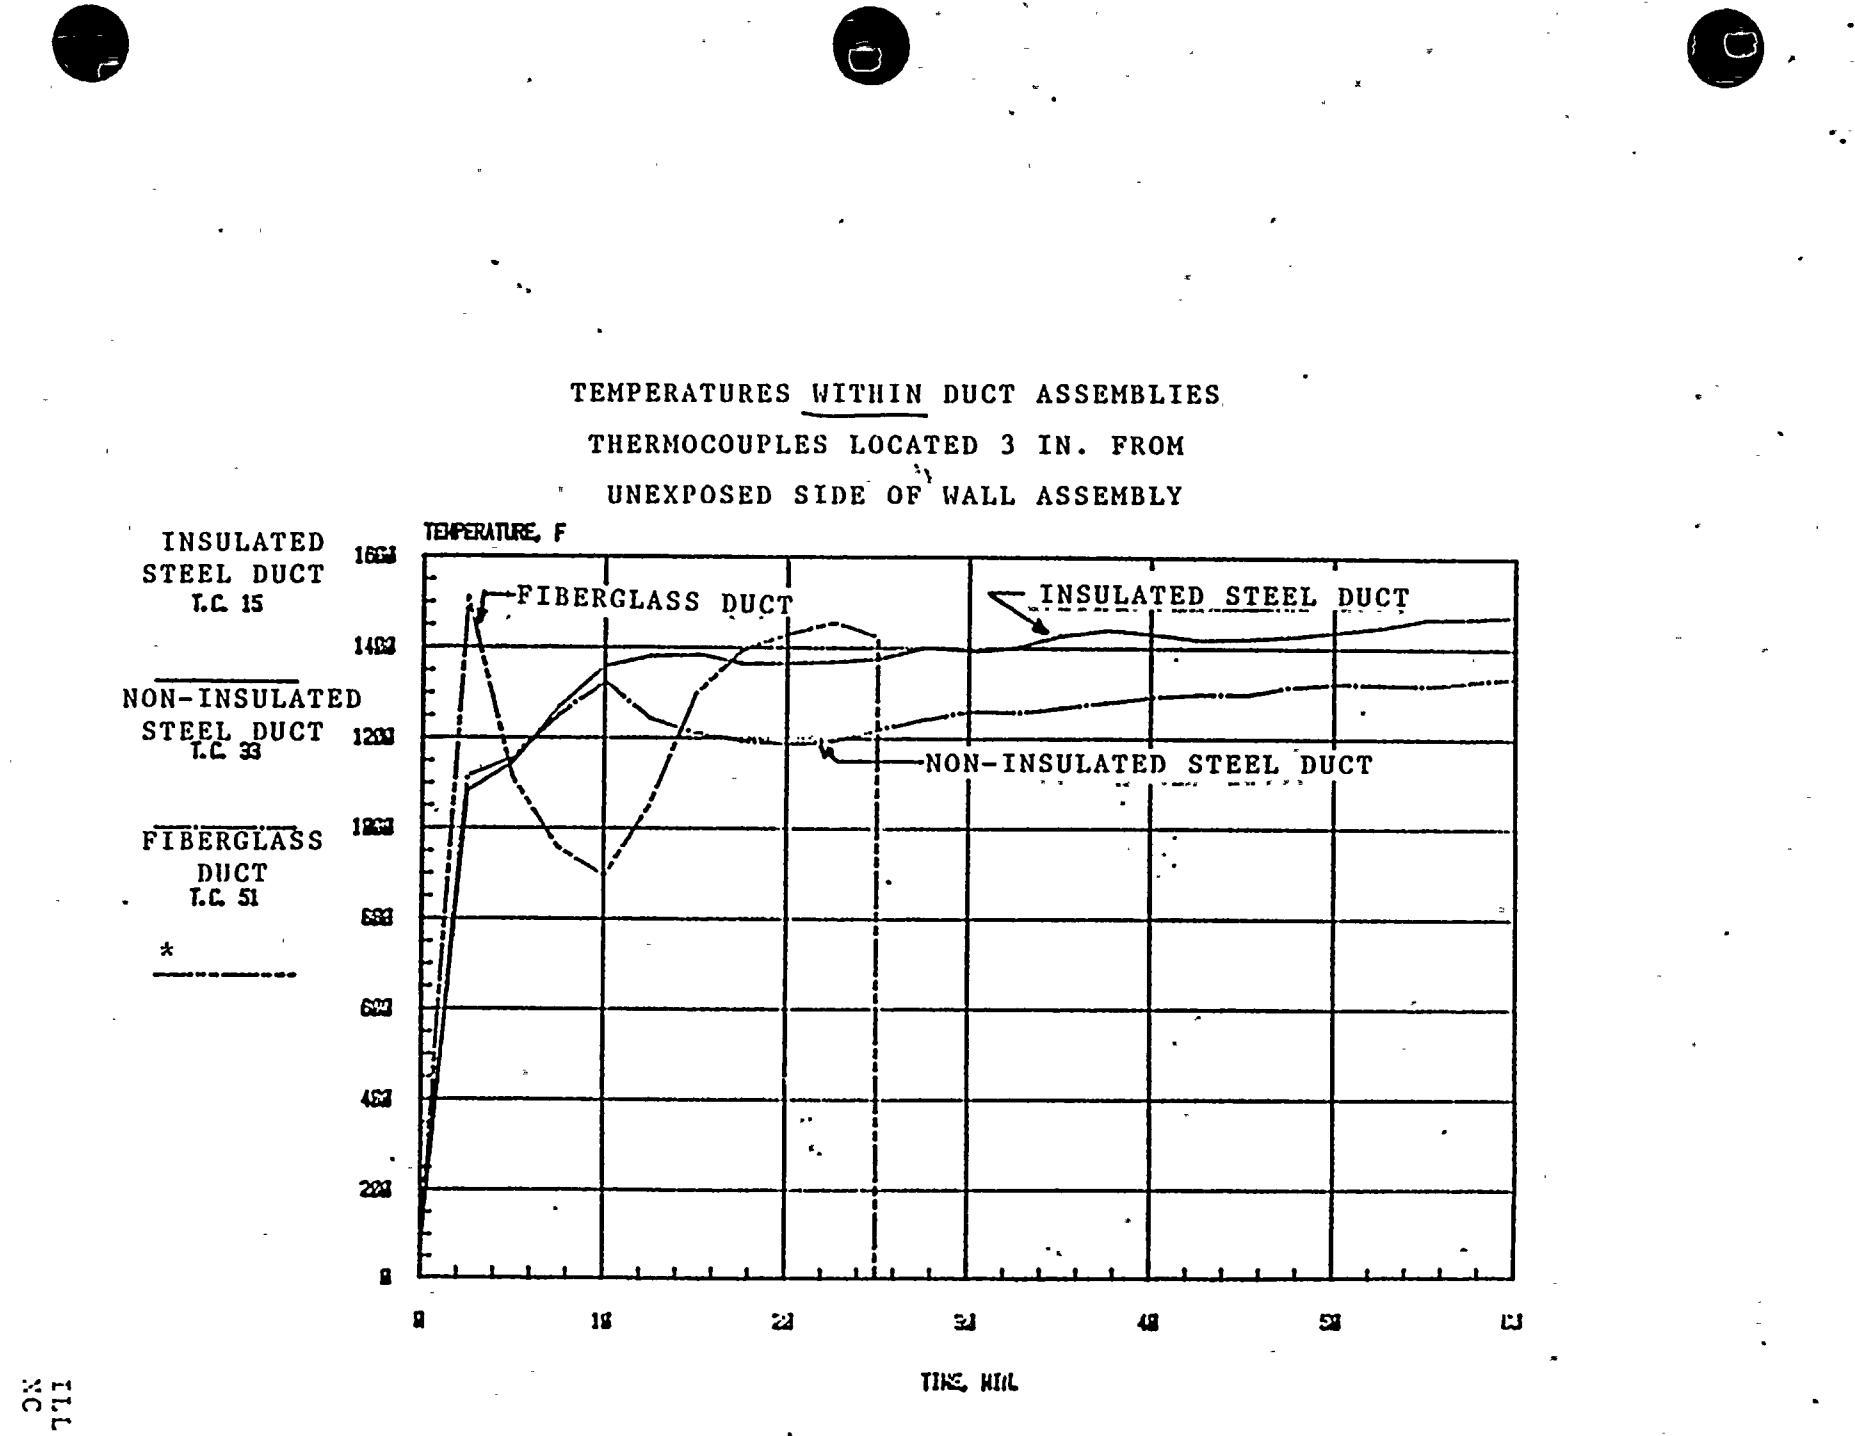
LL. 3 C 505-

\*SECTION OF FIBERGLASS DUCT IN AREA OF T.C. 51 COLLAPSED AT 25 MIN.

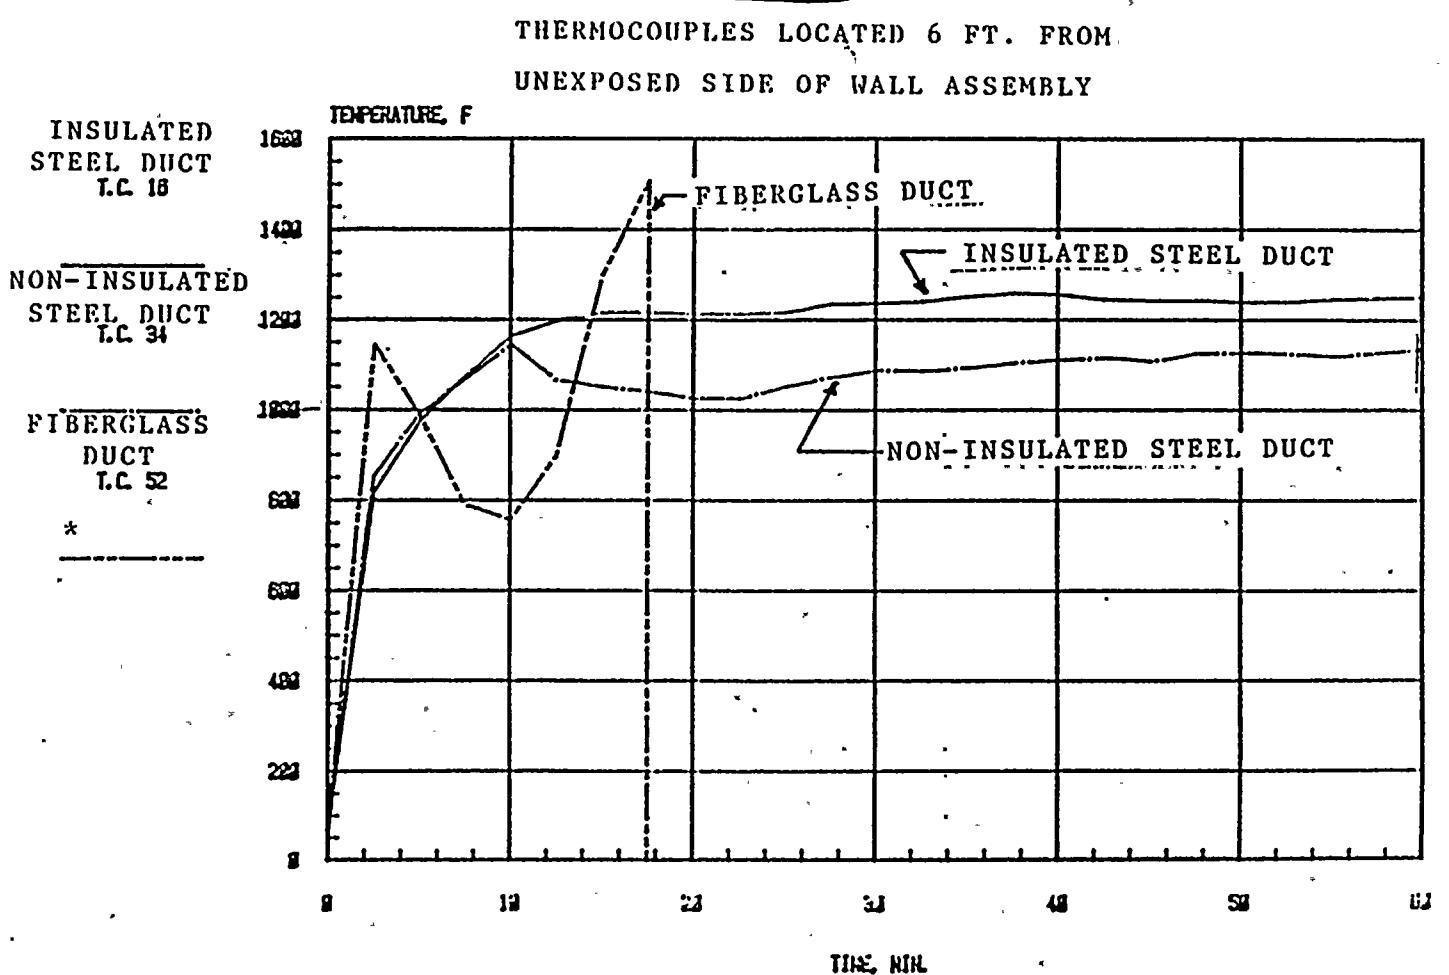
\*SECTION OF FIBERGLASS DUCT IN AREA OF T.C. 52 COLLAPSED AT 19 MIN.

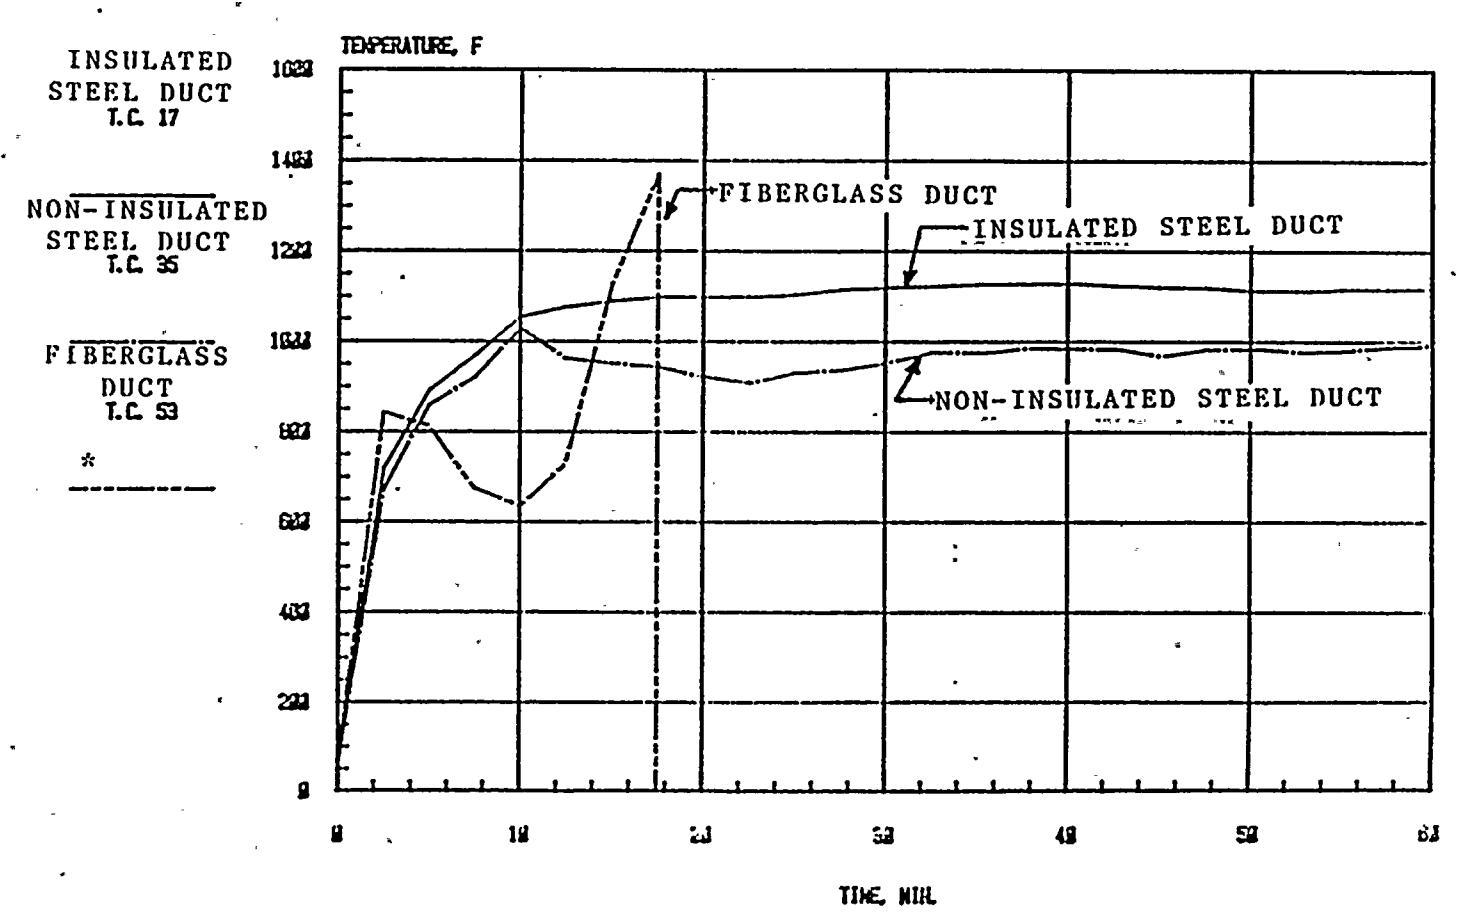
ELL. 10. . NC 505-12

\*SECTION OF FIBERGLASS DUCT IN AREA OF T.C. 53 COLLAPSED AT 25 MIN.

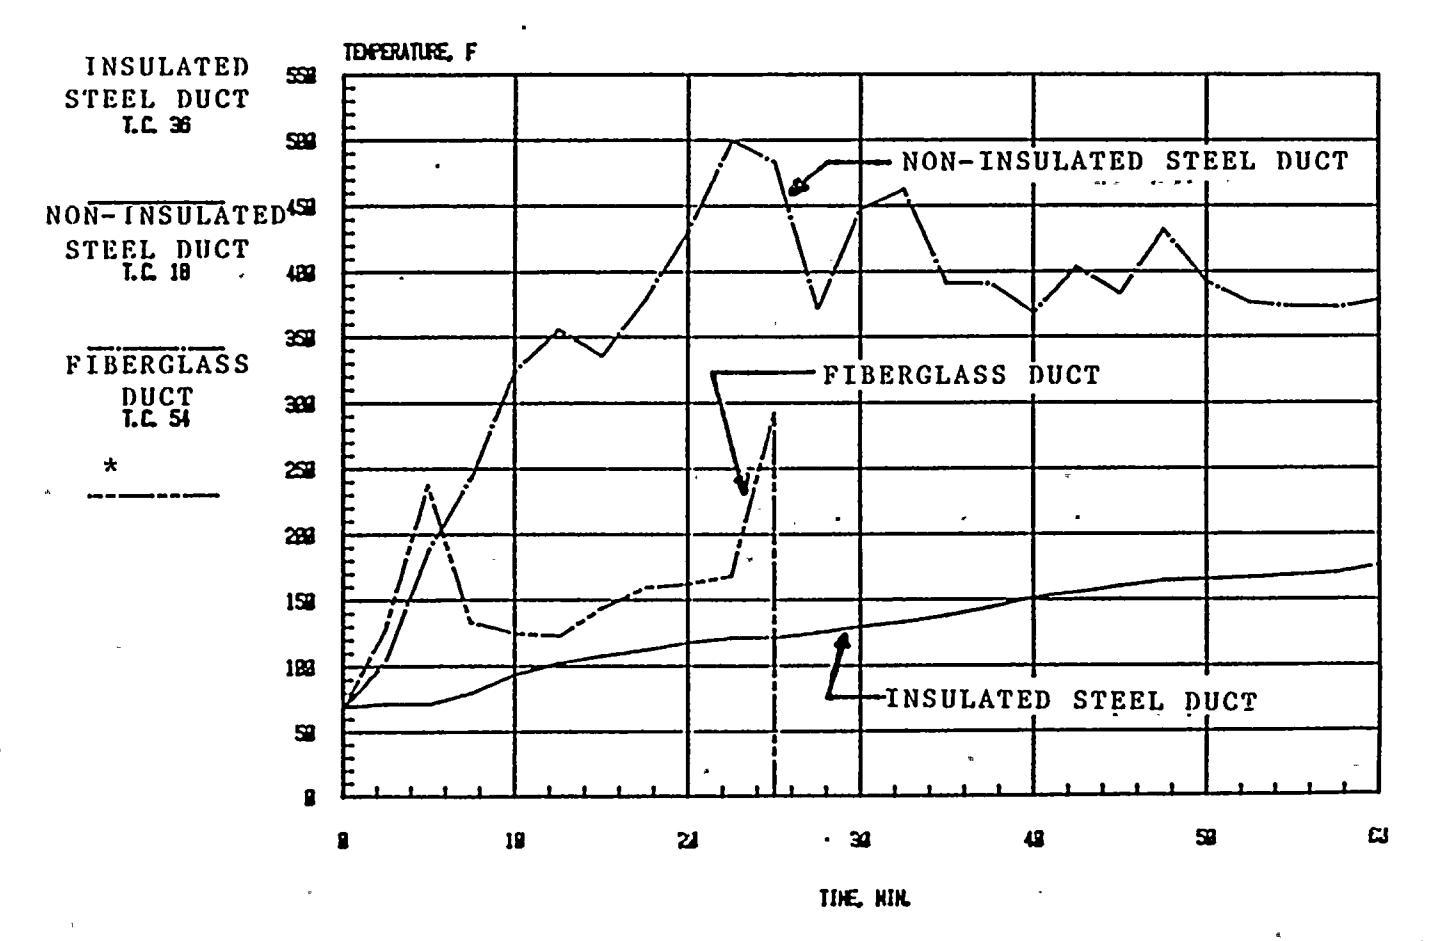
ILL. 11 NC 505-1

\*\*SECTION OF FIBERGLASS DUCT IN THE AREA OF T.C. 54 COLLAPSED AT 25 MIN.

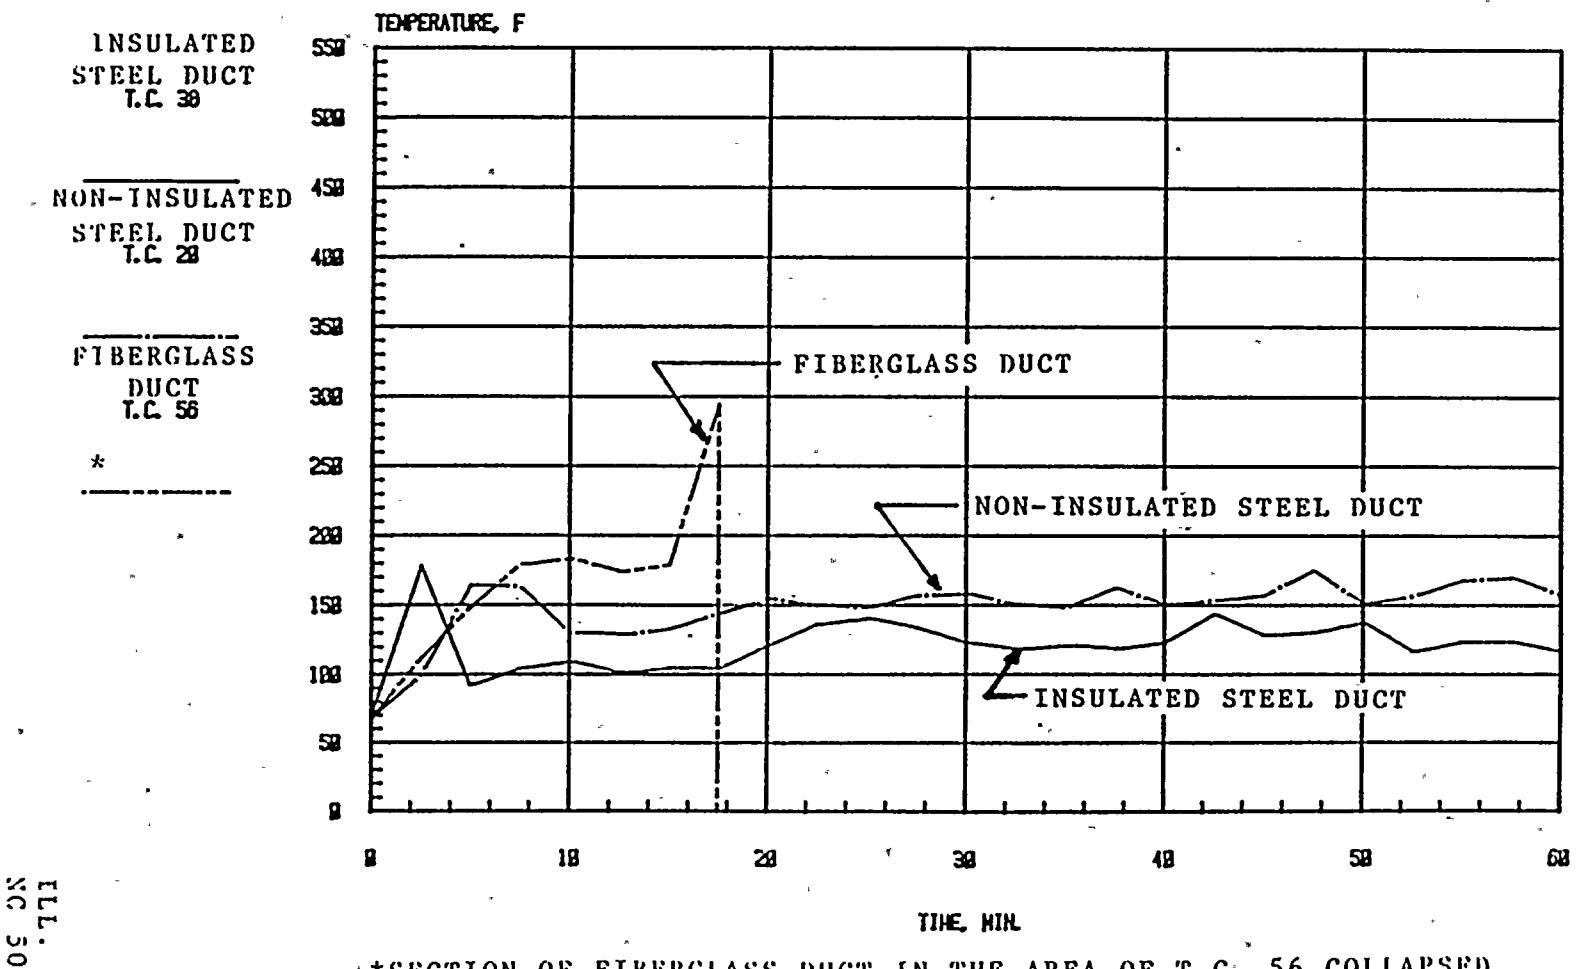
\*SECTION OF FIBERGLASS DUCT IN THE AREA OF T.C. 56 COLLAPSED AT 19 MIN.

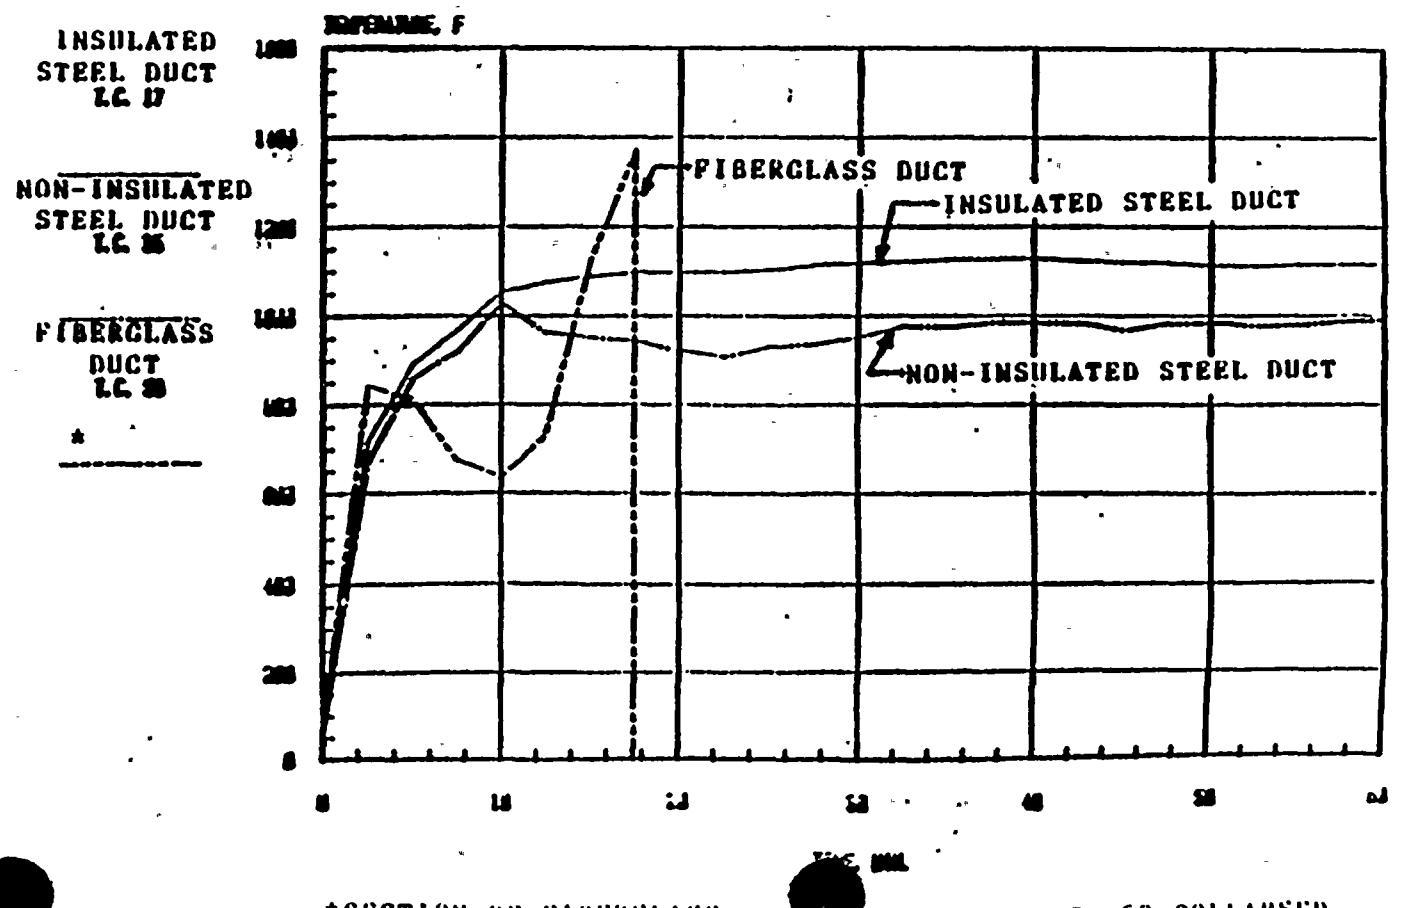
.\*SECTION OF FIBERGLASS DUC AREA OF T.C. 53 COLLAPSED AT 25 MIN.
