# **Nuclear Material Events Database**

## **Medical Events Involving Y-90 Microsphere Brachytherapy (Fiscal Year 2008-2017)**

Published January 2018

**Idaho National Laboratory  
Risk Assessment and Management Services  
Idaho Falls, Idaho 83415**

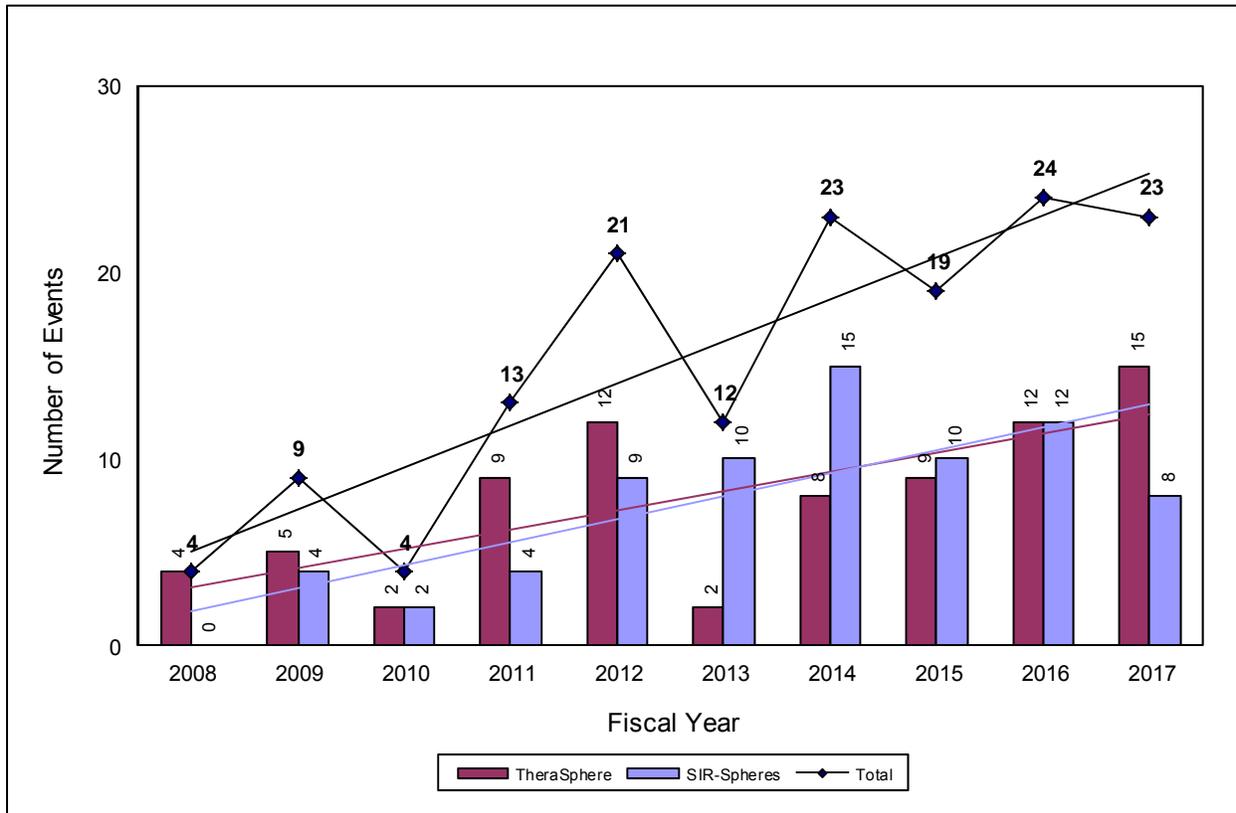
Figure 1 displays the annual number and trend of 152 medical events involving Y-90 microsphere treatments that occurred during the 10-year period. The trend analysis determined that the data represent statistically significant increasing trends (indicated by the trend lines). Note that the increasing trends could be the result of an increasing number of microsphere treatments performed. That specific information is currently not available for this review of NMED data.

Figure 1. Medical Events Involving Y-90 Microsphere Treatments (152 total events)

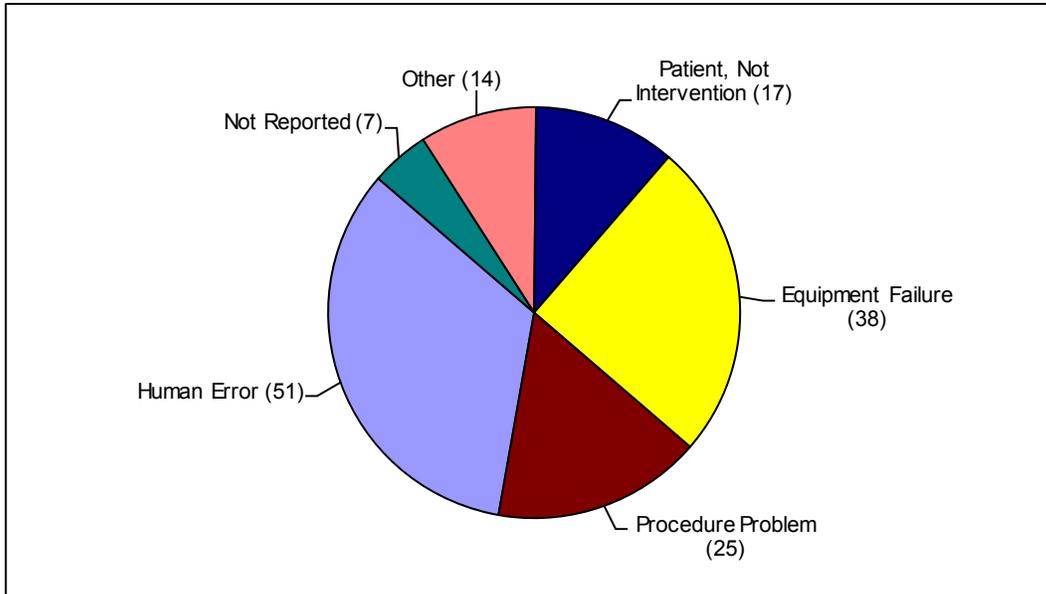
Figure 2. Event Causes

The Patient, Not Intervention data in Figure 2 represents events that do not result from patient intervention, yet are reported as beyond the control of the medical licensee. For example, an event where a non-intended site received microspheres due to a change in the patient’s vasculature between the time the treatment was planned and the time it was performed.

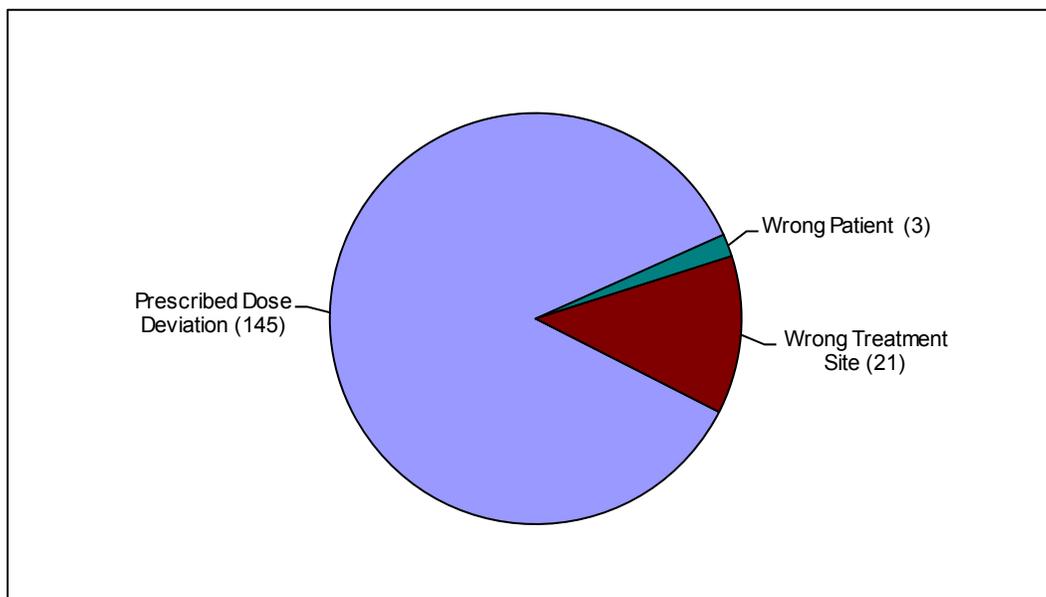
Figure 3. Event Problems (based on reporting requirements)

The Prescribed Dose Deviation data in Figure 3 includes both doses that were less than prescribed and doses that were more than prescribed.

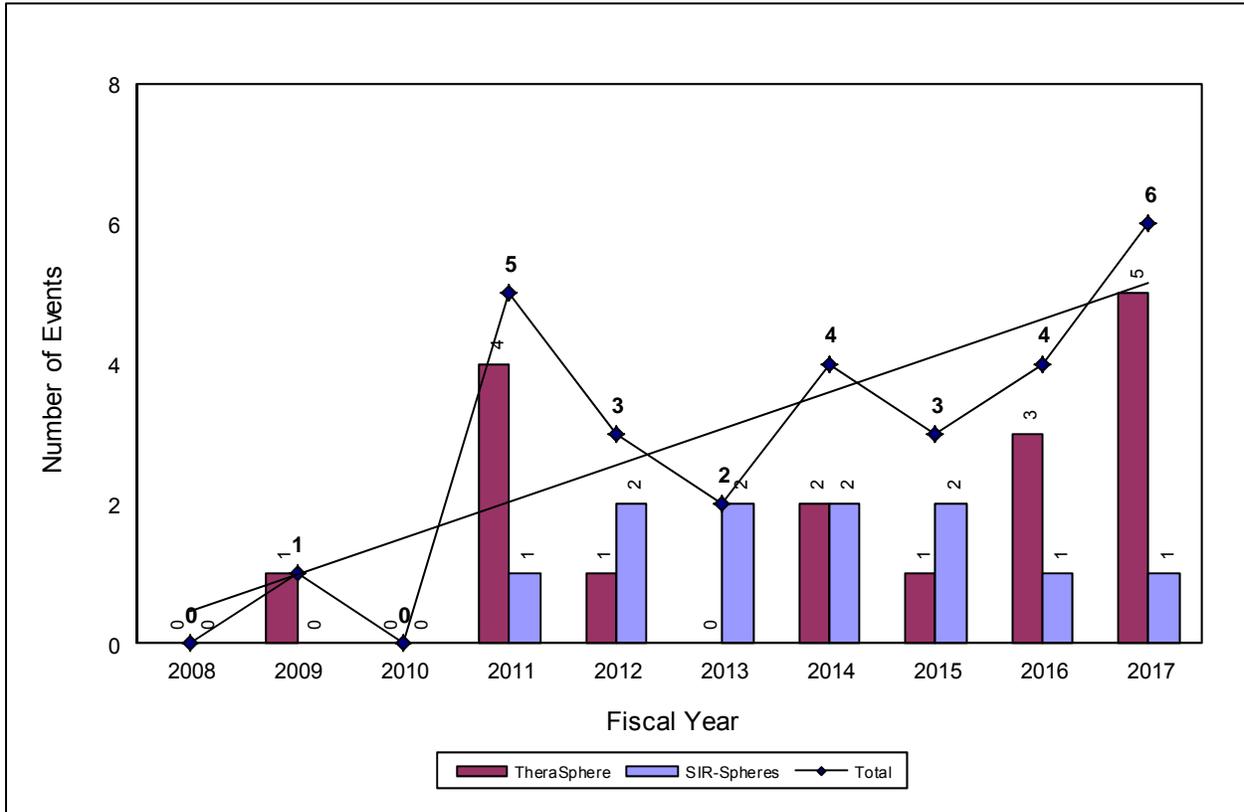
Of the 152 events, 28 were considered to be significant (classified as AOs or potential AOs). Recent events are marked as potential AOs until they complete the NRC's formal AO determination process and are reported in NUREG-0090, *Report to Congress on Abnormal Occurrences*. Figure 4 and Table 2 display these events. The trend analysis indicates that the Total data represents a statistically significant increasing trend. The following appendices contain the NMED abstracts for the 28 AO events.

Figure 4. Abnormal Occurrences (28 total events)

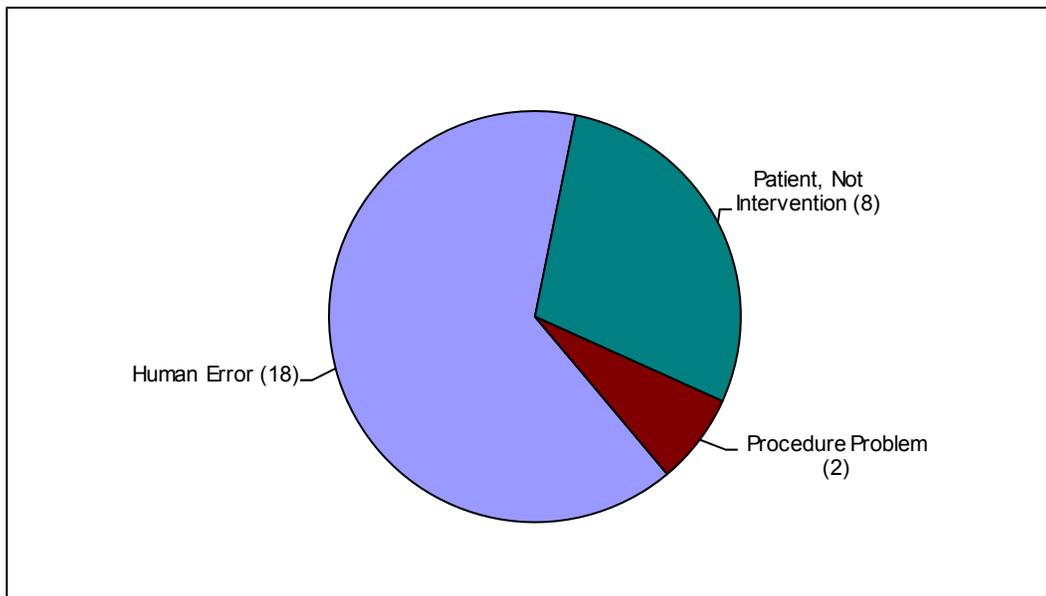
Figure 5. AO Event Causes

None of the events resulted from patient intervention. The Patient, Not Intervention data in Figure 5 represents events that do not result from patient intervention, yet are reported as beyond the control of the medical licensee. For example, an event where an unintended site received microspheres due to a change in the patient’s vasculature between the time the treatment was planned and when it was performed. However, the majority of AO events were caused by factors within the licensee’s control (Human Errors and Procedure Problems).
