VIRGINIA ELECTRIC AND POWER COMPANY

<u>VIRGINIA ELECTRIC AND POWER COMPANY</u> <u>SURRY POWER STATION UNIT 1</u> <u>RESPONSES TO QUESTIONS REGARDING UNRESOLVED ITEMS</u> <u>NRC INSPECTION REPORT NO. 50-280/94-02</u>

UNRESOLVED ITEM (URI) 50-280/94-02-02 "REVIEW REACTOR VESSEL LEVEL PROBLEM"

UNRESOLVED ITEM (URI) 50-280/94-02-03 "EVALUATION OF PRESSURIZER HYDROGEN BURN"

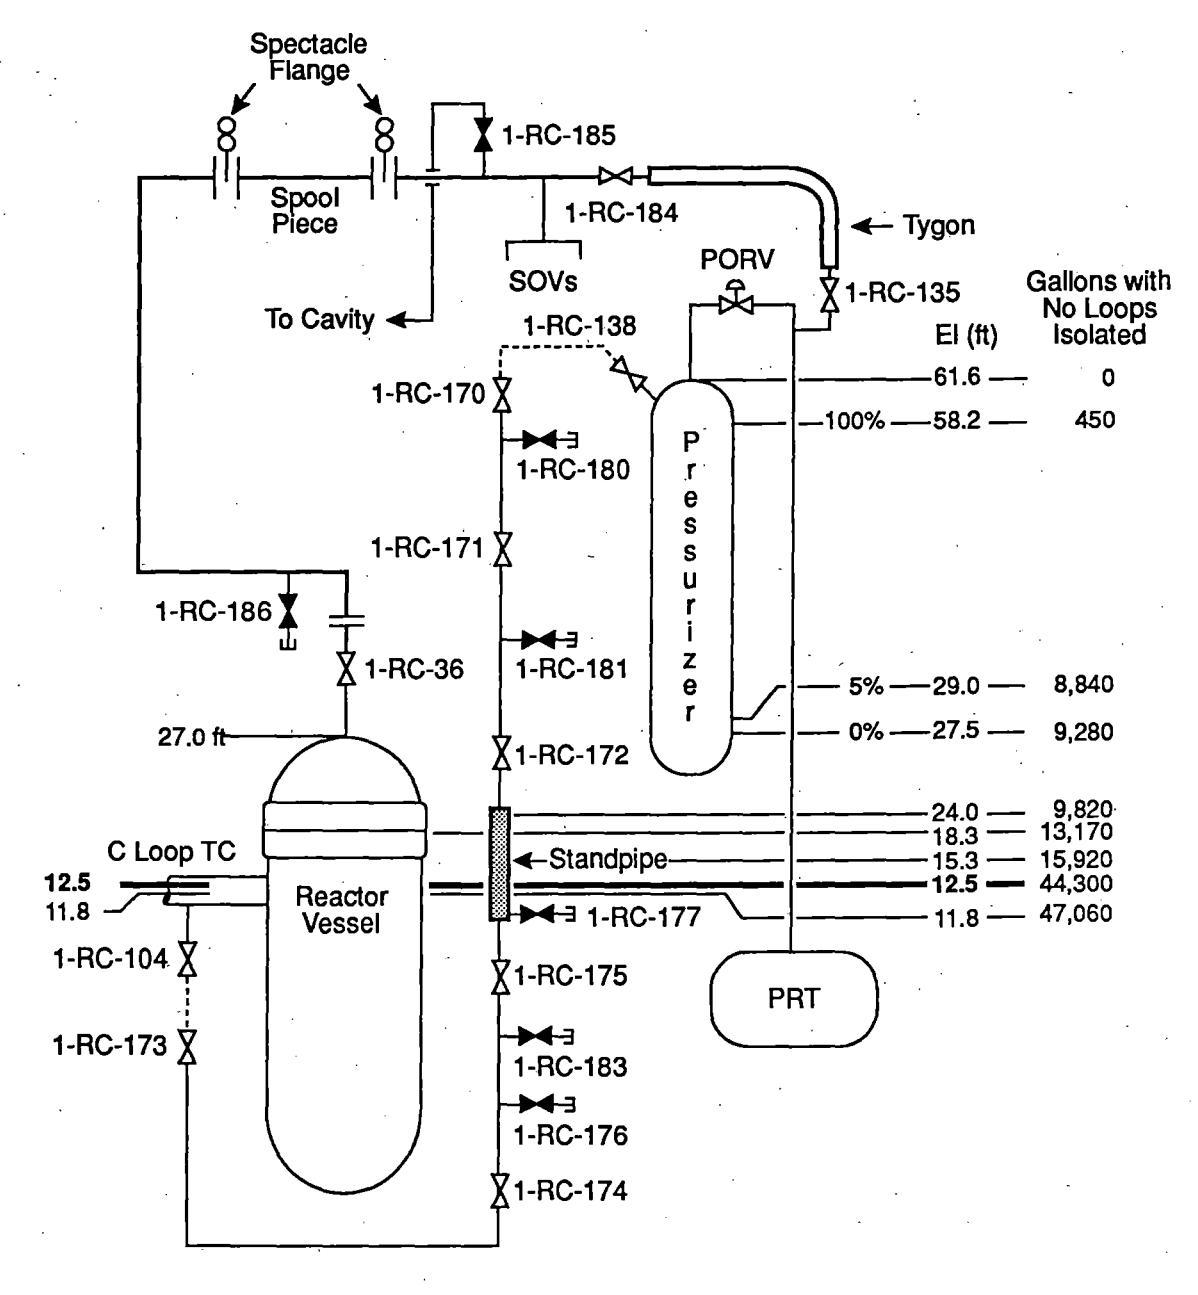
HEAD VENT AND STANDPIPE DIAGRAM

- o Background:
 - The change in Reactor Coolant System (RCS) level was detected at the standpipe installed in a line connecting the "C" Cold Leg of the RCS to the void space in the pressurizer. This permanent hard-piped system was installed in 1990 in response to Generic Letter 88-17, "Loss of Decay Heat Removal," dated October 17, 1988. In addition to the Generic Letter requirements to have the hard-piped level system in service for entry into reduced inventory conditions, the system is placed in service when it becomes necessary to reduce RCS inventory below the range of the pressurizer level instrumentation. An additional connection is made to the top of the pressurizer from the reactor vessel head vent valve. By equalizing pressures in these two lines, an accurate determination of RCS level may be obtained. (See attached drawing.)

- The reactor vessel was pressurized to a value calculated to be 0.7 psi greater than the pressurizer, which was vented to containment. The differential pressure was most likely caused by a vent line restriction and is discussed below.

- A restriction in the reactor vessel vent line allowed pressure in the reactor vessel to become slightly greater than that existing in the pressurizer.

- Since the spool piece connecting the reactor vessel vent valve piping and the pressurizer had been removed, the restriction was in the upstream, or reactor vessel, side of the vent line.

- o Conclusions:
 - At the beginning of the event, standpipe indication was not accurately representing reactor vessel level. Thus, when pressures between the reactor vessel and containment equalized, standpipe level dropped.

- The source of the head vent line blockage was not definitely determined.
 - When the obstruction in the vent line cleared, either because of a change in pressure or temperature or some other reason, pressures in the system equalized and proper level indication was restored.

o A Station Level I Project has been assigned to further evaluate this event and the similar one which occurred in 1992. This evaluation will include engineering review of the installations in both units, comparison between the two installations, and appropriate corrective actions. These actions will be completed prior to the start of the next refueling outage, currently scheduled for the first quarter of 1995. The Unit 2 standpipe level indication may be placed into service during a minioutage being planned for June, 1994. If the standpipe is required, reviews of the Unit 2 installation will be completed and any appropriate actions will be taken prior to placing the system in service.
