| MRP Materials Reliability ProgramMRP 2018-03 | | |
| Subject: | Transmittal of NEI-03-08 "Needed" Interim Guidance for PW<br>Wear | R CRDM Thermal Sleeve |

Subject: NEI 03-08 Needed Inspection Guidance for PWR CRDM Thermal Sleeve Wear

| Subject: Thermal Sleeve Flange Wear Leads to Stuck Control Rod | Number: NSAL-18-1 | | |

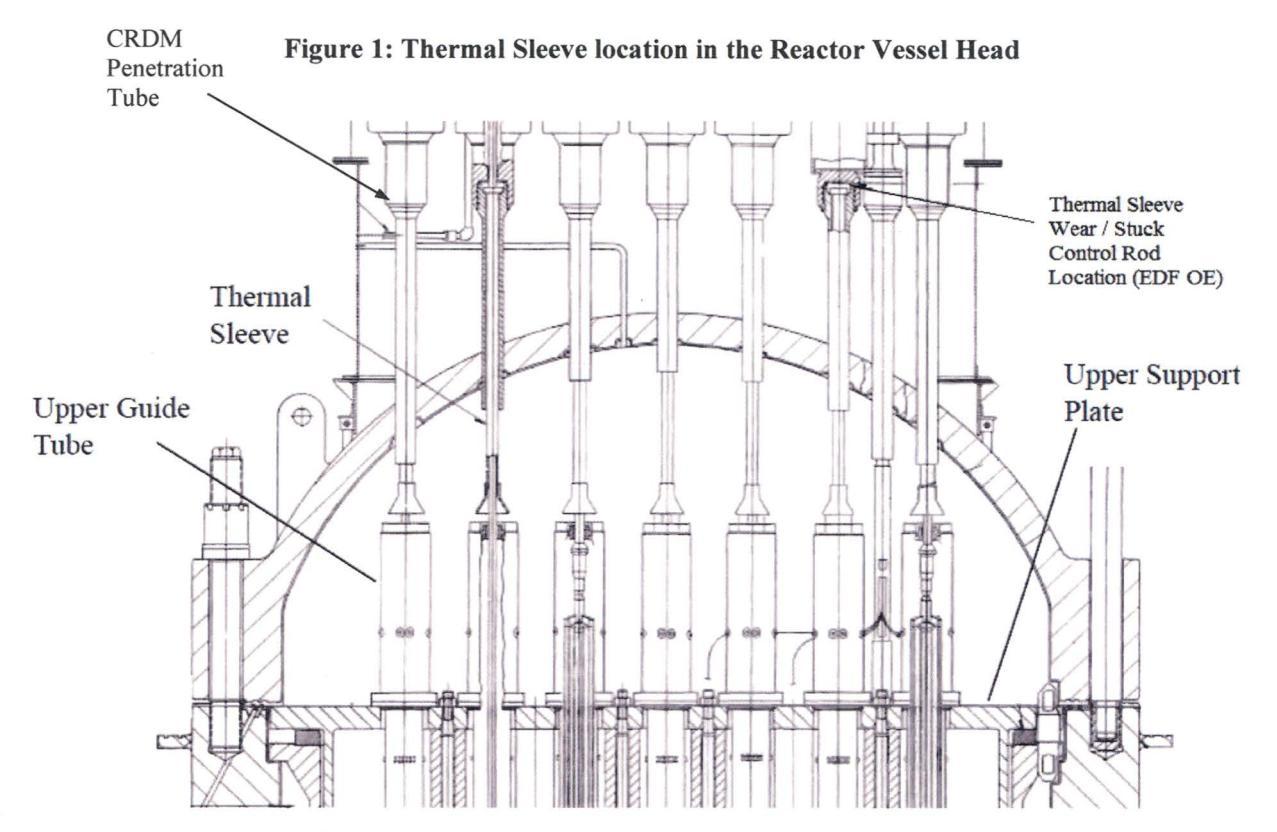
As described in the preceding Summary, the reported defect pertains to inspection guidelines for the thermal sleeve flange, located in the upper reactor vessel internals. Figure 1 depicts the label – Thermal Sleeve Wear/Stuck Control Rod Location (EDF OE) – in the upper right portion which identifies the specific area of observed wear which led to flange separation and interference with control rod movement.

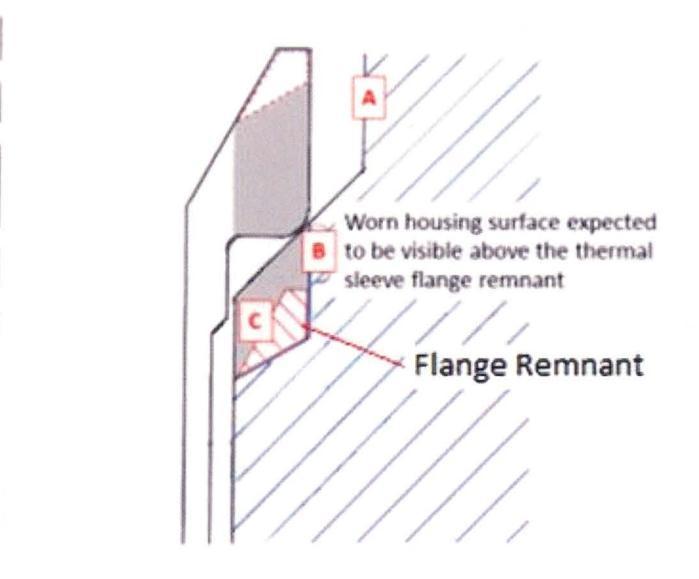
Figure 2: Worn Thermal Sleeve Flange and Image of Worn CRDM Housing

Examination of the failed sleeve in 2014 showed that the upper thermal sleeve flange, which rests inside the CRDM penetration tube, had worn through and become separated. Further inspection of the failed thermal sleeve and the CRDM penetration tube concluded that a mutual wear mechanism existed between the two components. Figure 2 shows the original CRDM housing surface (A), the worn CRDM penetration tube surface (B), and the thermal sleeve flange remnant (C). The shaded regions of the figure represent material removed by the wear. The result was separation of the remaining remnant (dotted red outline) of the upper flange and a worn pocket in the adapter tube.

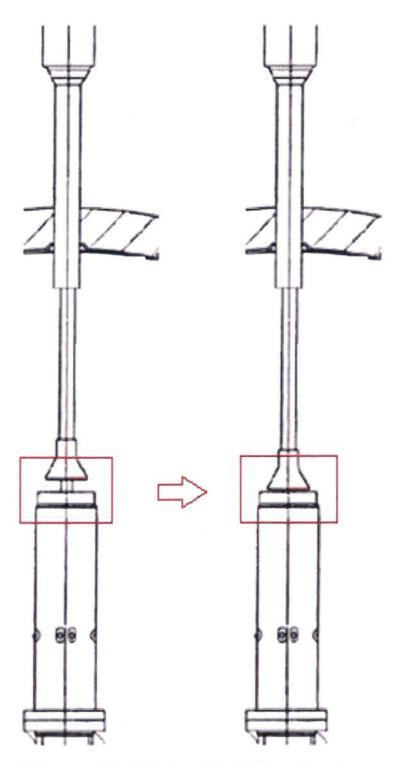
For plants with 14x14 guide tubes, the upper guide tube configuration is an open box-shaped tube with a top plate recessed from the top of the tube. These designs have either a fixed or a removable insert installed in this top plate which results in the top surface of the insert being flush or slightly recessed from the top edge of the tube. The width of the box tube for these guide tubes is smaller than the diameter of the funnel, so any contact would likely show up as intermittent shiny marks on the top edge of this tube. Furthermore, for the majority of the plants with 14x14 guide tubes (exceptions noted in Table 2) the spacing between the guide funnel and the upper guide tube is smaller than the lowering required for separation to occur. Therefore, with the exception of the two plants noted in Table 2, the wear markings on 14x14 guide tubes are likely to occur earlier in operation but are not necessarily an indication of imminent flange separation. For the two exceptions noted in Table 2, the spacing between the guide funnel and the upper guide tube is nearly the same distance as required for flange separation. Therefore, wear markings on the upper guide tube may or

may not signify complete separation of the thermal sleeve flange; however, it is a clear indication that significant wear of the thermal sleeve flange has occurred and will likely require action.

- For plants with 15x15 guide tubes and the two plants with 14x14 guide tubes noted in Table 2, look for shiny marks on the top edge of the upper guide tube enclosure.

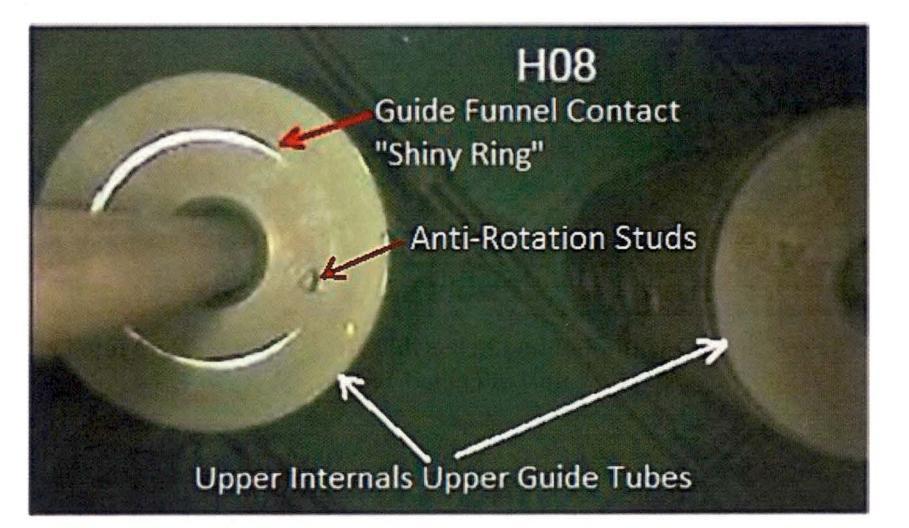
Figure 4: "Shiny Ring" Evidence of Guide Funnel Contact Wear on the UGT at Belleville Unit 2

For plants with 17x17 and 16x16 guide tubes, actual contact of the guide funnel with the UGT top housing plate will likely only occur after the flange has completely separated from the thermal sleeve. In December 2017, a 4-loop 1300 MW EdF plant in France, Belleville Unit 2, experienced complete wear-through and separation of one of the thermal sleeve flanges at a rodded location (Core Location H-8). Figure 4, taken from Belleville Unit 2, illustrates the wear marking ("shiny ring") that may be visible on the UGT top housing plate after the reactor vessel head is removed, if a plant has been operating with a failed thermal sleeve.

Figure 4 also shows the anti-rotation stud design used on the EdF guide tubes. Westinghouse NSSS plants have an anti-rotation stud/nut configuration on the top housing plate which results in the stud protruding slightly higher and the nut extending more into the diameter of the wear ring. This difference in configuration may result in slightly different wear markings on the stud and nut as compared to what is shown in Figure 4. While signs of contact between the guide funnel and the anti-rotation stud/nut may be visible before flange separation occurs, this wear pattern indicates that significant thermal sleeve flange wear has occurred.

- For plants with 17x17 and 16x16 guide tubes, look for the "shiny ring" shown in Figure 4.
- During the next under-head inspection (i.e., the volumetric inspections required by ASME Section XI Code Case N-729-4 [5] and 10 CFR 50.55a), and at subsequent under-head inspections:
