Department of Energy

Subject: Position Paper: Suspension of Groundwater Extraction and Evaporation Pond Operations, Shiprock, New Mexico, Disposal Site (NRC Docket No. WM-0058)

Position Paper: Suspension of Groundwater Extraction and Evaporation Pond Operations, Shiprock, New Mexico, Disposal Site

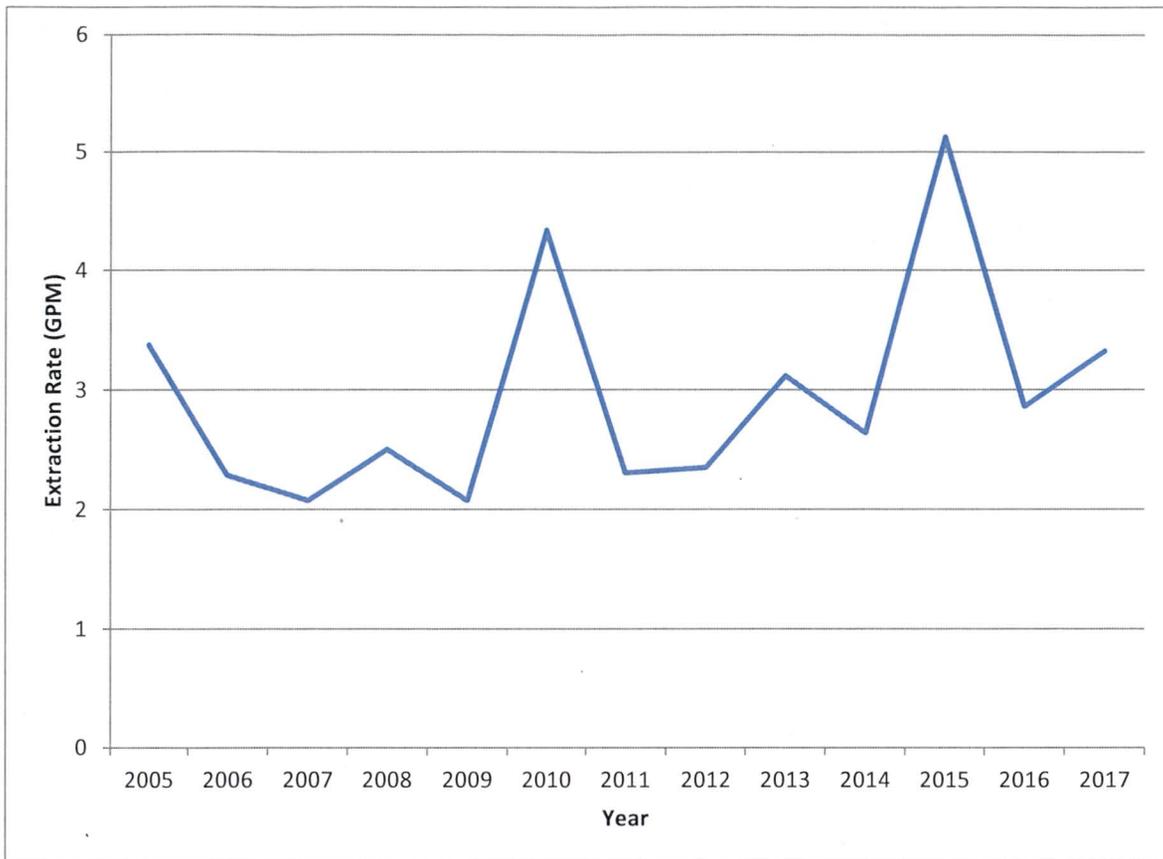
Figure 4. Average Annual Extraction Rates from Bob Lee Wash: 2005–2017

The current remediation system eliminates surface water in Bob Lee Wash. However, groundwater flows to the surface when the remediation pumps are not operated (for repairs and maintenance). Thus, the current terrace groundwater extraction system has been ineffective in achieving the remediation objective for Bob Lee Wash, reducing flow to eliminate exposure pathways. In general, the average annual extraction rate of groundwater pumped from the Bob Lee Wash interceptor drain has increased since remediation began (Figure 4).

Eliminating surface exposures in Bob Lee Wash when remediation pumps are not in operation will require implementing interim actions prior to suspending active pumping in support of decommissioning activities. Potential interim actions for consideration include piping water from the interceptor drain sump to the floodplain, armoring exposed water with rock, and the implementation of phytoremediation plantings.

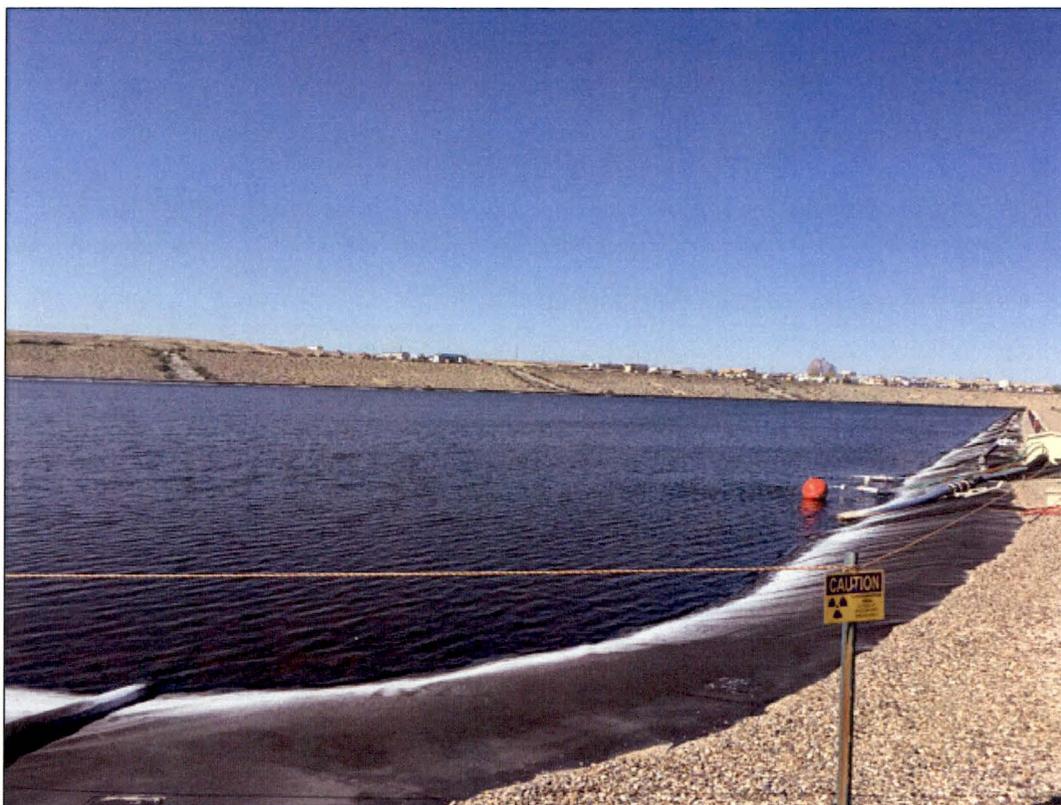
Figure 5. Current Evaporation Pond Conditions

The evaporation pond has a total depth of 10 feet, and was designed for a maximum fill capacity of 8 feet, which allows for a freeboard of 2 feet above the water level when filled to capacity. When full (8 feet of water), the pond provides a total capacity of 25.37 million gallons of liquid. In April 2017, the water level in the pond reached the maximum fill capacity of 8 feet. The volume of solids in the bottom of the pond is not known.

With each successive visit the liner repair crew commented on the increased difficulty in patching the liner. LM's main concern is that the liner is beginning to develop areas of degradation from exposure to the sun (polypropylene is a simple chain polymer and it has a high degradation rate when exposed to UV light like the Sun. UV light causes the bonds holding the polymer together to break which weakens the plastic.). Consequently, it becomes more problematic to find enough surface area that can be ground to a clean surface for welding patches. Additionally, the thickness of the remaining polypropylene above the scrim and reinforcing material is insufficient to establish a good seal. As a result, future repairs will require a different patching method. For example, if there is insufficient surface to grind, double-sided tape can be used to patch and seal areas requiring repair.

LM recommends suspension of pumping to the evaporation pond to facilitate planning and decommissioning of the evaporation pond. As of April 2017, the pond held approximately 25 million gallons of contaminated water and an unknown volume of contaminated sediment (Figure 5). The polypropylene pond liner is increasingly exhibiting signs of deterioration. To ensure that operation of the evaporation pond continues in a manner protective of human health and the environment, these actions should be conducted well in advance of the 20-year design life of the pond liner. Planning for decommissioning activities and evaporation of the current volume of water in the pond will require several years.

LM will conduct routine inspections of the evaporation pond to document the pond conditions as water levels decrease due to the suspension of active groundwater pumping. LM will develop a plan and implementation requirements for addressing pond sediments exposed as a consequence of decreasing pond water levels to ensure that wind-blown dispersion of sediments do not present a risk to human health and the environment.
