RE: 44 Fed. Reg. 50925  
Abnormal Occurrence Event

### Abnormal Occurrence Event; Damage to New Fuel Assemblies

### Abnormal Occurrence Event; Indication of Low Water Level in a Boiling Water Reactor

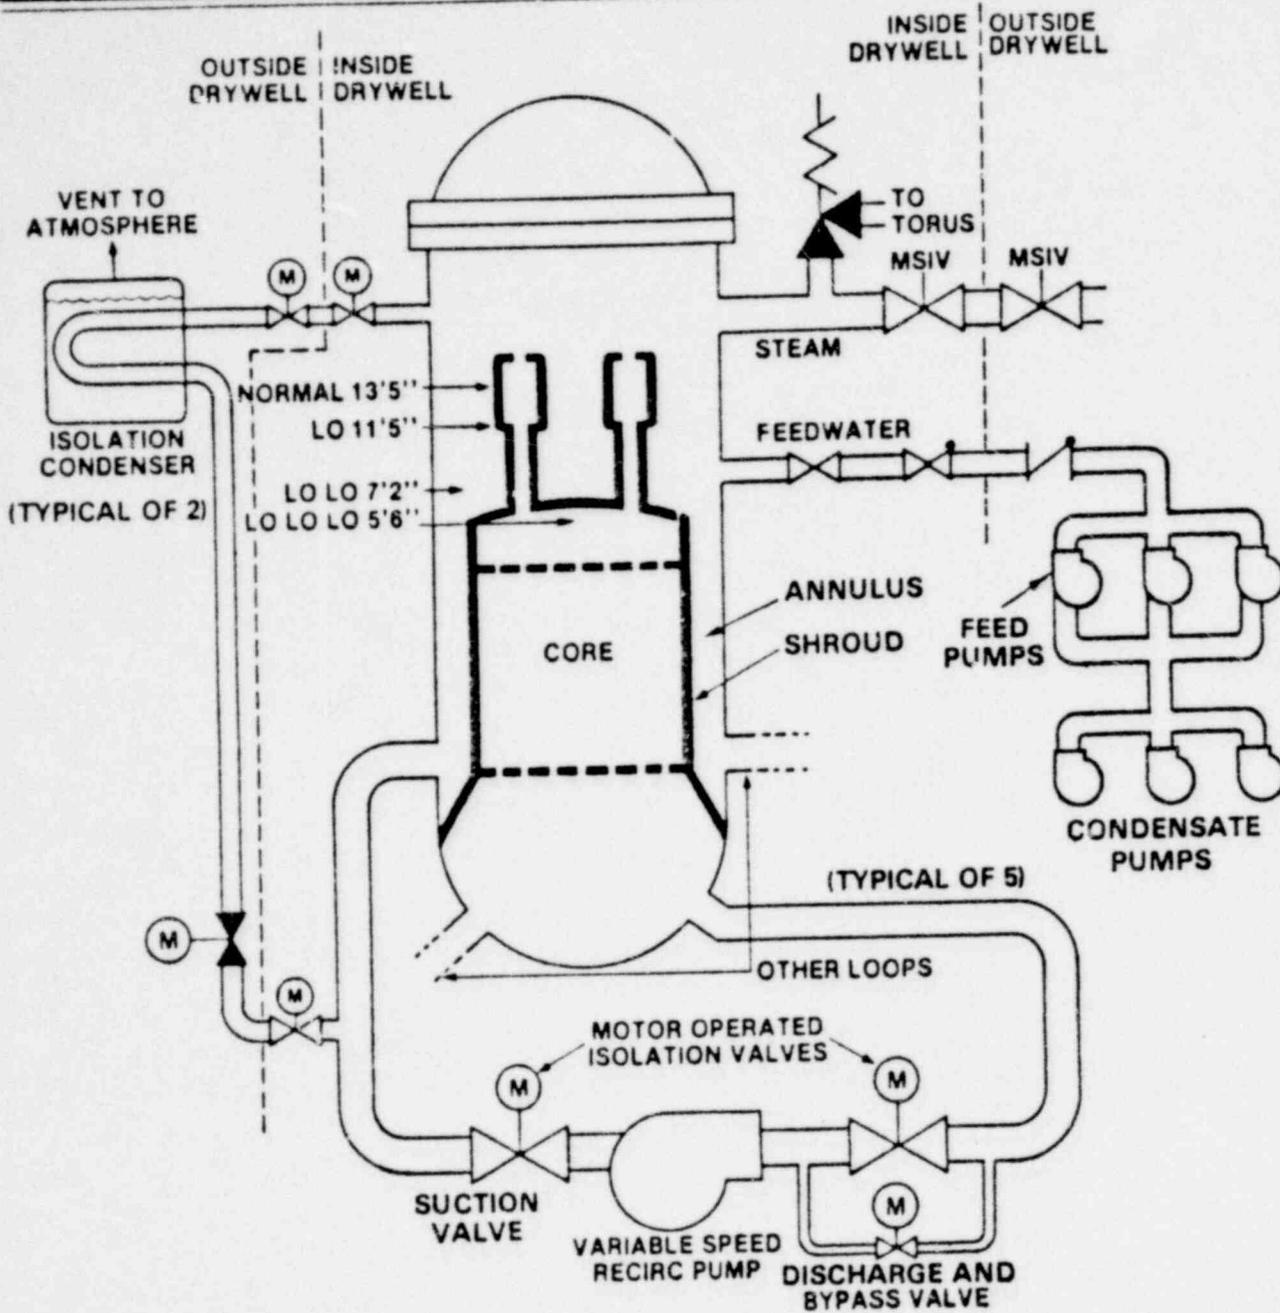
Figure 1. RECIRCULATION, STEAM AND ISOLATION CONDENSER SCHEMATIC

After closure of the MSIV, an isolation condenser was manually placed in service for core decay heat removal. The isolation condenser was condensing steam from the core and returning the condensate to the reactor annulus through a connection to a recirculation loop pump suction line (Figure 1). At approximately a minute and a quarter after the reactor scram, the discharge valves in "A" and "E" recirculation loops were closed in accordance with a Standing Order that was in effect. Closing the "A" and "E" loop discharge valves had been necessary to prevent inadvertent stopping of the isolation condenser due to forced flow from operating recirculation pumps being sensed as if it were an isolation-condenser line break. (This Standing Order was no longer appropriate since an ATWS modification had been made that tripped the recirculation pumps coincident with high-pressure or low-level scrams. The necessary procedure change had not been performed following the plant modification.) At the same time, the "B" and "C" loop discharge valves were apparently closed, in anticipation of restarting the recirculation pumps. The "D" loop discharge valve had been closed prior to the event because the associated pump was out of service.

The triple-low level in the core shroud area resulted from the restriction of the flow path between the annulus and the core region by closure of all recirculation pump discharge valves. With the recirculation pump discharge valves closed (discharge piping is over 2 feet in diameter), the only flow path back to the core region was via the 2-inch bypass lines around the discharge valves. The effect of this flow restriction was to reduce the water level in the core region and to increase the level in the reactor annulus area.
