U.J. NUCLEAR REGULATORY COMMISSIO. OFFICE OF INSPECTION AND ENFORCEMENT

Report No. 50-293/77-31		
Docket No50-293		
License No. DPR-35 Priority	Category	с
Licensee: Boston Edison Company		
800 Boylston Street		
Boston, Massacnusetts 02199		
Facility Name: Pilgrim Nuclear Power Station, Unit 1		
Inspection at: Plymouth, Massachusetts		
Inspection conducted: November 28-30, 1977		
Inspectors: Jahn Hith	1/12/	178
R. White, Radiation Specialist	date	signed
L. Thonus, Radiation Specialist	1 - 12 date	179 signed
		5
(, ATT	date	signed
Approved by: 1000000000000000000000000000000000000	1-17	178
Section, FF&MS Branch	date	signed

Inspection on November 28-30, 1977 (Report No. 50-293/77-31)

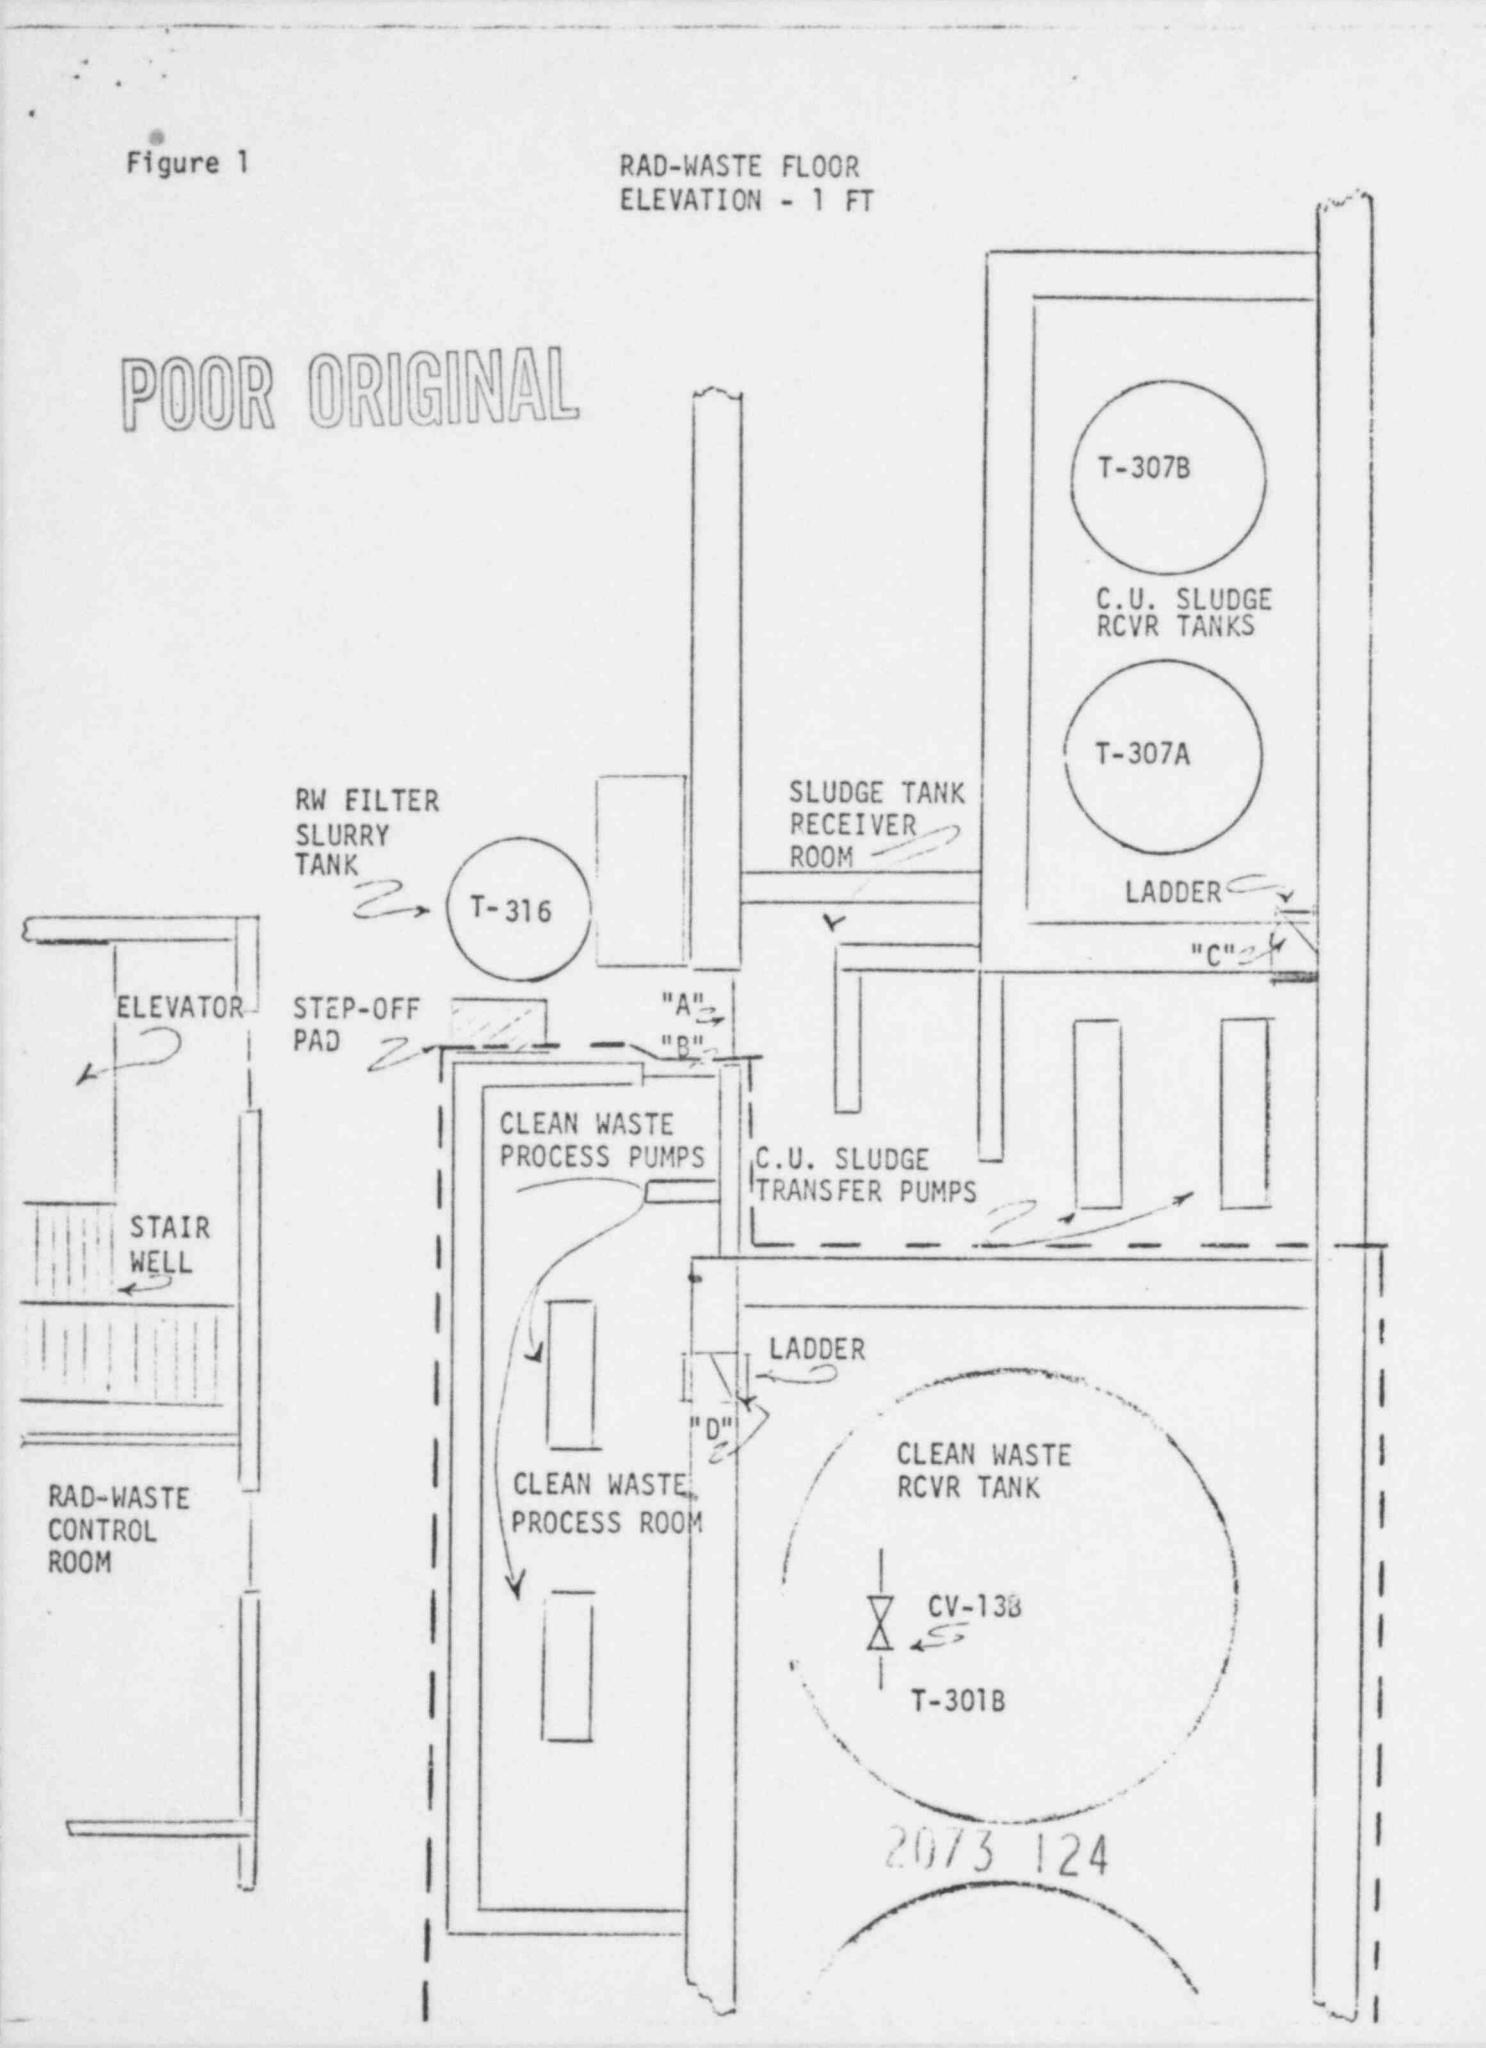
The personnel associated with this event (Repairmen A and B, Crouse Foreman, Maintenance Supervisor, HP Engineer, and HP Technician) gathered at the step-off pad common to both the Clean Waste Process Room and the Sludge Tank Receiver Room (see Figure 1). Since none of the personnel knew where valve CV-13B was located within the Clean Waste Process Room, directions were solicited from the Rad Waste Coordinator who was in the vicinity. The Coordinator explained the location of the valve using a survey map for reference, and indicated the position of service outlets and the tank configuration. The survey map covered only the area within the dotted lines in the lower right hand corner of Figure 1 The wording appearing on Figure 1 was not present in the survey map shown to the workers. It is apparently at this point that all personnel mistook the entrance to the Sludge Tank Receiver Room for the entrance to the Clean Waste Process Room (the rooms are adjacent to each other but the entrances were not identified). and after the Coordinator left the area the personnel apparently assumed that door "A" (Figure 1) was the access to the Clean Waste Process Room, since it was most visible from the step-off pad.

Repairmen A and B, re-entered the Sludge Tank Receiver Room and determined that the service outlets were not located as previously described. Repairman B climbed the tank vault access ladder and found that there was a locked gate (gate "C", Figure 1) on the top of the vault wall. Repairman B noted that there was a service outlet on the other side of the gate. The repairmen returned to the step-off pad to inform personnel of the locked gate.
