NUREG-0312

INTERIM TECHNICAL REPORT ON BWR FEEDWATER AND CONTROL ROD DRIVE RETURN LINE NOZZLE CRACKING

Office of Nuclear Reactor Regulation U. S. Nuclear Regulatory Commission

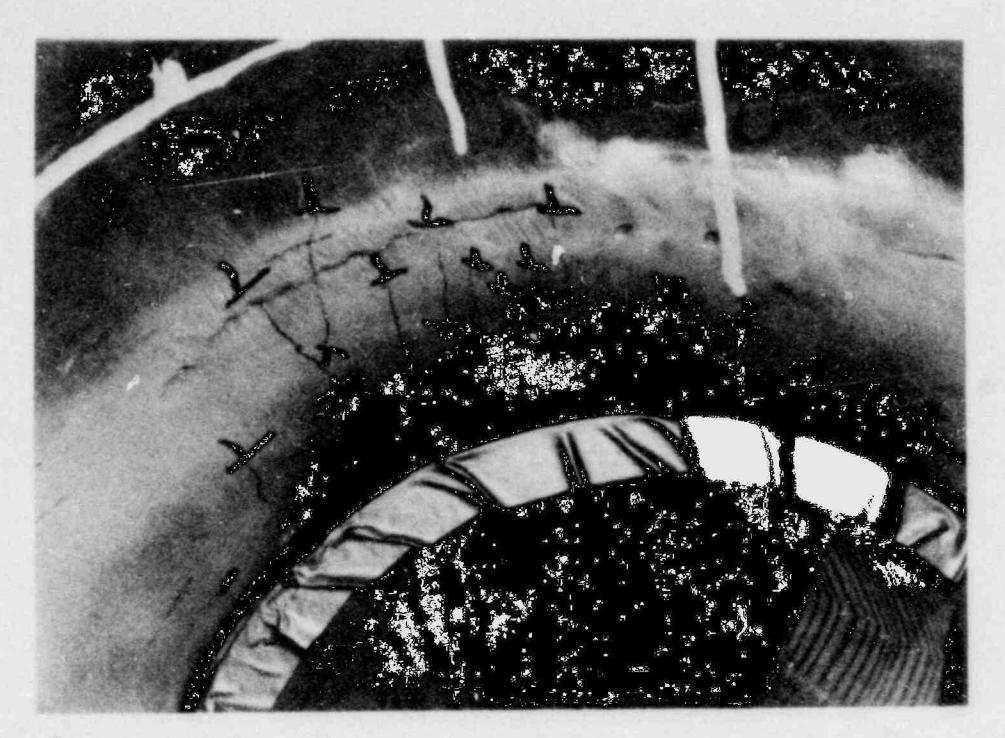
Attachment 1.a - Typical example of light cracks on a feedwater nozzle.

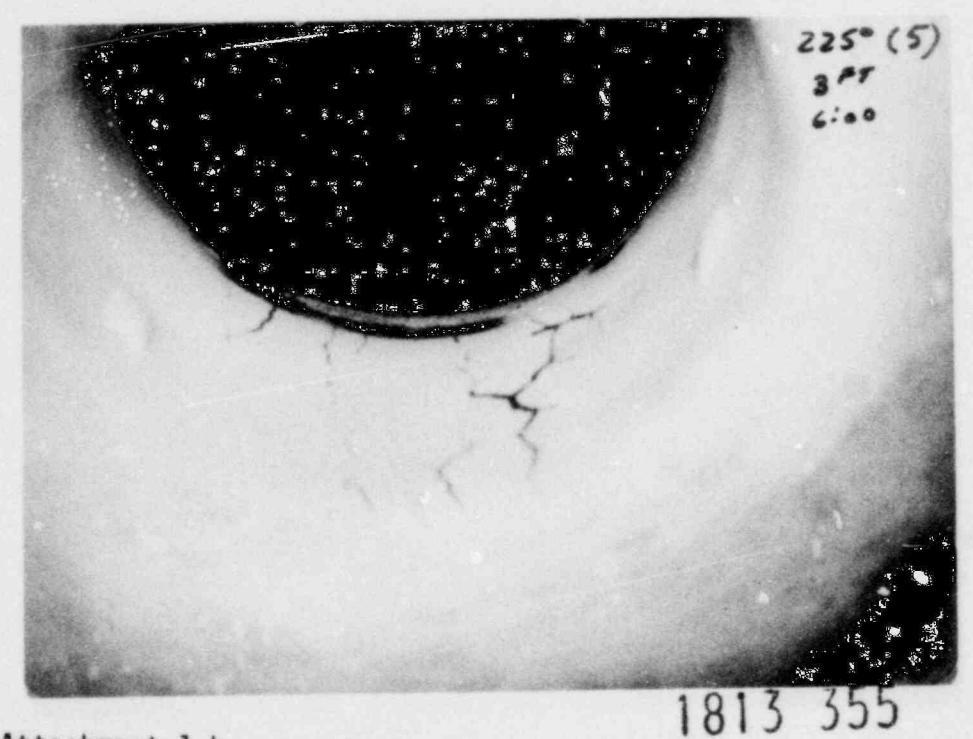
Attachment 1.b - Heavy feedwater nozzle cracking in a plant different from Attachment 1.a.

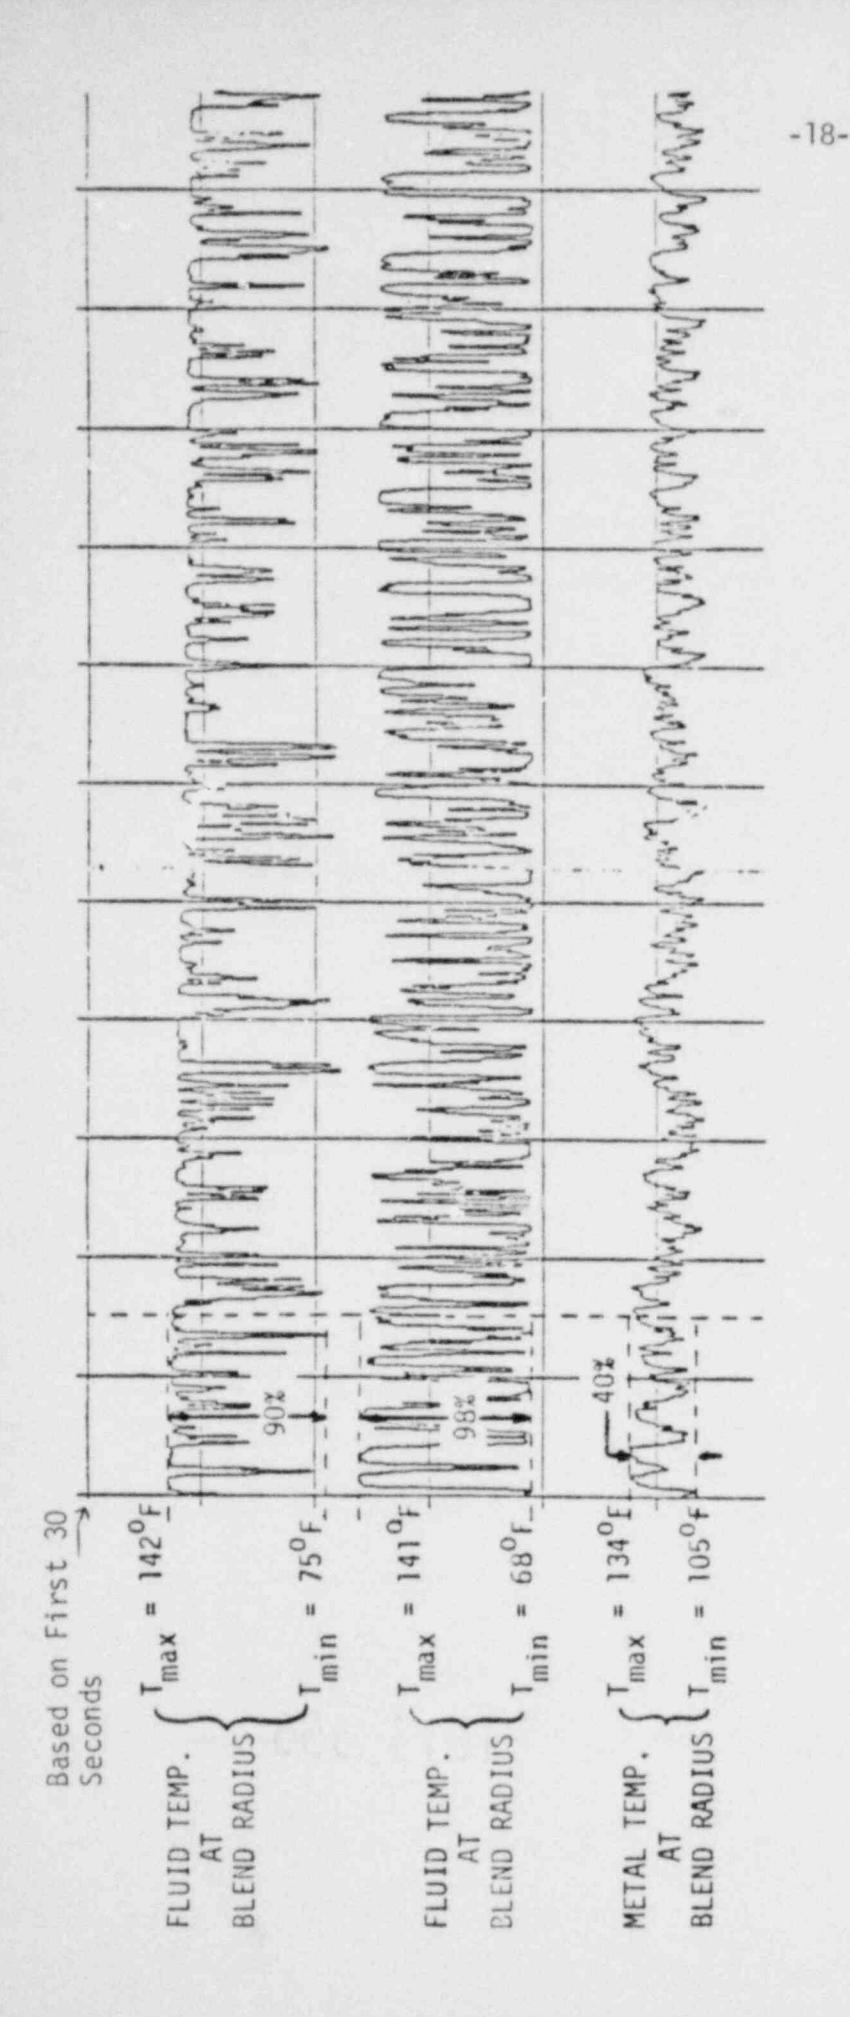
ATTACHMENT 2

fluctuations in water temperature within the vessel in the spargernozzle region during periods of low feedwater temperature when the flow may also be unsteady and perhaps intermittent. Attachment 2 is a trace of such temperature fluctuations as they were measured in a mock-up of a typical feedwater nozzle. Once initiated, the cracks are believed to be driven deeper by the larger, relatively low frequency, startup/shutdown pressure and thermal cycles. The latter

TIME HISTORY TRACES FOR HIGH LEAKAGE/LOW SPARGER FLOW CASE

$(\Delta T_{avail} = 73^{0}F)$
