REPORTABLE OCCURRENCE 79-02 ISSUE 0 Page 1 of 5

FORT ST. VRAIN NUCLEAR GENERATING STATION PUBLIC SERVICE COMPANY OF COLORADO P. O. BOX 361 PLATTEVILLE, COLORADO 80651

REPORT NO. 50-267/79-02/03-L-0

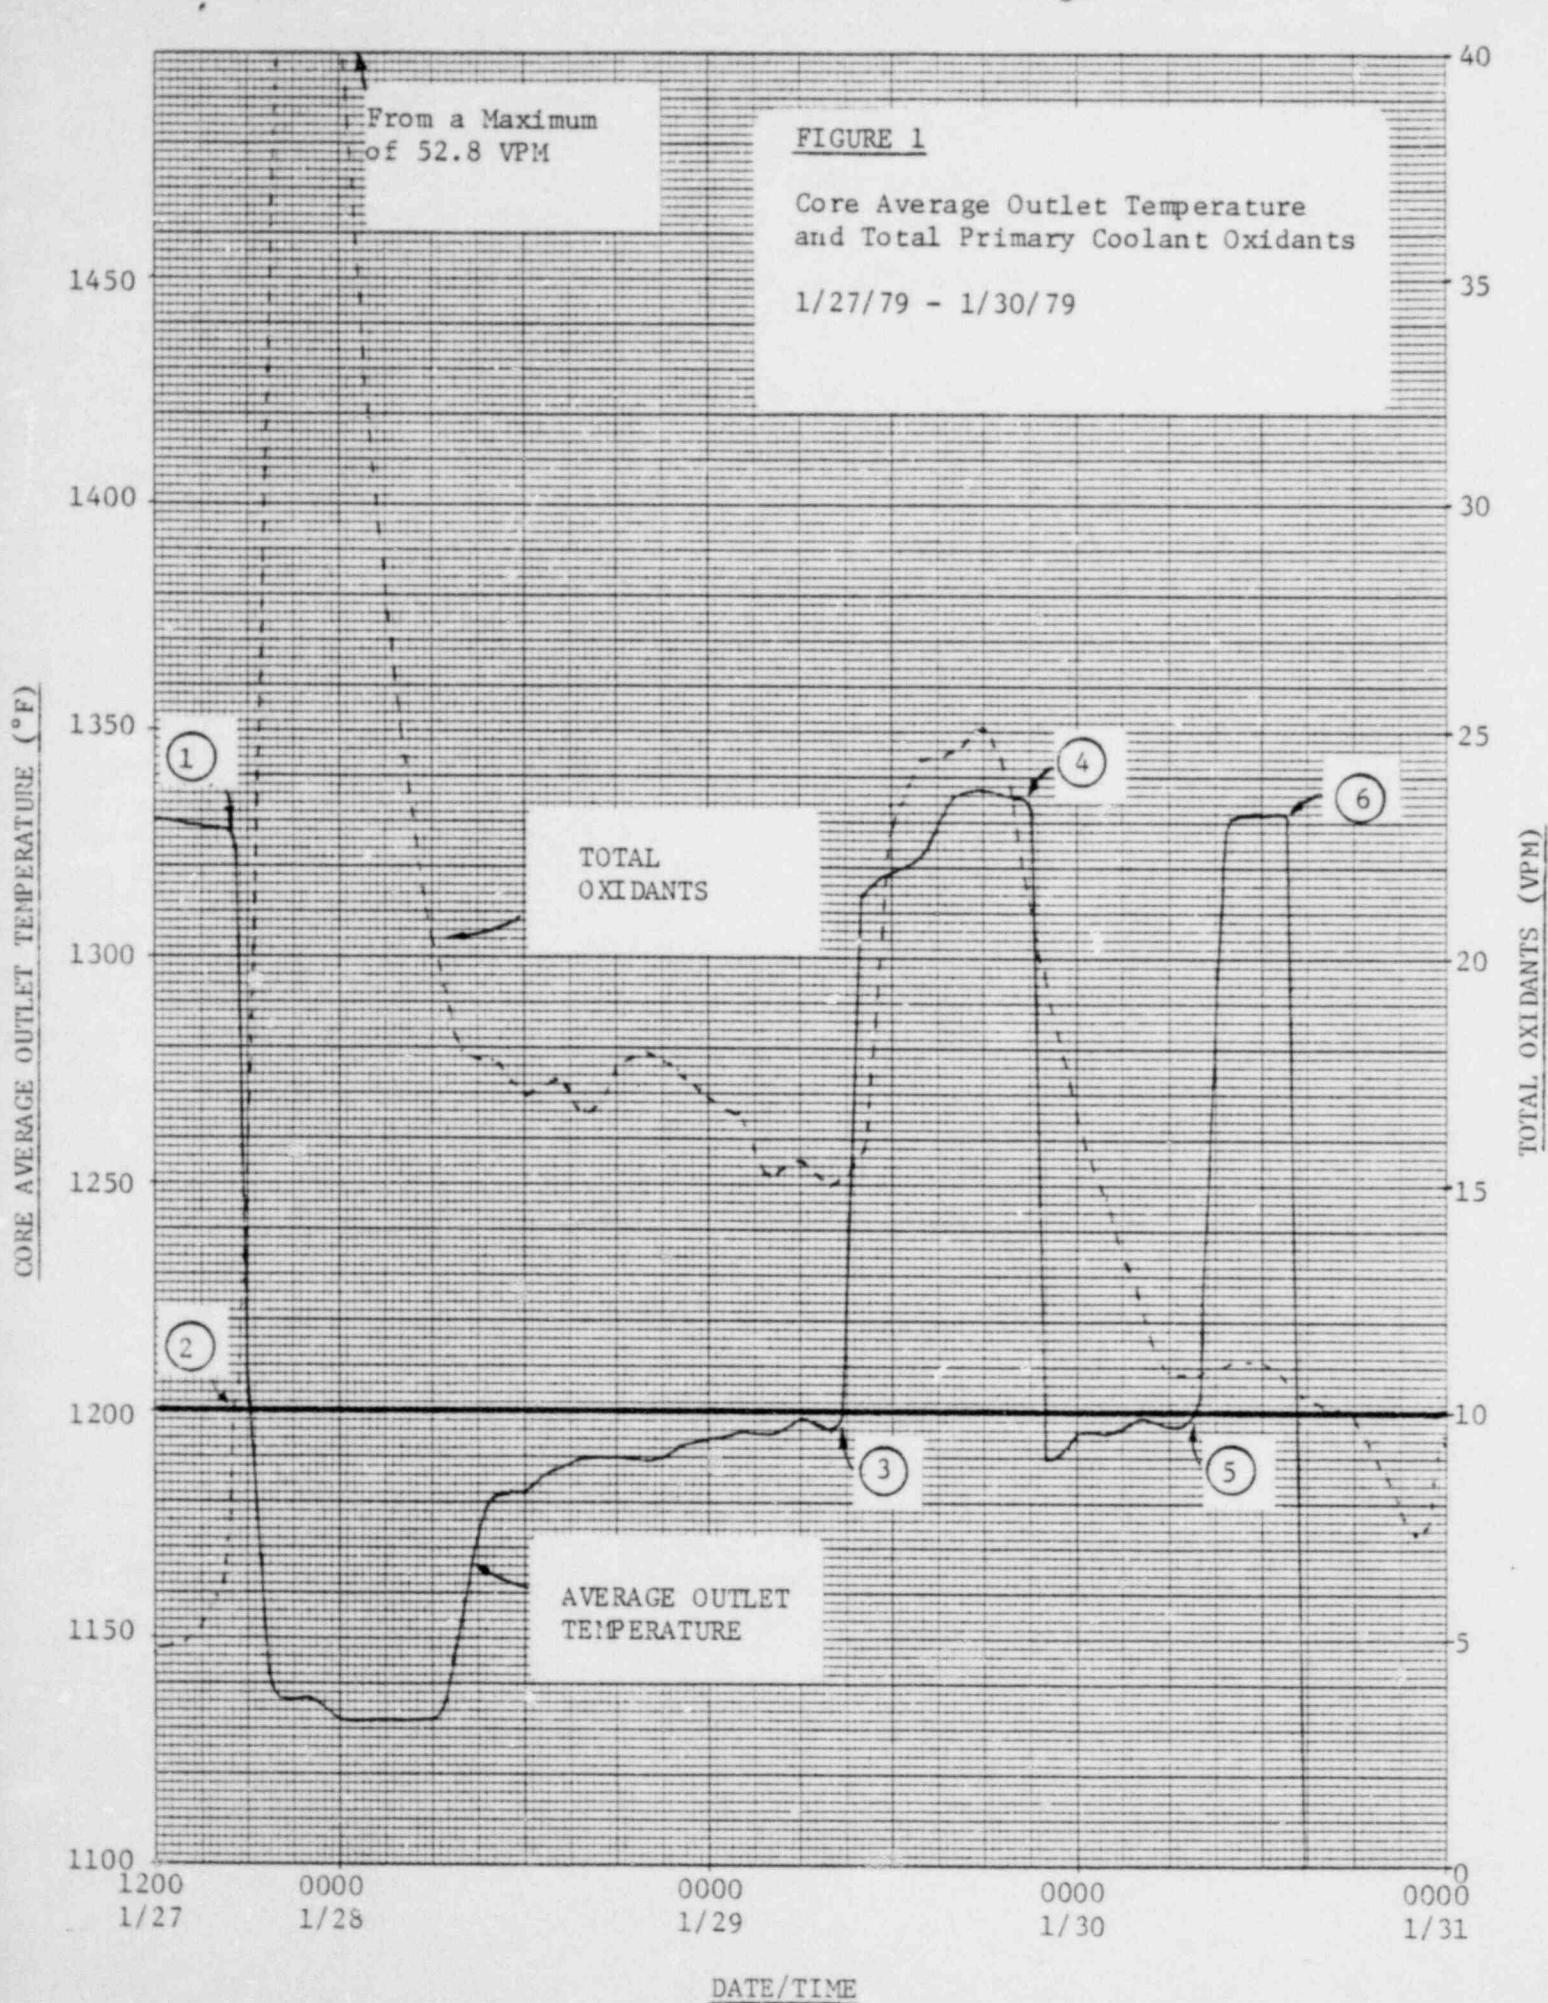
The total oxidant and moisture concentration had decreased to 15.0 vpm and 0.6 vpm, respectively, by 0800 hours on January 29, 1979. Because as much moisture as possible had been removed for the existing plant conditions, reactor power was increased to 60% and the core average outlet temperature again exceeded 1,200°F (Point (3)).

The increase in the primary coolant temperature caused residual moisture to be removed from the core graphite and an increase in the total oxidant concentration to about 25 vpm. Because this concentration persisted, the reactor power was again reduced to 42% at 2040 hours (Point (4)). The core average outlet temperature was again less than $1,200^{\circ}$ F by 2125 hours.

On January 30, 1979, at 0800 hours, reactor power was raised to 60% while the oxidant concentration was at 10.8 vpm and on a downward trend (Point 5). At 1338 hours (Point 6), while performing electrical maintenance, a voltage transient caused a reactor scram. No further degraded mode operations of LCO 4.2.10 or LCO 4.2.11 have occurred to date.
