MIDLAND NUCLEAR PLANT UNIT NO 1, DOCKET NO 50-329 UNIT NO 2, DOCKET NO 50-330 UNIT NO 1, REACTOR VESSEL BROKEN ANCHOR BOLT

MCAR 37 (issued 12/28/79)

Broken Reactor Vessel Anchor Stud in Unit 1

INTERIM REPORT 1

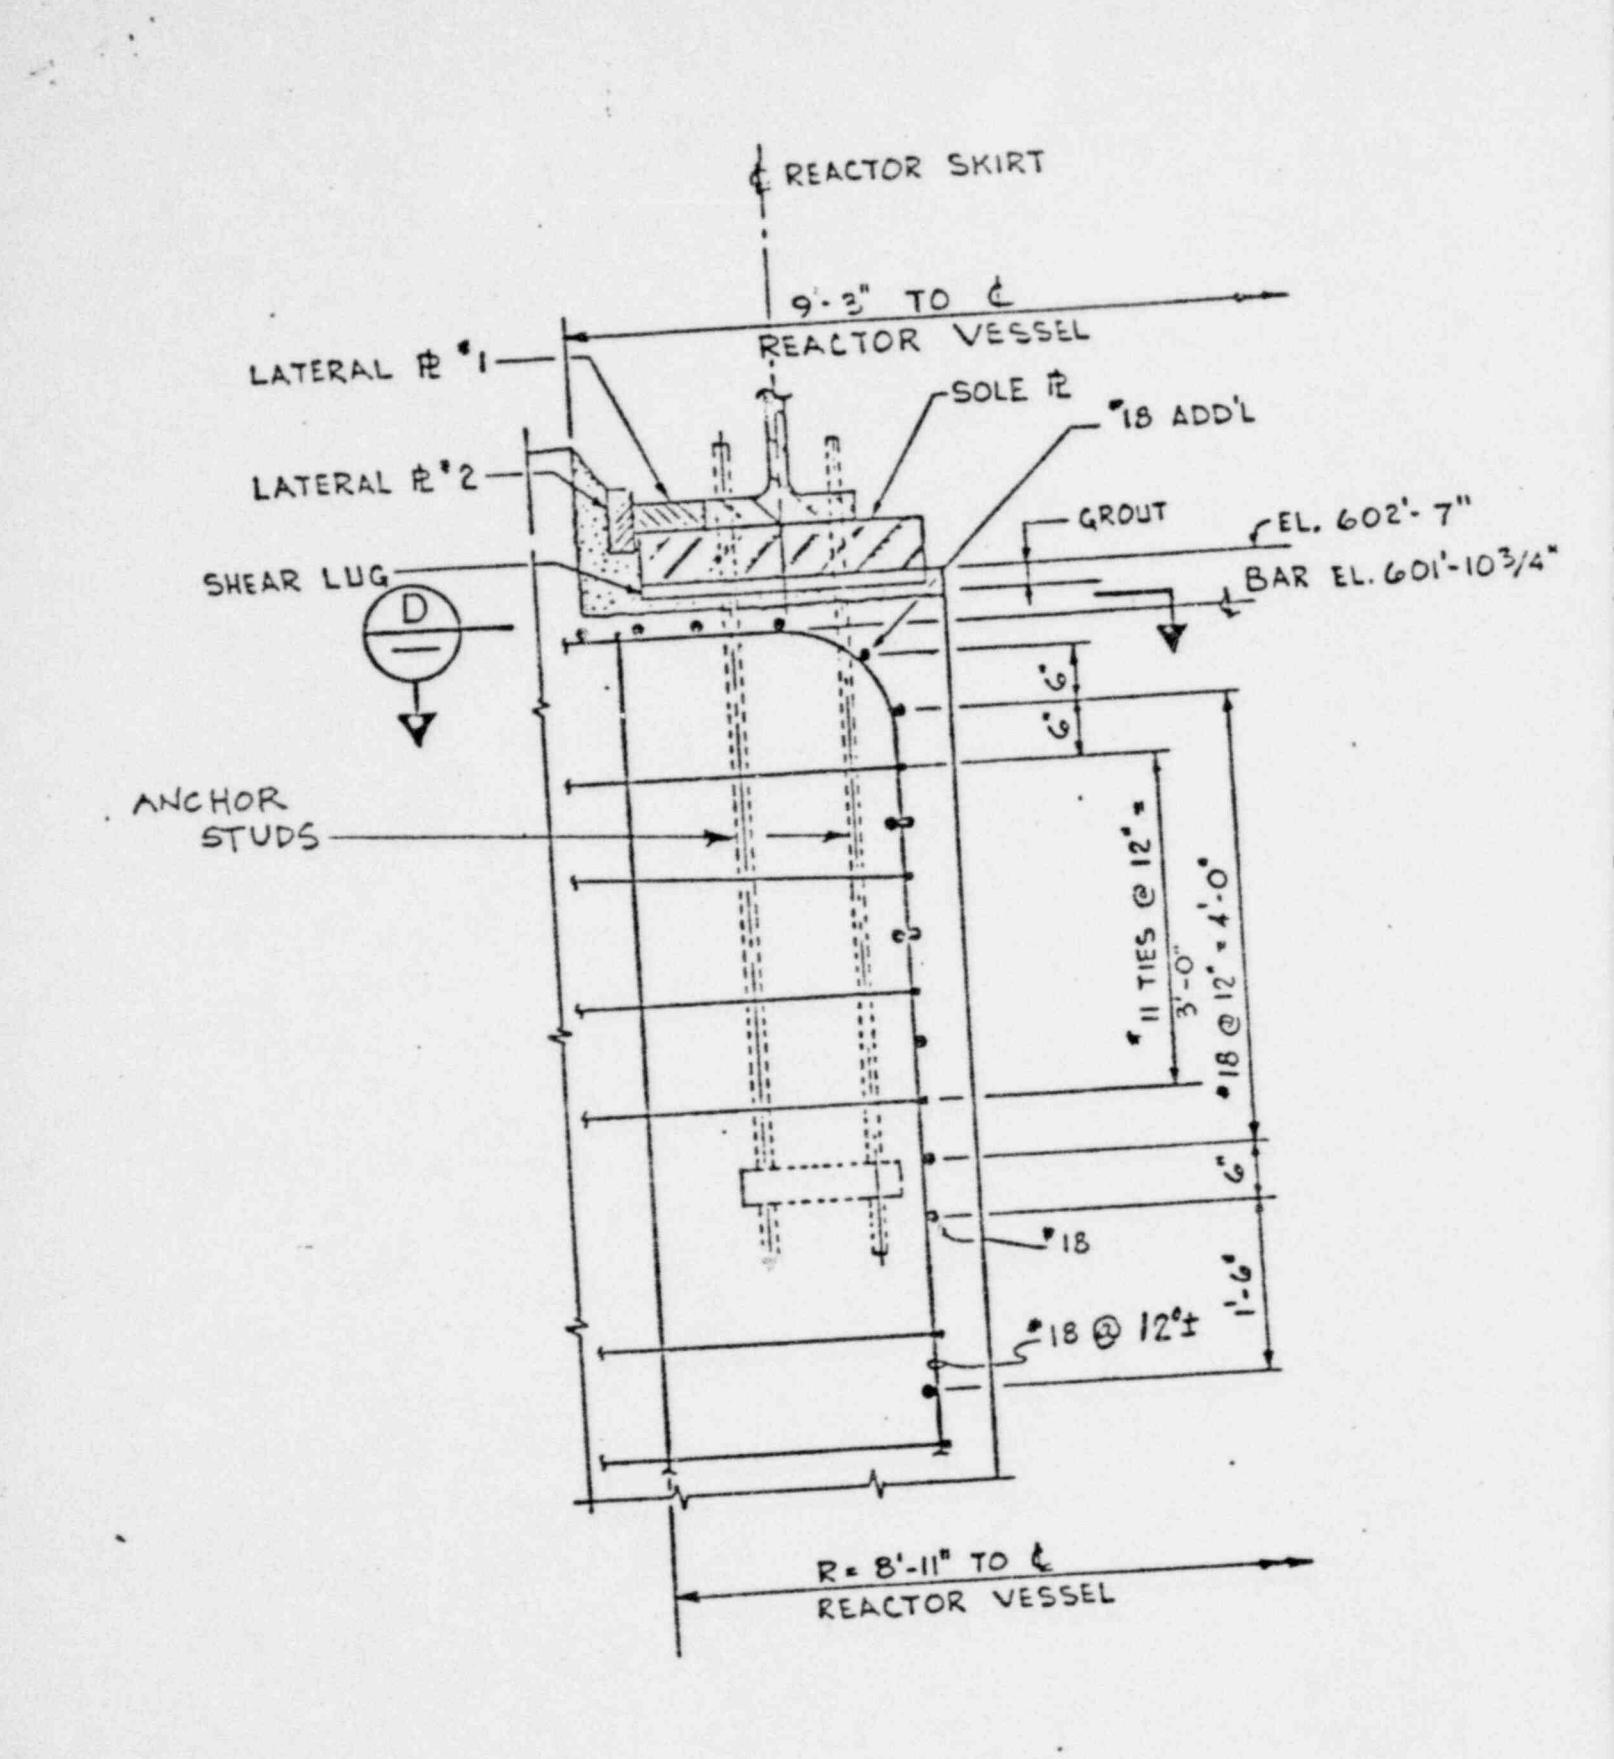
FIG. 1

The anchor study in question are 2-1/2 inches in nominal diameter and 7 feet 4 inches long, embedded vertically in the reinforced concrete reactor vessel pedestal (Figure 1). There is a total of 96 studs per reactor vessel as shown in Figure 2. The study extend approximately 15 inches out of the concrete to bolt the reactor vessel skirt flange to the foundation structure. All the studs were purchased to a modified version of ASTM A 354-66, Grade BD standards by Bechtel. The modification was a waiver of the maximum diameter allowed in the 1966 version for Grade ED bolts. Each stud was preloaded to an initial nominal stress of 75 ksi in the shank region (A = 4.9 square inches except where the shank diameter was reduced to the equivalent effective thread area) before relaxation losses are taken into account. Design calculations indicate that the prestress force should have been computed on the basis of effective tensile area (A = 4.0 square inches). The result was a higher than planned preload (92 ksi versus 75 ksi), but the resultant stresses remained well under the design allowable stress of the material, which is 105 ksi.

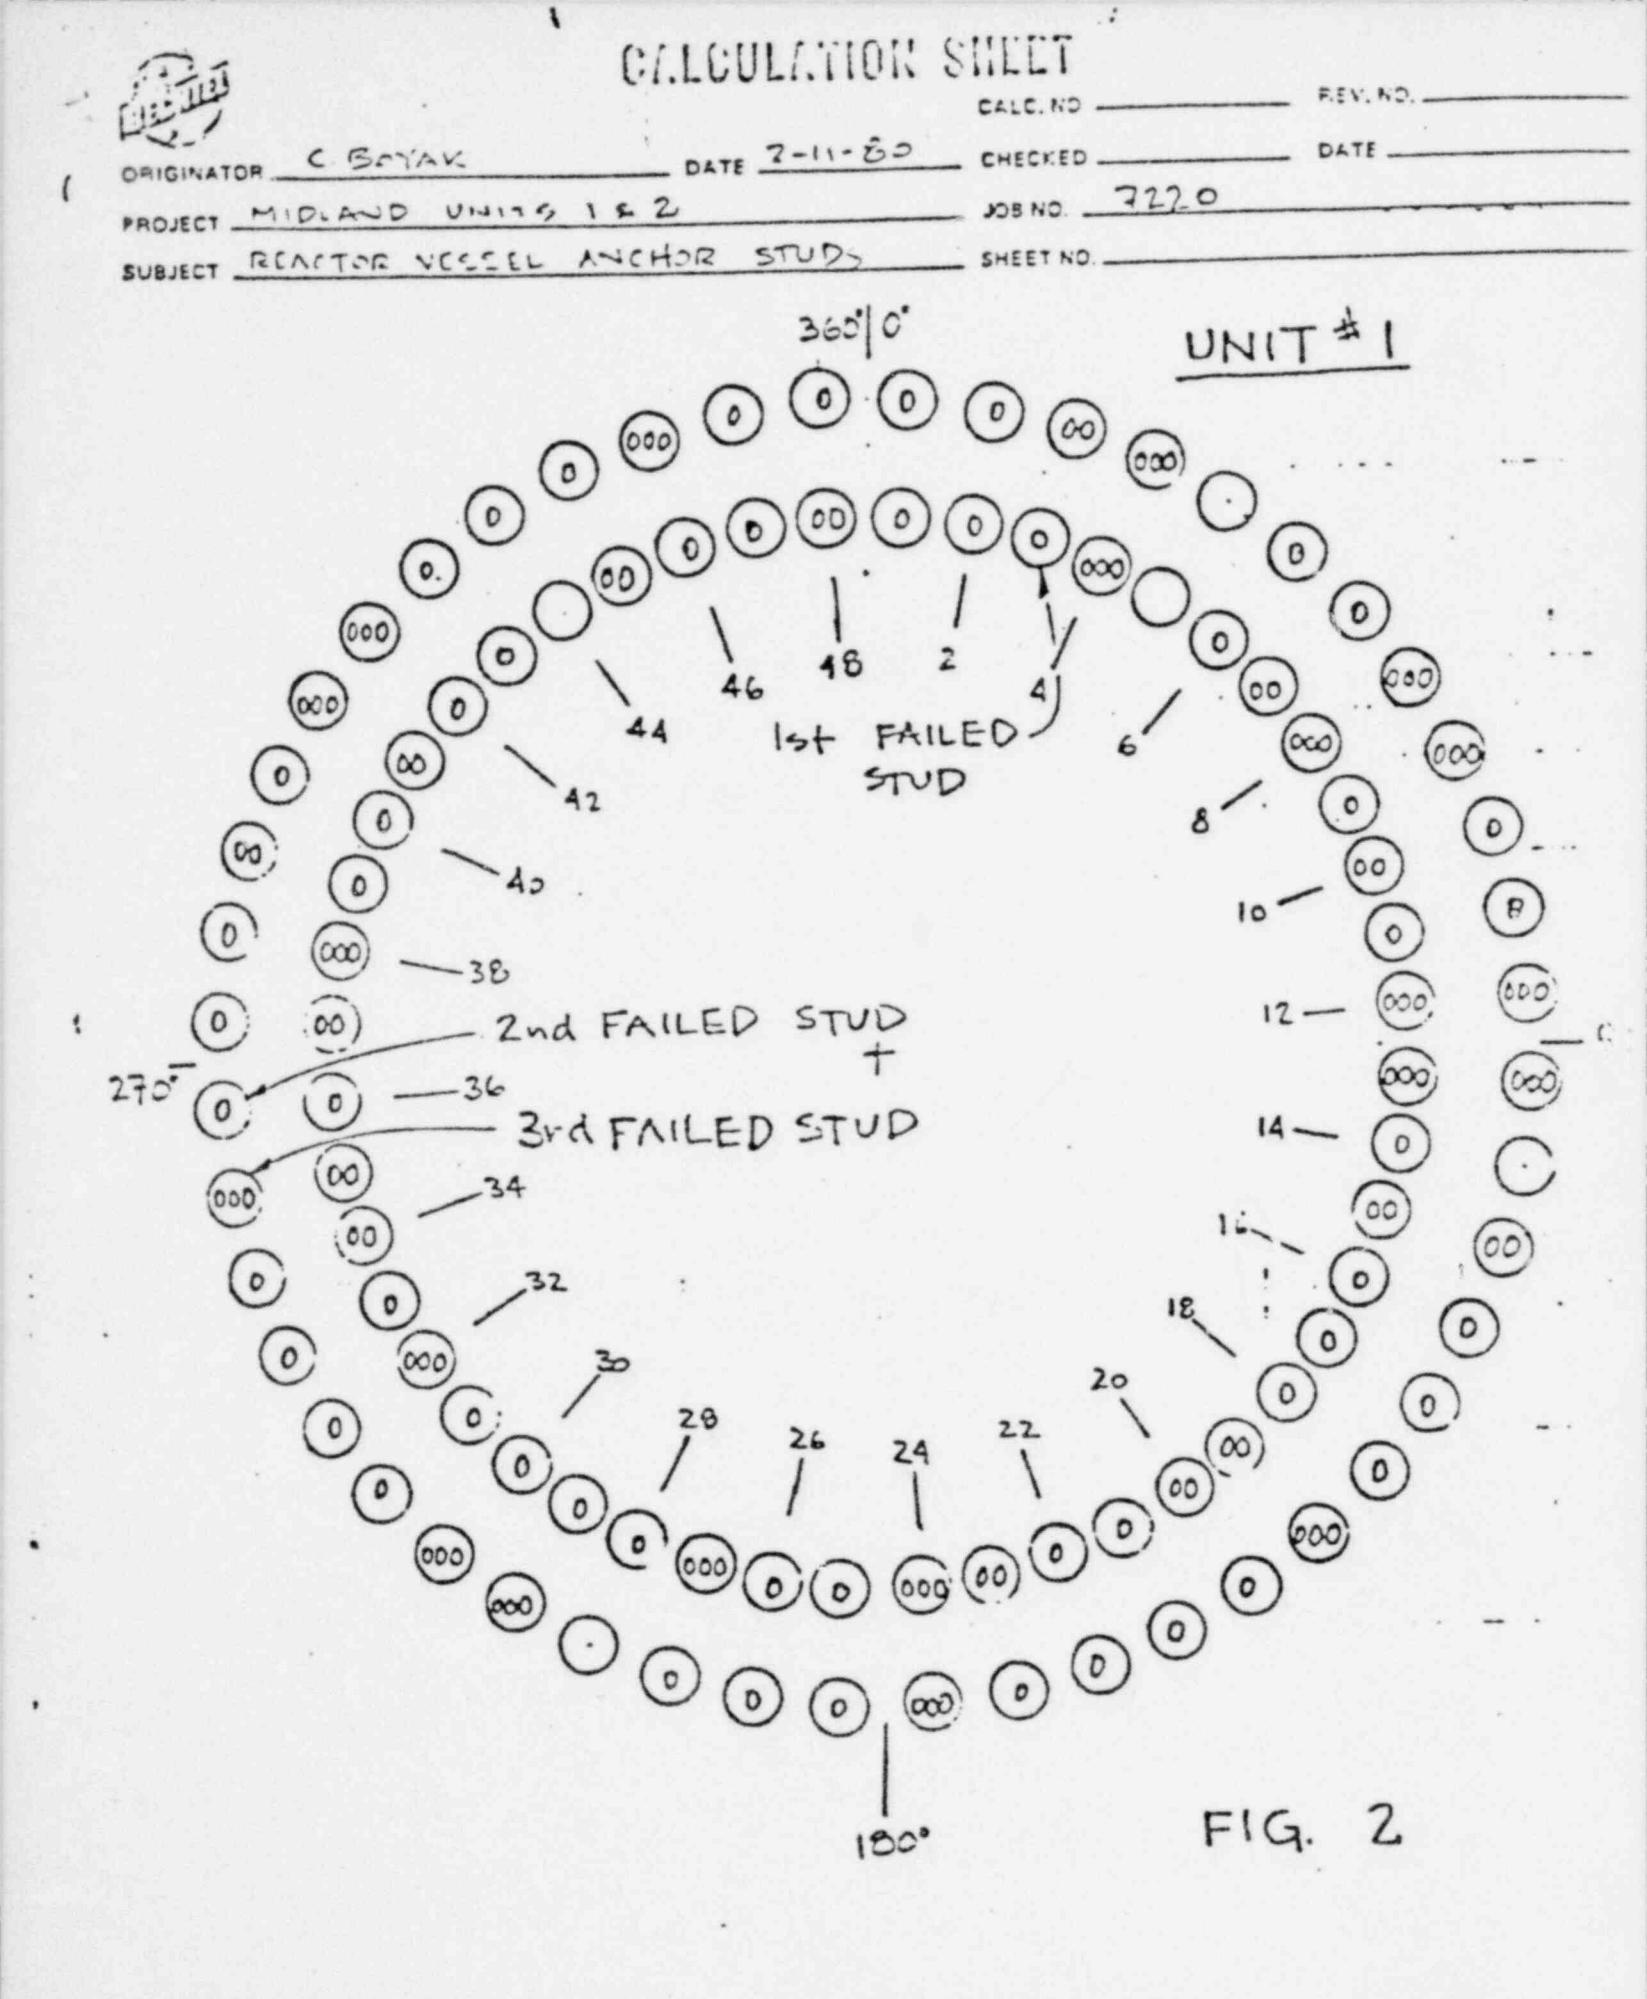
These studs were received on site by Bechtel in early 1976, embedded in April 1977 by Bechtel, and tensioned in late July 1979 by Babcock & Wilcox Construction Company (B&W CC), subcontractor to Bechtel, as part of its responsibility for installation of the nuclear steam supply system. The failure of the first stud was discovered on September 14, 1979. Failure of the second and third studs was reported on December 20, 1979, and February 5, 1980, respectively. The locations of these studs are shown in Figure 2. Based on an ultrasonic test, it is presently believed
