### UNITED STATES NUCLEAR REGULATORY COMMISSION OFFICE OF INSPECTION AND ENFORCEMENT WASHINGTON, D.C. 20555

September 11, 1980

IE Bulletin No. 80-22: AUTOMATION INDUSTRIES, MODEL 200-520-008 SEALED-SOURCE CONNECTORS

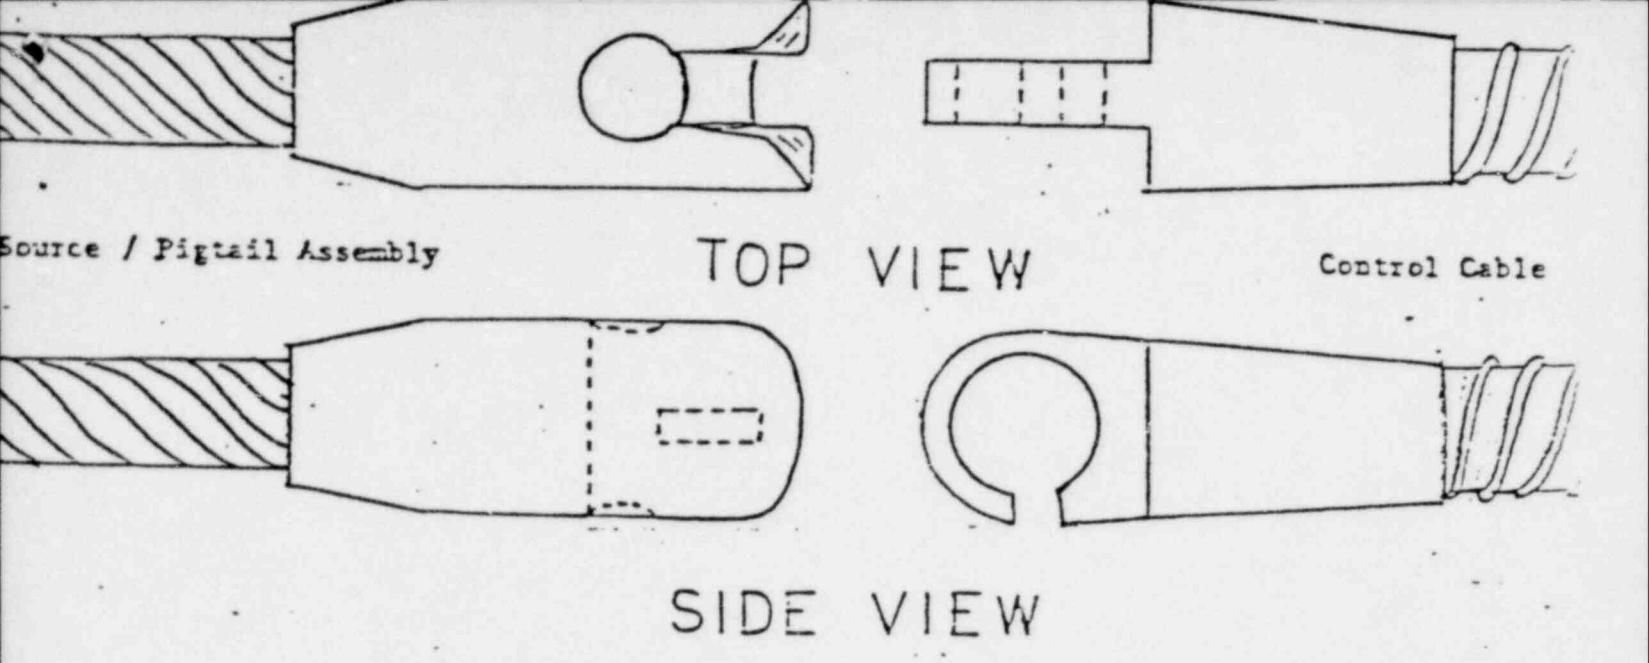
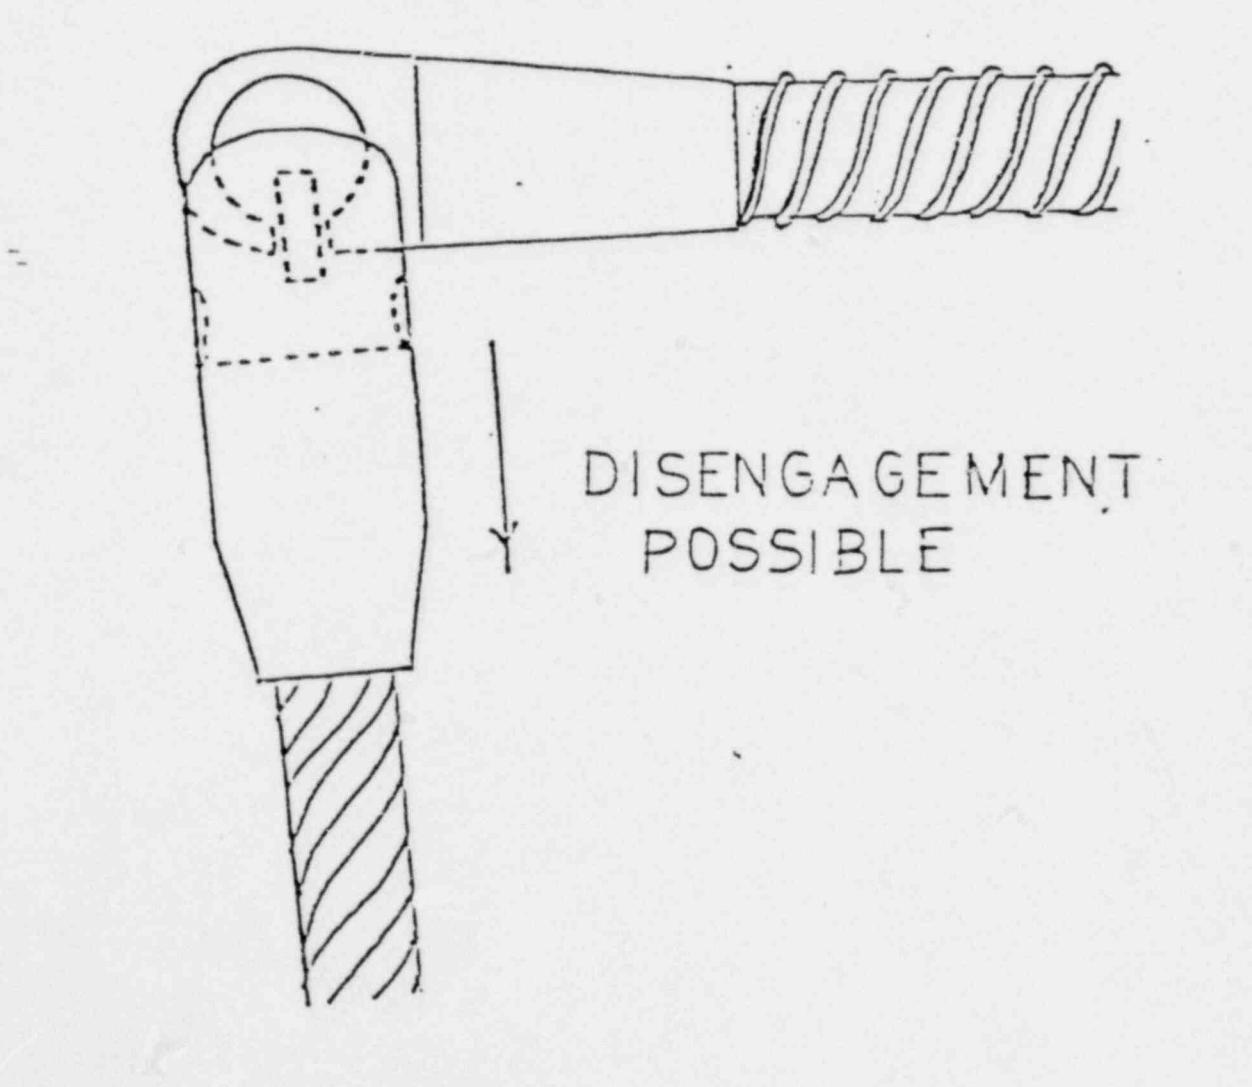
FIGURE 1

An accident recently occurred in the State of California (an Agreement State) that resulted in several serious overexposures (see enclosed Circular 79-16). The accident involved the use of an Automation Industries (AI) Model 200-520-008 source pigtail to drive cable connection. The connector is identified by the manufacturer as its "quick disconnect" type of connector and is used with several models of cobalt-60 and iridium-192 source assemblies distributed by the manufacturer. The connection is a simple hook and eye connection (see Fig. 1) that will permit separation of the eye from the hook when they are oriented at right angles to each other without any further positive action. As a result of the design, a disconnection may occur any time the source assembly is cranked out of the exposure device without the guide tube being attached. Since the Automation Industries Model 200-520-008 sealed-source assembly is authorized to contain up to 120 curies of iridium-192, a source disconnection creates a potential for a serious exposure.

The removal from service of the "quick disconnect" type of connector will require that those drive cables having the matching open hook connector be modified.
