#### UNITED STATES NUCLEAR REGULATORY COMMISSION WASHINGTON, D. C. 20555

Enclosure: Second draft: Human Factors

2.0 HUMAN FACTORS CONSIDERATIONS IN

THE TMI-2 ACCIDENT

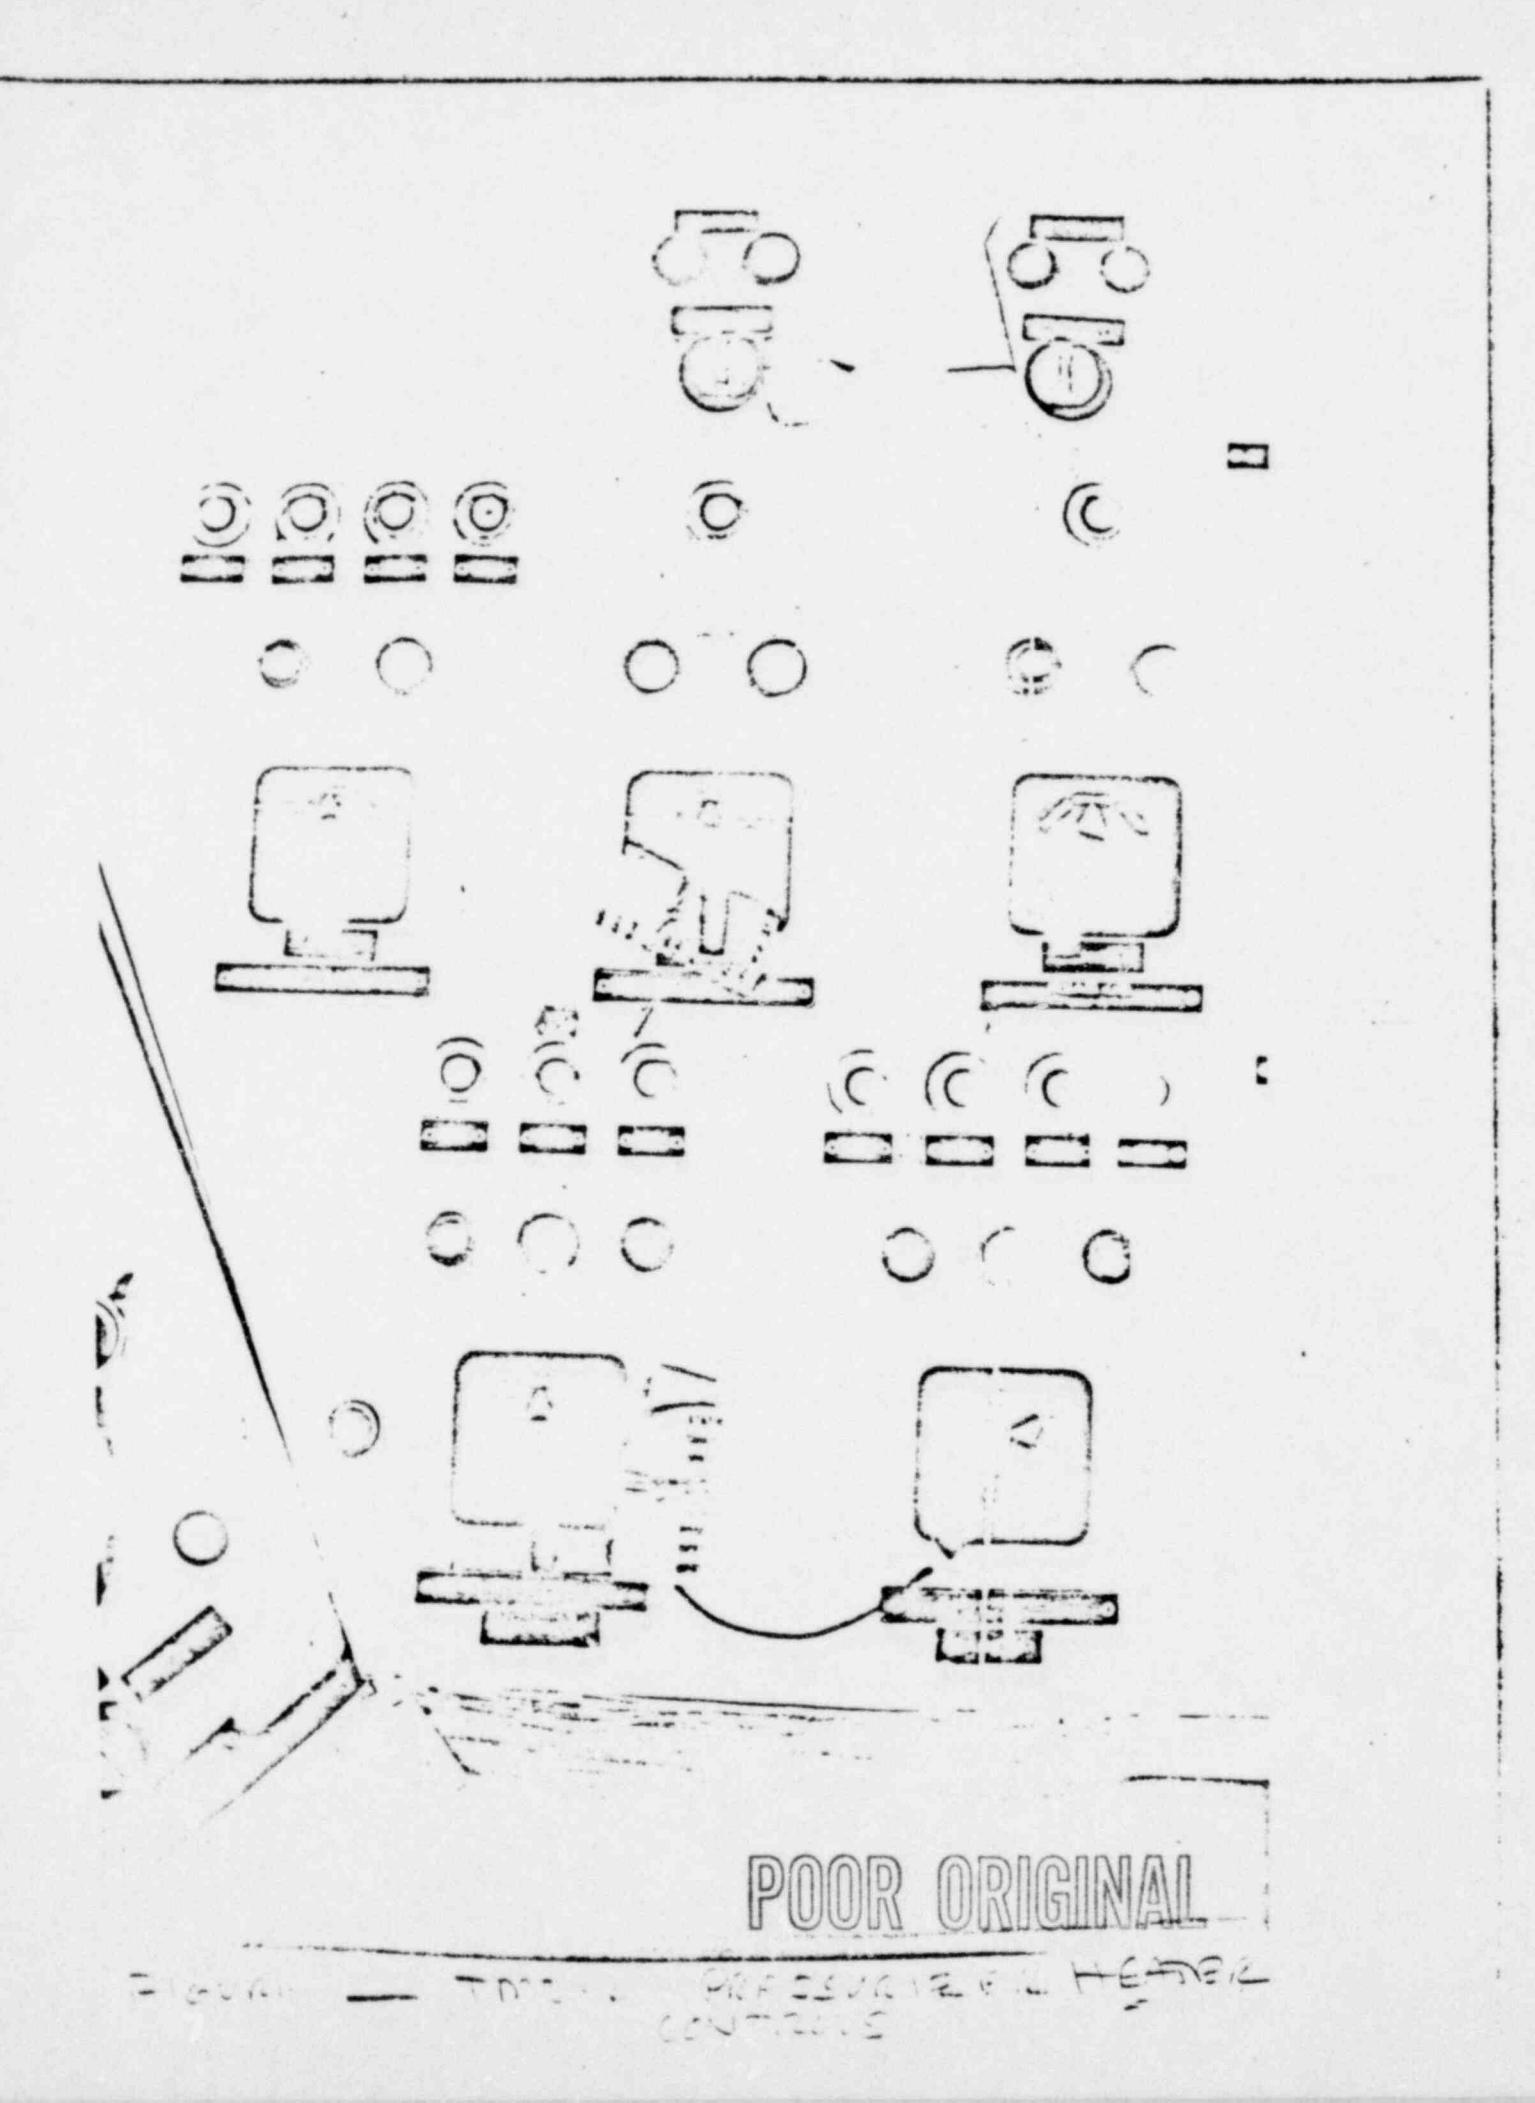
Essex examined the benchboards and the attached vertical panels in TMI-2 for reaching requirements. The levels of excessive reach requirements were defined using the stature of the fifth percentile male (street clothes) as a basis.<sup>1</sup>

They found that 18 chart recorders, 10 control stations (10 switches) and 31 . switches (most with frequent use) required a reach of 10"-14" greater than that of the fifth percentile male standing erect, necessitating him to bend over the panel to actuate the control or switch.
