IE Bulletin No. 80-16

POTENTIAL MISAPPLICATION OF ROSEMOUNT INC. MODELS 1151 AND 1152 PRESSURE TRANSMITTERS WITH EITHER "A" OR "D" OUTPUT CODES

IE Circular No. 80-16

OPERATIONAL DEFICIENCIES IN ROSEMOUNT MODEL 510DU TRIP UNITS AND MODEL 1152 PRESSURE TRANSMITTERS

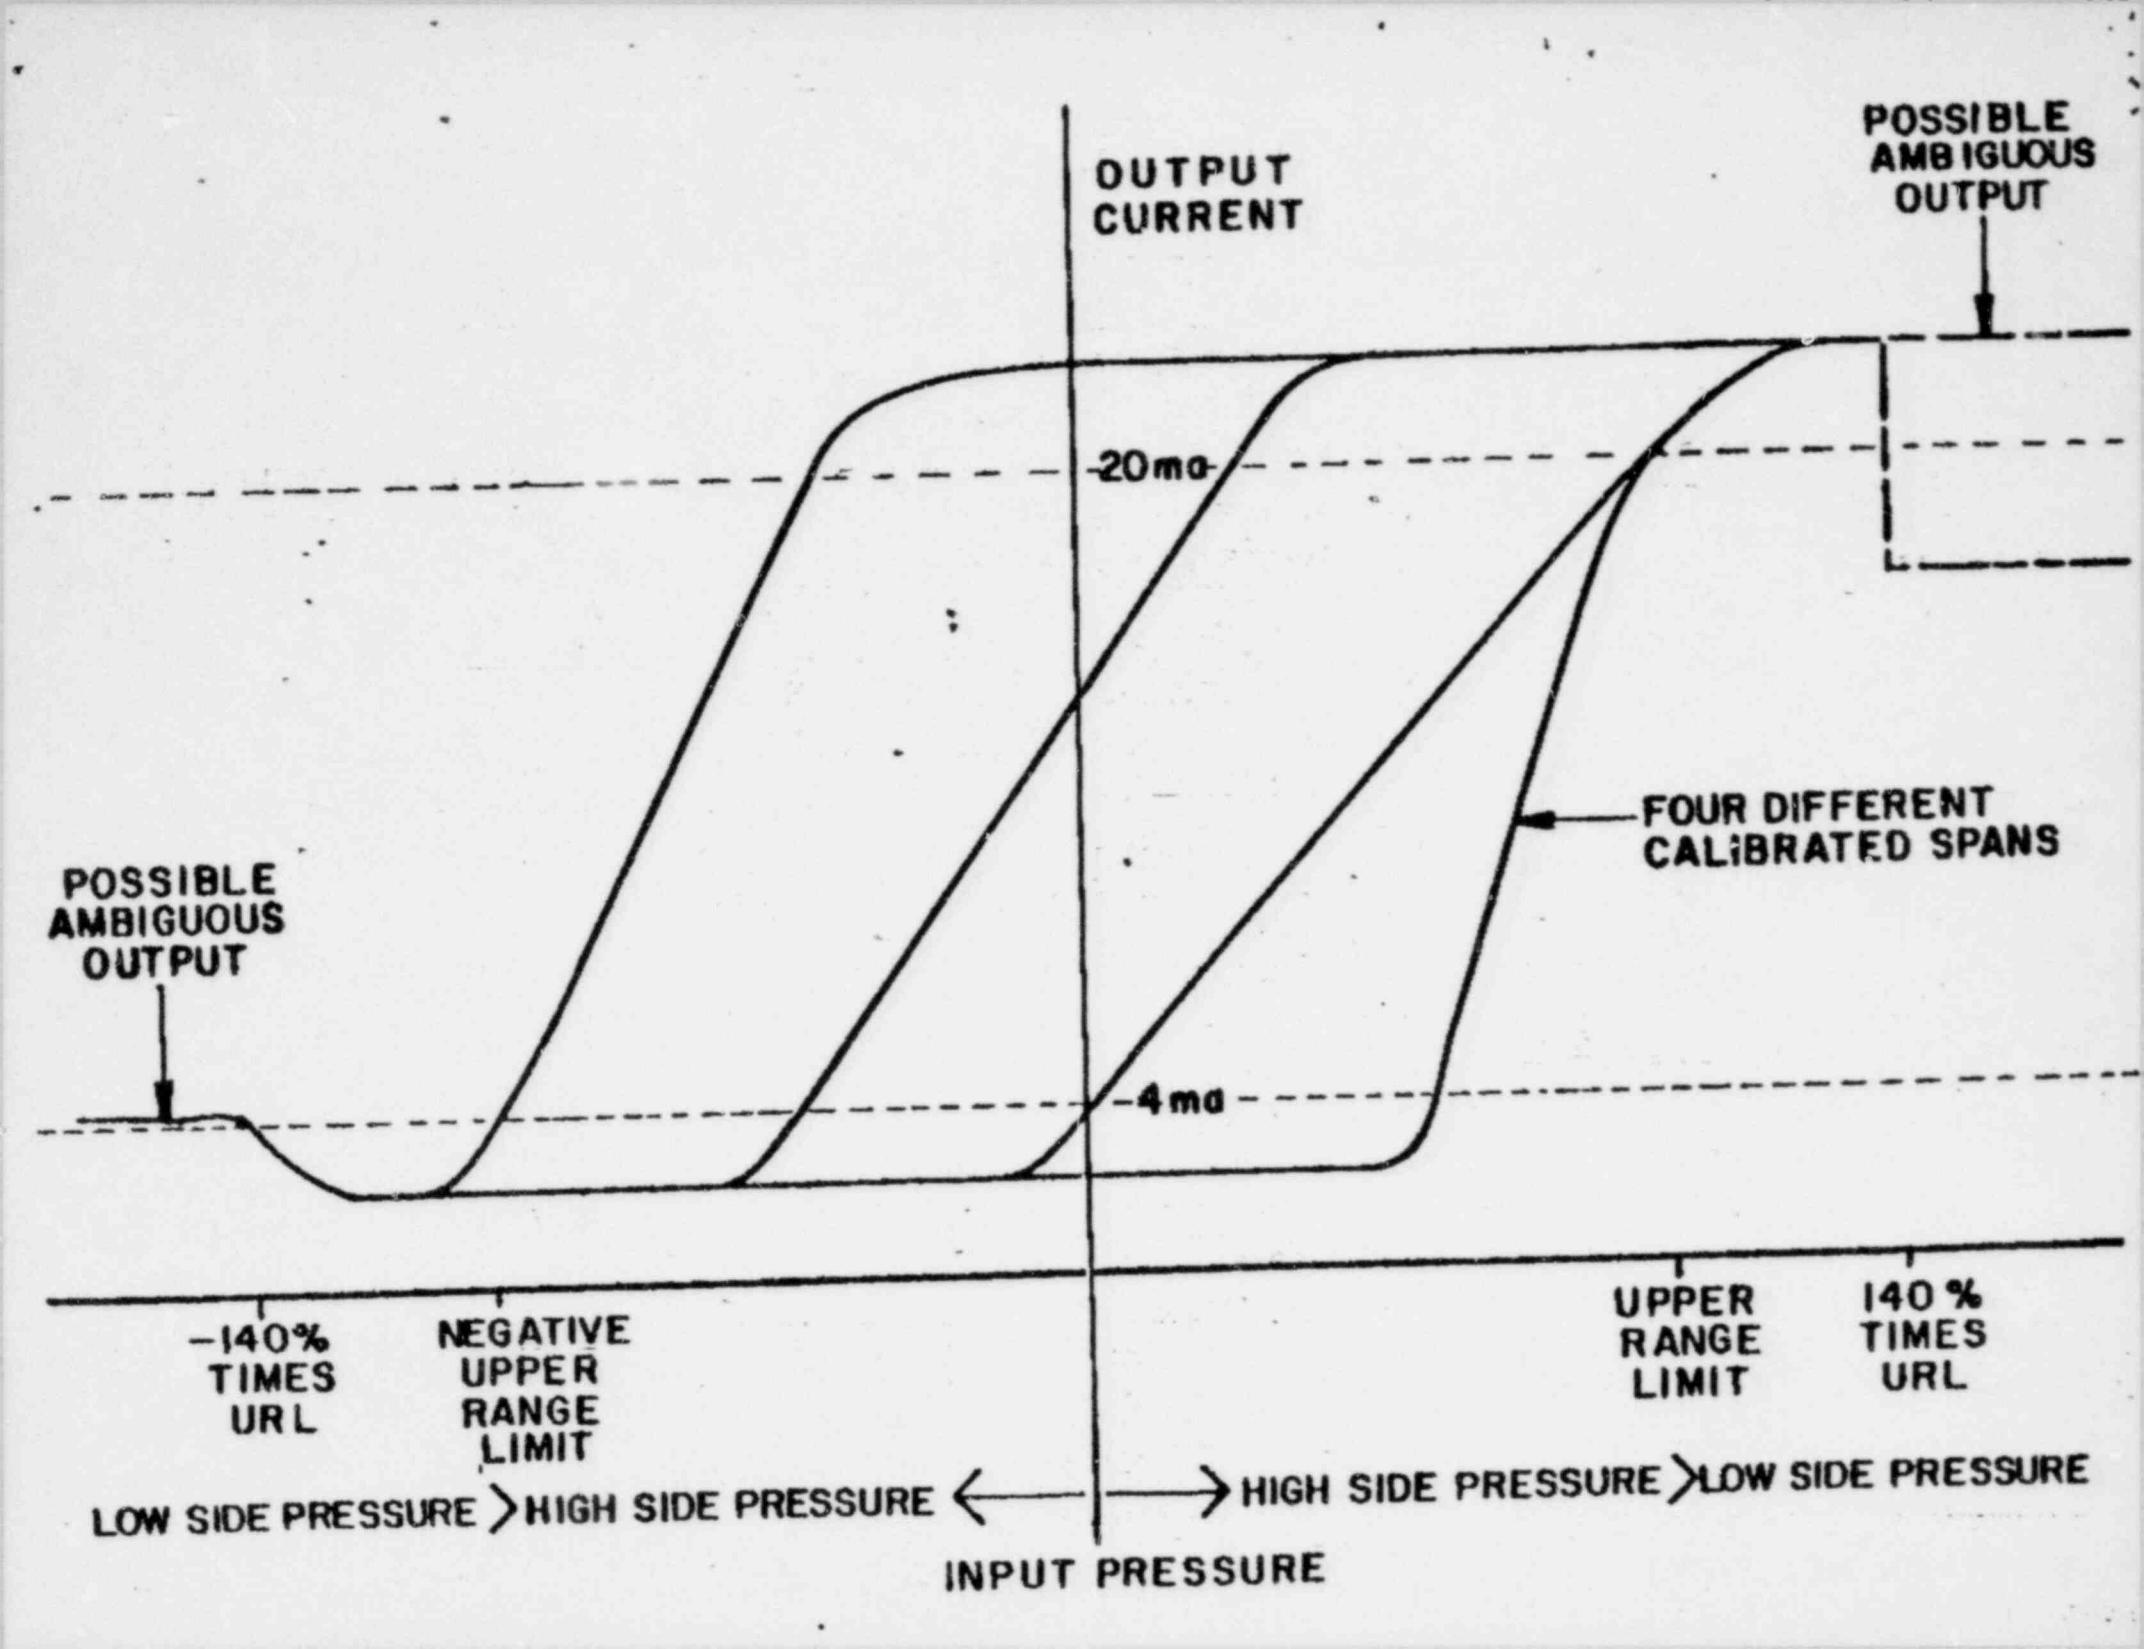
Attachment:

Enclosure 1 contains Rosemount Inc.'s technical description of the potential application problems for Pressure Transmitters Model 1152. This information is applicable to Model 1151 Pressure Transmitters also. This information includes the reasons for the maloperation of the transmitters, a typical pressure versus current output curve and examples of the results of the maloperations. Available information indicates that the problem was reported to each customer who was furnished the subject transmitters by Rosemount Inc.

For the over pressure condition, the effect of the high capacitance from the sensor is a modulated output on the oscillator circuit which may cause the output current of the transmitter to drop below 20 mA. In a limited sample size, the ambiguous output during this over pressure condition occurred in 5% of the transmitters at ambient conditions. Referring to the attached graph, this does not occur until the over pressure condition is 2 140% of the upper range limit regardless of span. At that point a discontinuity can occur with the output current instantaneously decreasing to less than 20 mA. As an example of this potential applications problem, the upper range limit of a range 5 1152 differential pressure transmitter (Model 1152DP5A22) is 750"H_O. The range of this pressure transmitter can be set from 0 to 150"H_0. If the ambiguous output in the over pressure condition is to occur, it will occur at 140% or more of the upper range limit or, in this case, at pressures ≥ 1050"H_0 (750"H_0 x 1.4). The transmitter than could give an output less than 20 mA at a pressure that is, in this example, seven

times (1050"H₂O + 150"H₂O) the upper range value. Note that the significant figure for use in determining the pressure above which an ambiguous output can occur is the specified upper range <u>limit</u> (750" H₂O in this example) not the customer selected upper range <u>value</u> (150"H₂O in this example).

For the reverse pressure condition, the effect of the high capacitance from the sensor is the oscillator circuit drawing more current which may cause the output current of the transmitter to exceed 4 mA. In a limited sample size, the ambiguous output during this reverse pressure condition occurred in 55% of the transmitters at ambient conditions. Referring to the attached graph, this does not occur until the reverse pressure condition exceeds 140% of the upper range limit regardless of the span. At this point the output may exceed 4 mA. As an example of this potential applications problem consider the range 5 differential transmitter in the previous paragraph. If the ambiguous output in the reverse pressure condition is to occur, it will occur at 140% or more of the upper range limit, or in this case at reversed pressures 2 1050" H.O (750"H.O x 1.4). The transmitter then could give an output greater than 4 mA at a pressure that is, in this example, seven times (1050" H_O + 150" H_O) the upper range value, but reversed. Also note that with absolute pressure units a reverse pressure is not possible since the low pressure side of the cell is evacuated. With gage units a reverse pressure is possible only if a vacuum is present on the connected part since the low pressure side of the cell is vented to ambient atmosphere. Since the maximum reverse pressure would be one atmosphere, only range 3 and 4 gage units could obtain a reverse pressure exceeding 140% of the upper range limit.

The safety system should be analyzed in view of this supplementary report to determine if a potential application problem exists and appropriate corrections to the safety system should be implemented.
