Report on CRDCS Breaker Cabinet Seismic Qualification

This report, pursuant to 10 CFR 50.53(e) on Significant Deficiencies, is to document the investigation of the significant deficiency in the seismic qualification on the Control Rod Drive Control System Trip Breaker Cabinets.

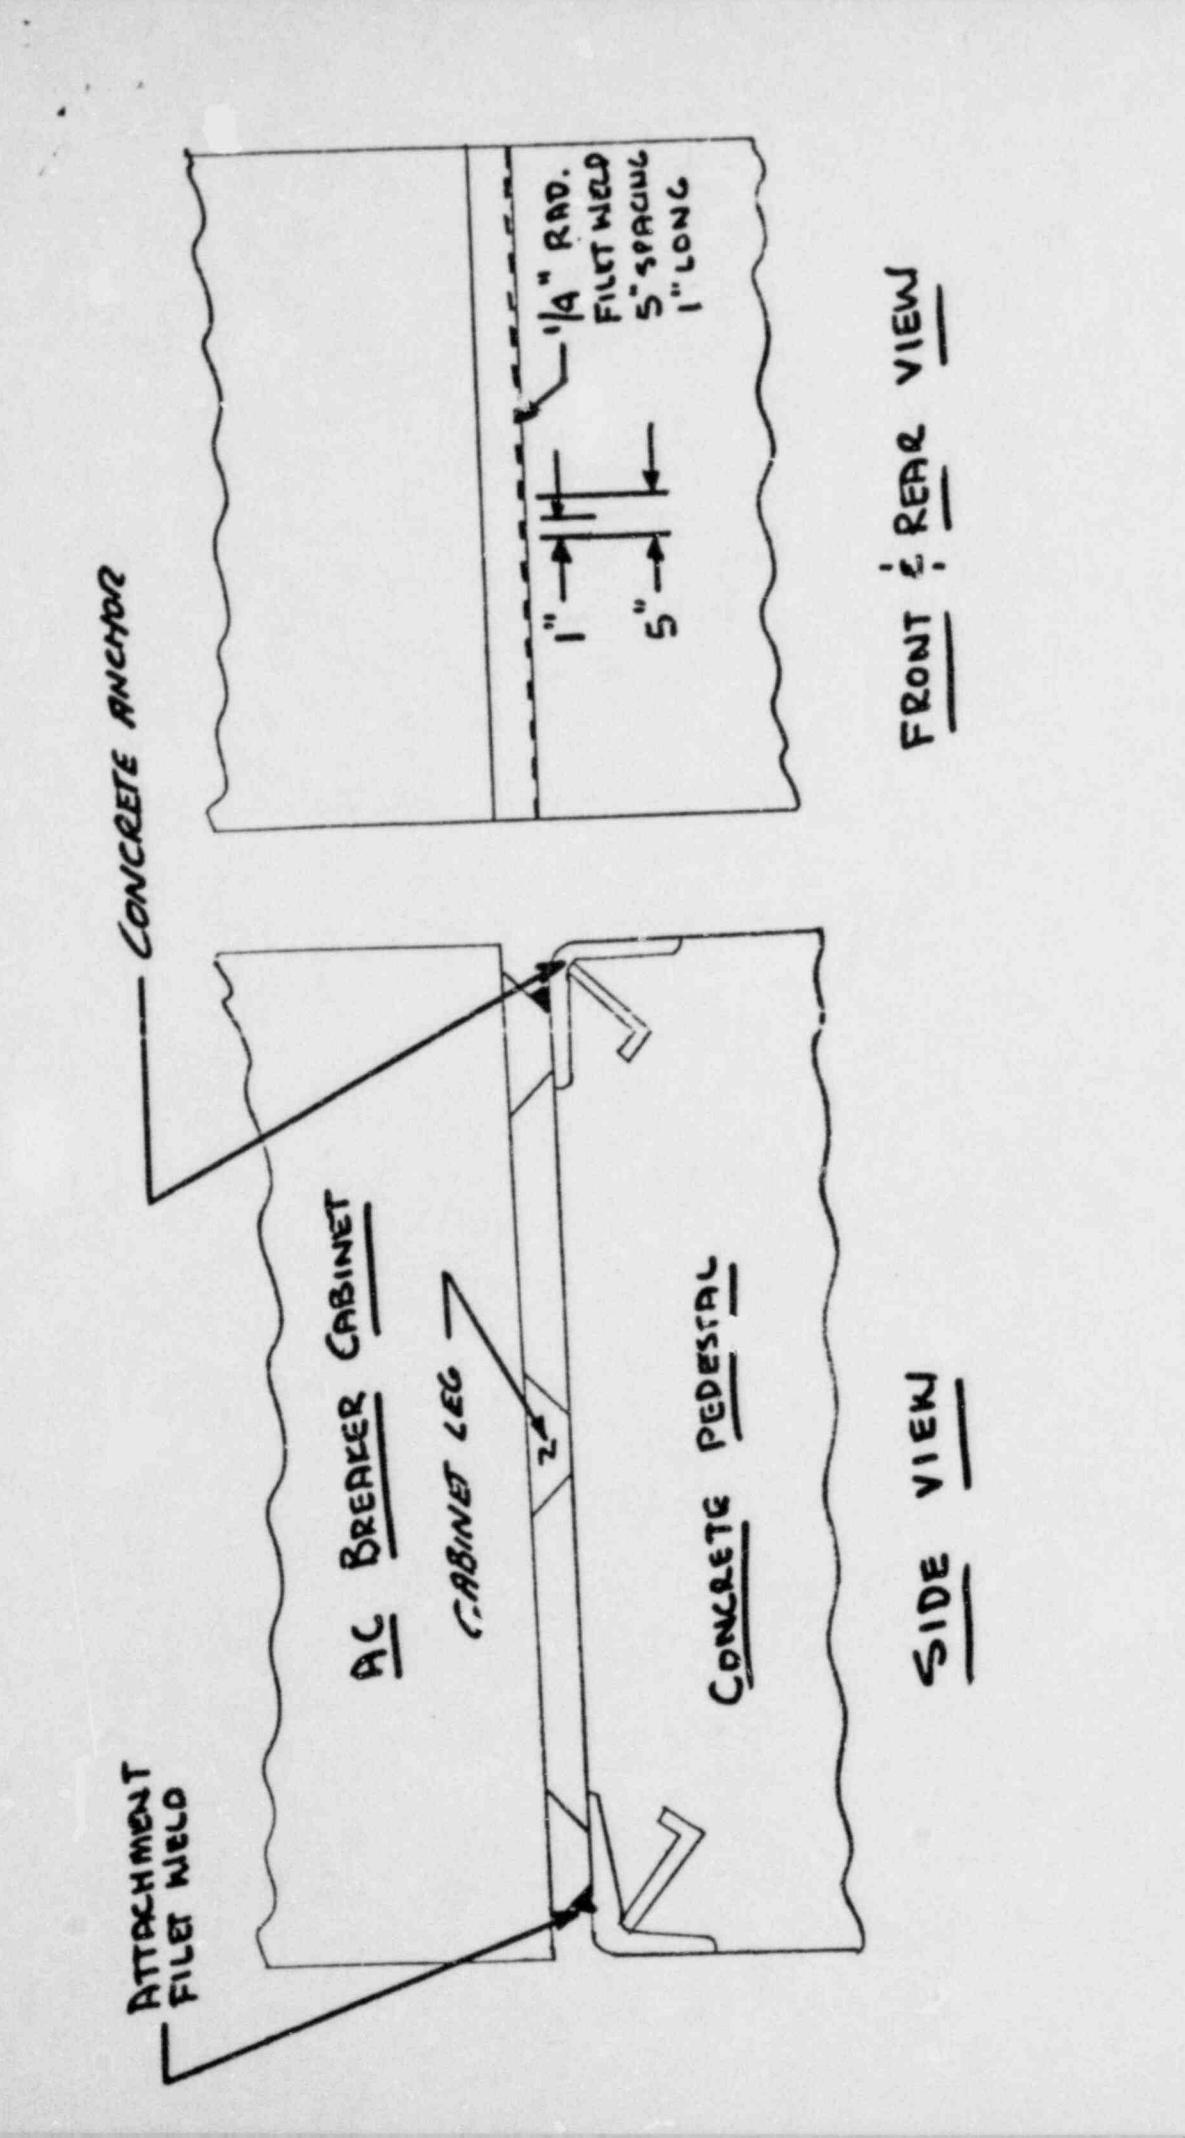
AC BREAKER CABINET ATTACHMENT MODIFICATION

A reevaluation of the seismic qualification of the control rod drive control system AC breaker cabinets has found that the recommended attachment of the cabinet to the floor is inadequate to withstand the SSE acceleration levels.

In the event of an SSE, the AC Breaker Cabinets could, as per the finite element stress analysis, break loose from the floor mounting. With the cabinets unattached, the rand- motion or even falling over could cause accelerations of the breakers that have not been analyzed or damage to the breakers, wiring, or connections which could compromise the ability of the breakers to trip the control rods. Analyses cannot show that the failure will always be fail safe. Therefore, the deficiency in the design of the structural attachment of the AC Breakers Cabinets to the floor could adversely affect safety. This problem is thus considered to be a Significant Deficiency as per 10 CFR 50.55 (e).

The attachment of the AC Breaker Cabinet to the floor has been redesigned (see attached figure). Depending upon the arrangement at the particular site, eith r additional bolts will be included or a series fillet welds will be added to inc. ase the attachment strength. Each plant with a construction permit or operating license is being evaluated on an individual basis. Newer plants are employing cabinet holddown designs which will assure the ability to withstand SSE loadings.
