Subject: Waterford SES Unit No. 3 Docket No. 50-382 Final Report of Significant Construction Deficiency No. 15 "Procedural and Performance Deficiencies in Ultrasonic Testing of Structural Welds Performed by Industrial Engineering Works"

WATERFORD SES UNIT NO. 3

Final Report of Significant Construction Deficiency No. 15 Procedural and Performance Deficiencies in Ultrasonic Testing of Structural Welds Performed By Industrial Engineering Works

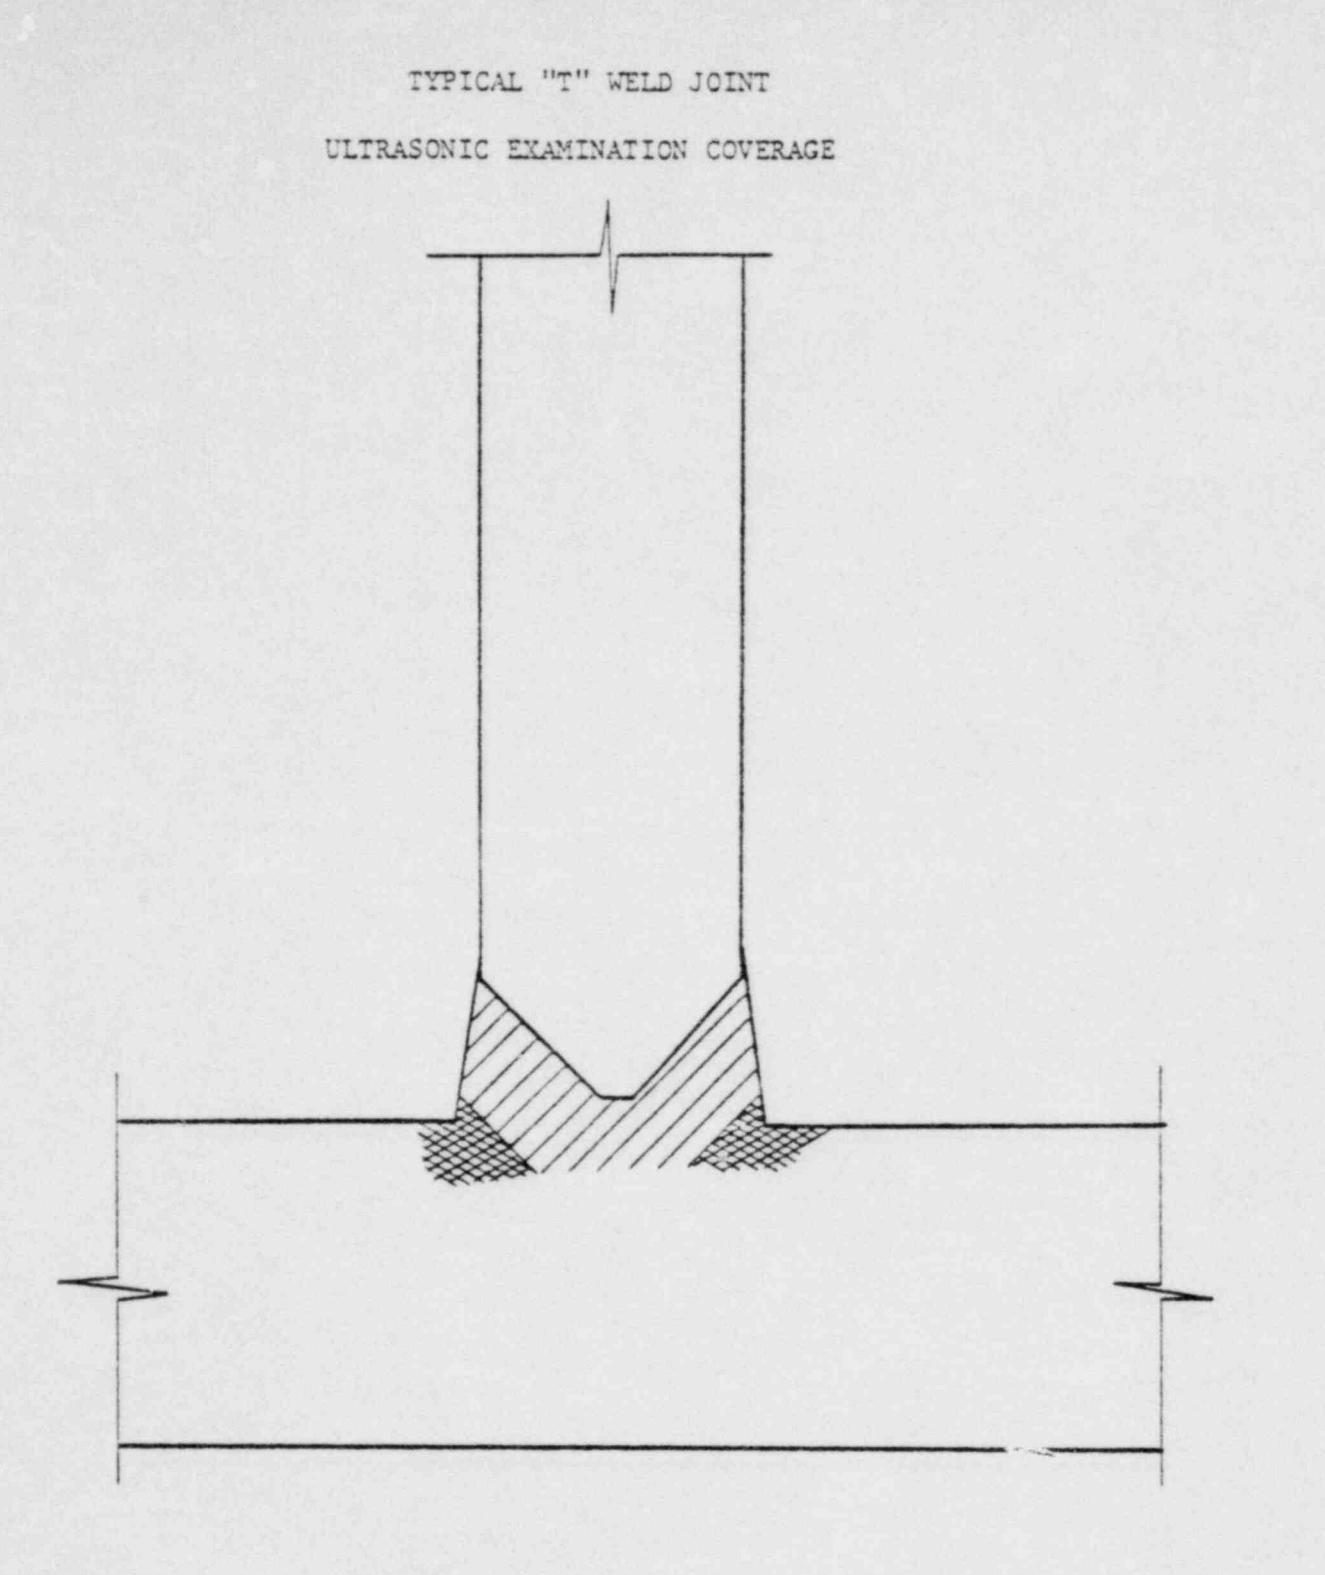
The IEW examination was performed in one direction only using a single search unit from the web surface(s) only. This resulted in not achieving 100% volumetric coverage. The attached sketch of a typical "T" weld representing the worst condition illustrates the area where the beam did not pass through the veld in two directions. The portion of the weld that did not receive complete examination was approximately 20%.

Weld & HAZ Examined with Ultrasonic Beam Passing through in two directions

Weld & HAZ Examined with Ultrasonic Beam Passing through in one direction
