MIDLAND NUCLEAR PLANT UNIT NO 1, DOCKET 40 50-329 UNIT NO 2, DOCKET NO 50-330 HELBA RESTRAINT DESIGN FILE: 0.4.9.41 UFI: 73*10*01 SERIAL: 8830

High-Energy Line Break Analysis (HELBA), Pipe Whip Restraint Designs

INTERIM REPORT 1

PROJECT: Consumers Power Company Midland Plant Units 1 and 2 Bechtel Job 7220

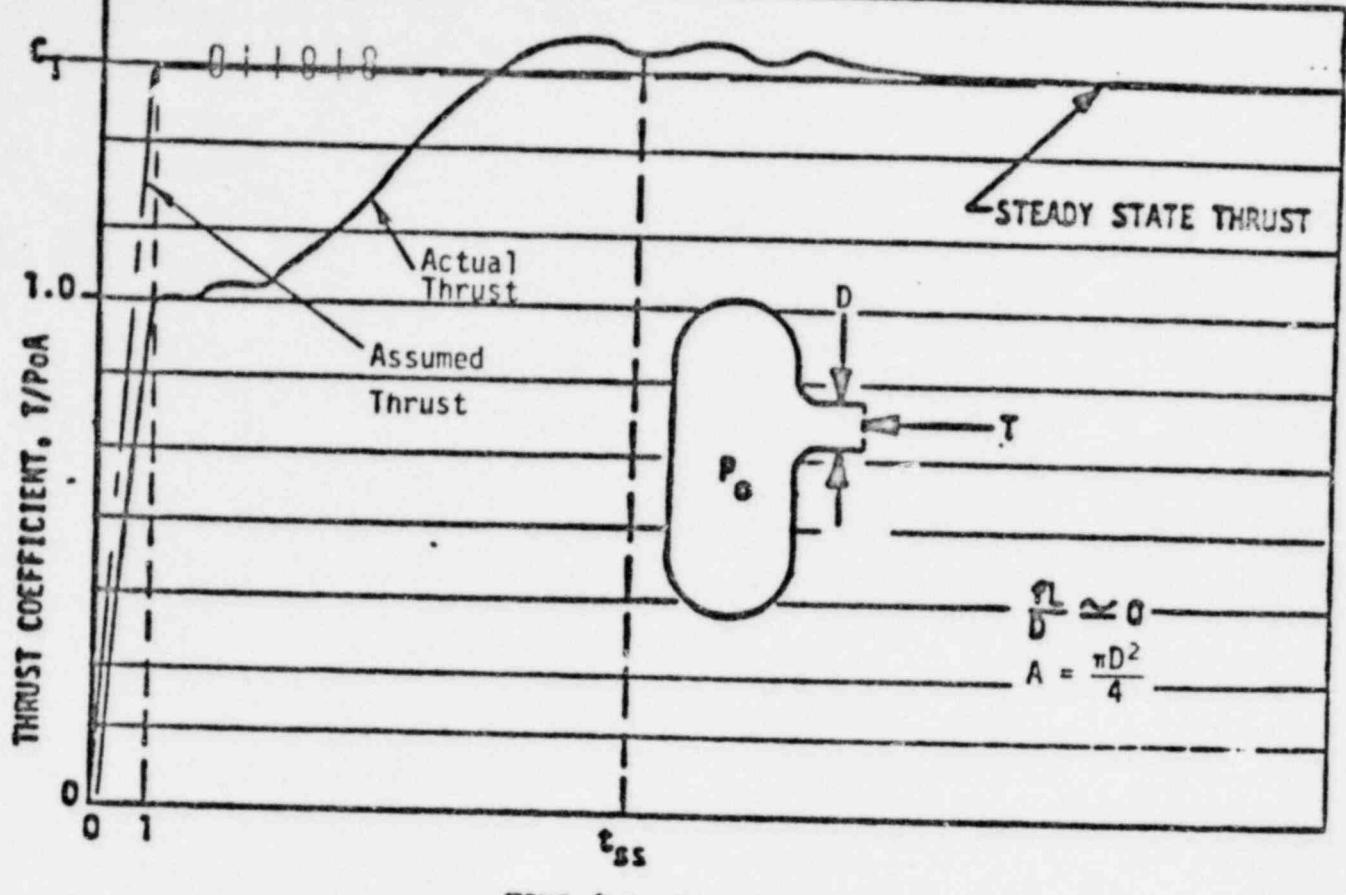
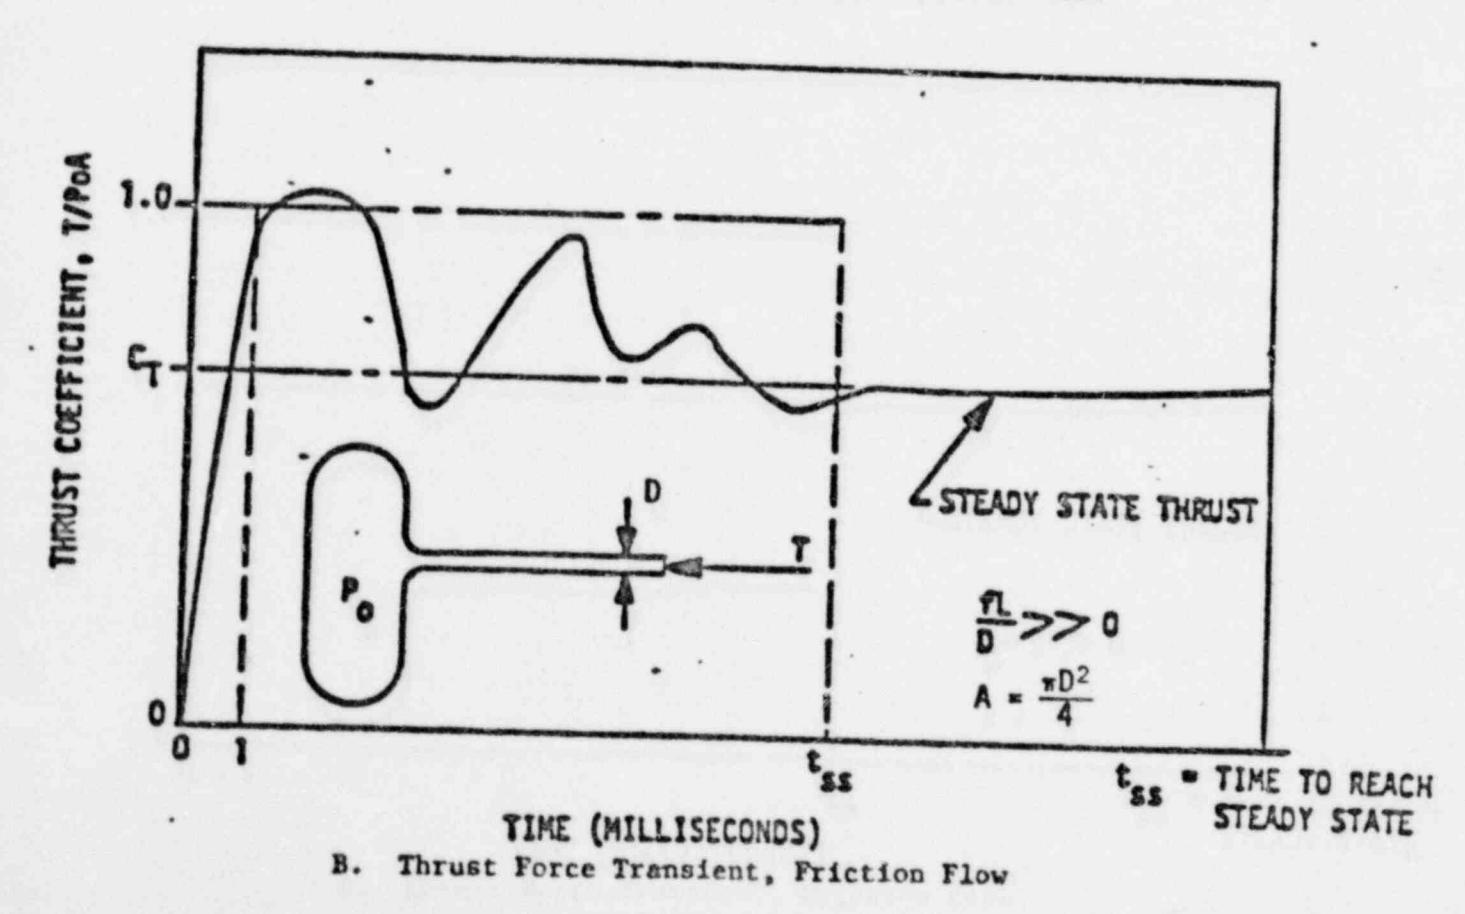
JAC/LHS/bjm 9/3/7 TYPICAL THRUST FORCE TRANSIENTS

FSAR Section 3.6.2.2 states that the analysis of the thrust forces which result in the event of a pipe rupture is described in BN-TOP-2. Contrary to the intent of BN-TOP-2, the steady-state thrust forces rather than the transient peak thrust forces were used in the energy balance techniques for the design of HELBA pipe whip restraints (see attachment, Figure B). Design documents have been released for construction/fabrication and most of the restraints have been installed.

A. Thrust Force Transient, Very Low Friction Flow

The affected restraints are being reevaluated using conservative thrust force time-histories input to energy balance and/or time history methods as described in BN-TOP-2.
