# NORTHEAST UTILITIES

Millstone Nuclear Power Station, Unit No. 1  
Fire Protection Commitment - Blast Wall

MILLSTONE NUCLEAR POWER STATION, UNIT NO. 1

TURBINE BUILDING SEISMIC REVIEW

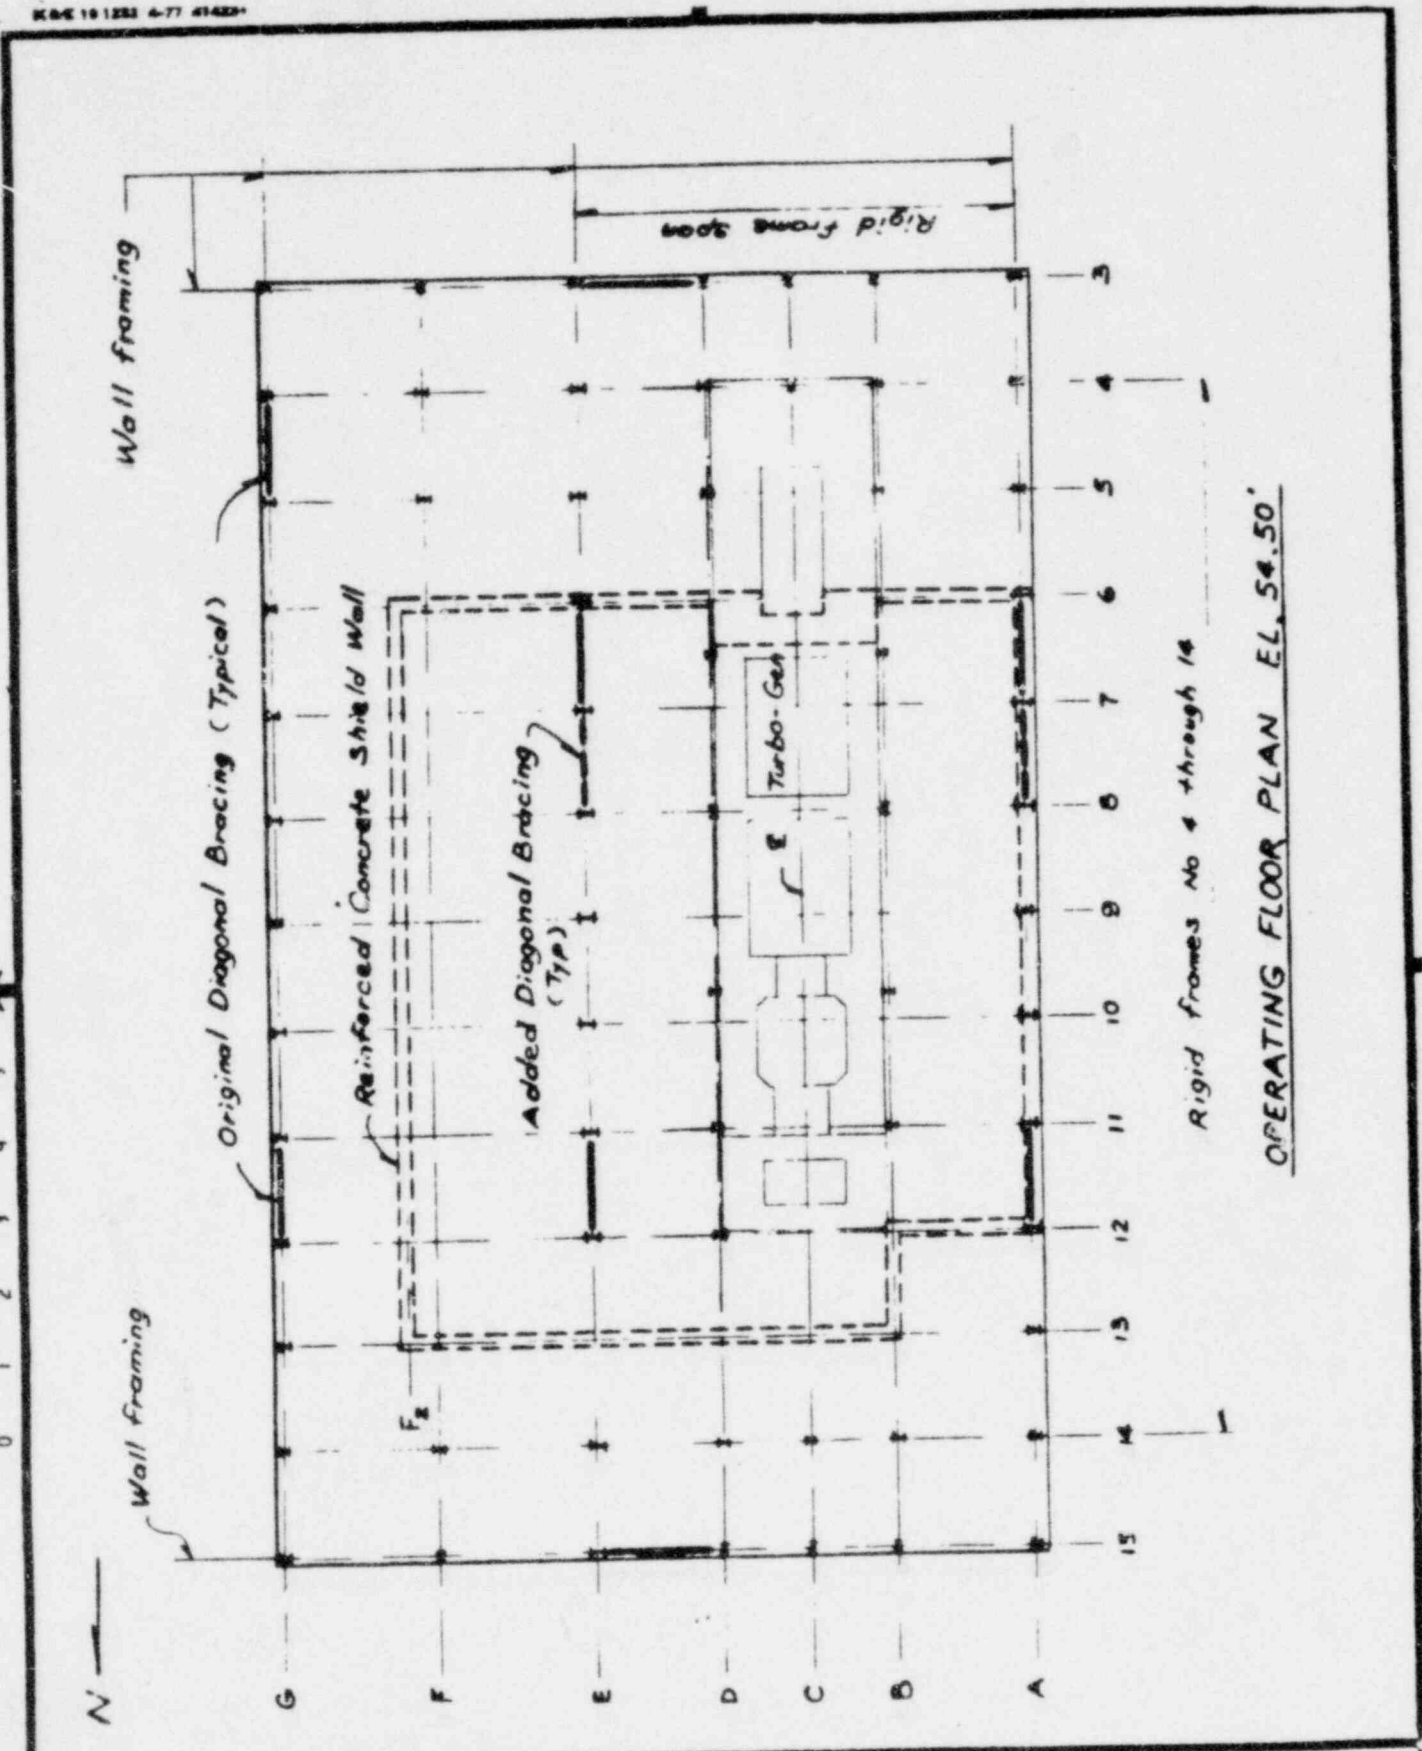
EBASCO SERVICES INCORPORATED		MILLSTONE UNIT NO. 1 TURBINE BUILDING	Fig. 1
DIV. Civil DR. MCH	APPROVED		
DATE CH			
SCALE

- A. Rigid Frames (Ref. Drawings: G-187985, 187989)  
As shown in Figure 1, the rigid frames were provided along Column lines 4 through 14 spanning between column lines A & E. Each frame, consisting of a steel girder and columns of the built-up type, provides support for the Turbine Building crane runway along column lines A and E at El. 86.42' and the roof deck at El. 104.75'. It was also designed to withstand any lateral loads in the East-West direction, wind or the crane thrust, that could be generated within the 25-ft. bay.

Each set of bracing was reviewed for strength and stability under the postulated seismic conditions and was found satisfactory except that located on Column lines A and B.

Instead of strengthening the originally designed bracing, a new set of bracing was installed between Column lines 7 and 8 on Column lines A and E as shown in Figures 1 and 2.

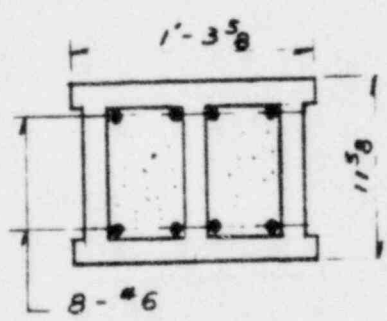
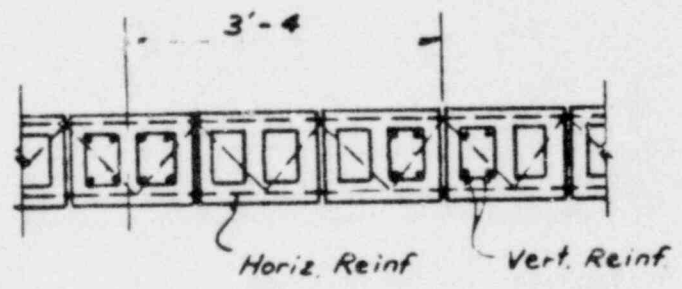
Figure 3

The Battery Room and Diesel Generator Room are enclosed by 12 in. concrete block walls designed to withstand a tornado wind of 300 mph (185 psf). As shown in Figure 3, the block walls were reinforced with 8-#6 verticals clustered every 3 ft 4 in. Prefabricated truss bars (Dur-o-wall) were provided at every second course for horizontal reinforcing. The tornado design was considered similar to the Design Earthquake with a factor of 2.4 and with allowables up to the yield stresses.

Seismic review calculations for the block have not been identified, however, the lateral loads that could be induced by the postulated seismic conditions would be less than the tornado load by observation.
