DRESDEN NUCLEAR POWER STATION

COMMONWEALTH EDISON COMPANY

ANNUAL REPORT OF STATION OPERATION FOR THE YEAR 1968

January 20, 1969

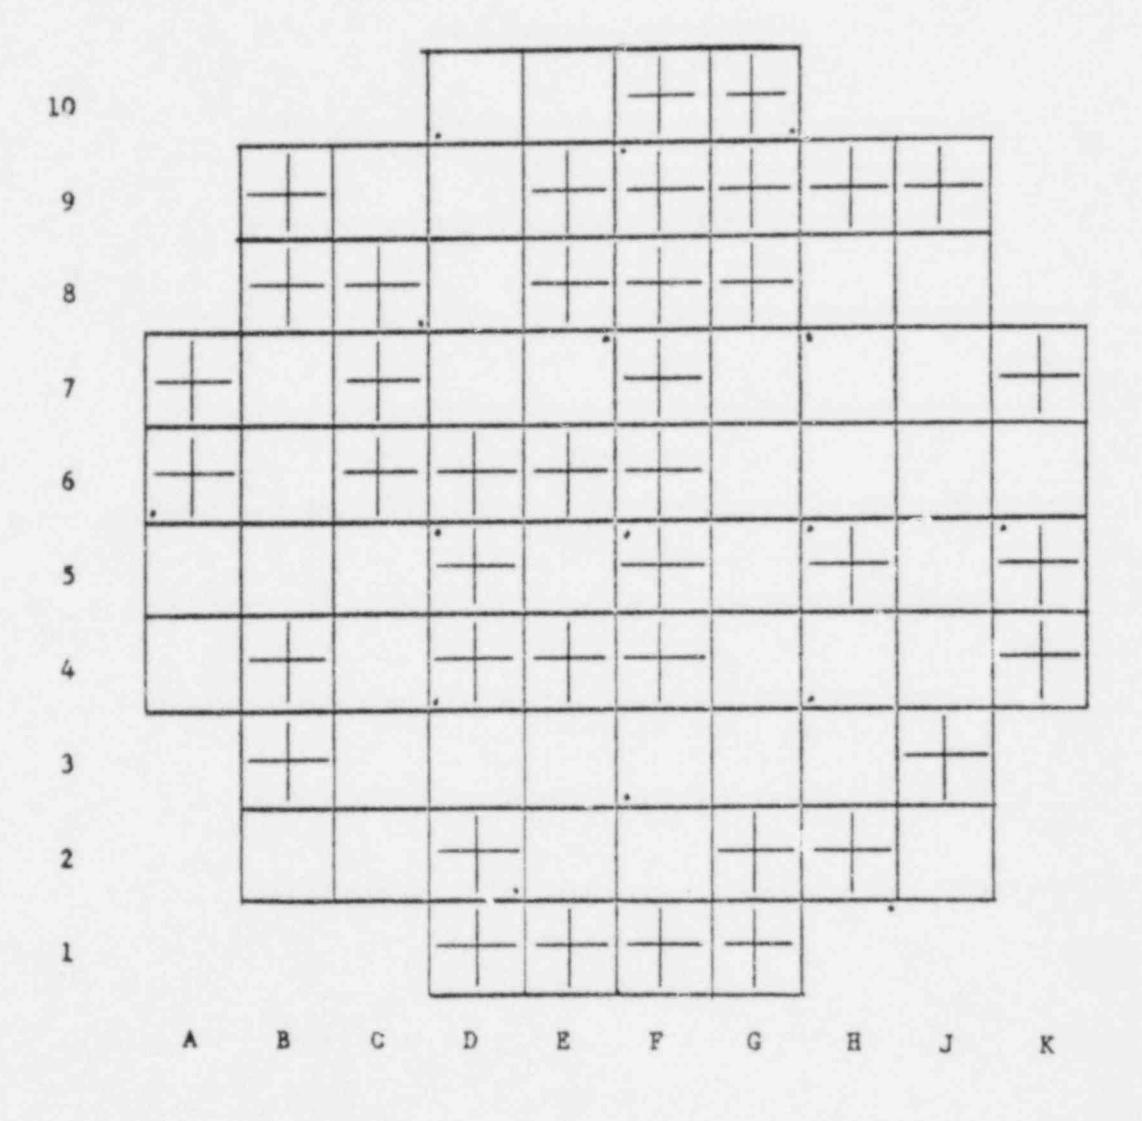
Forty control rod drives were removed and replaced with repaired drives during the fifth partial refueling outage. Many of these drives had exhibited long insert times during Cycle V. Four spare drives, SN 1233, SN 1273, SN 1257 and SN 1243, were overhauled prior to the outage and were tested satisfactorily in early February, 1968, in the drive test facility. These drives replaced four drives removed from the reactor, of which two of the replaced drives plus 38 others removed during the outage were overhauled, inspected returned to the reactor, and satisfactorily tested before reloadings started. Figure 2 shows the location of the 40 drives removed.

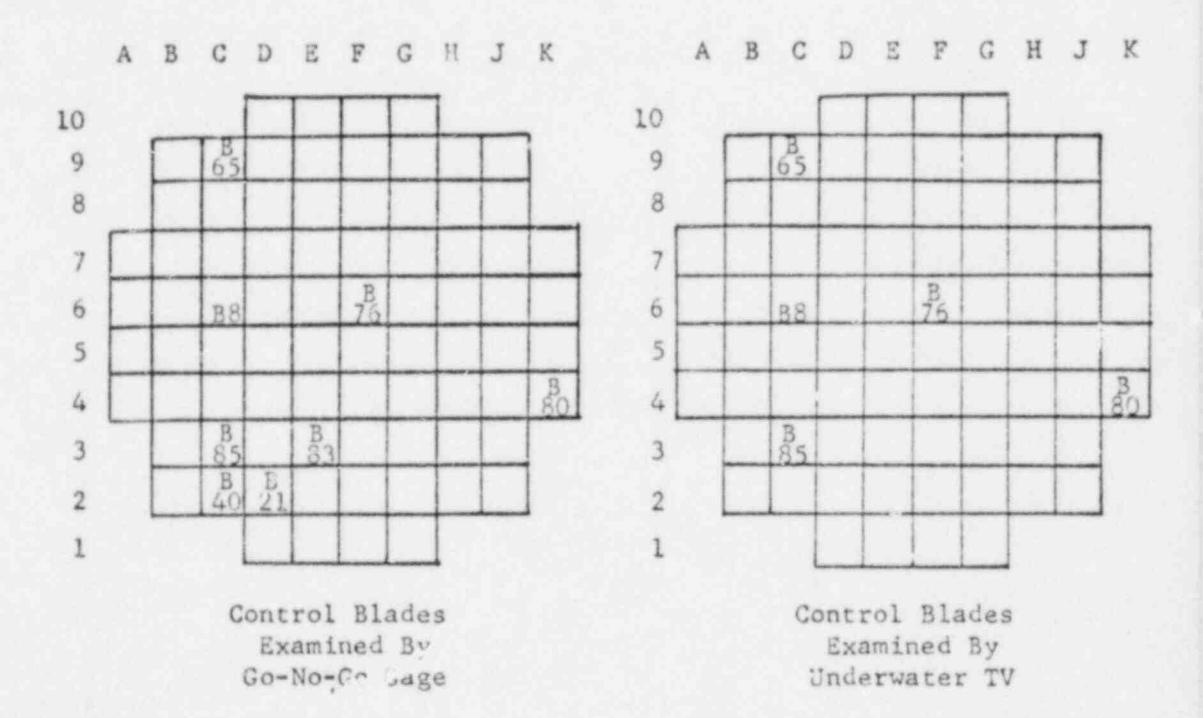
Control blades were inspected in the fuel building storage pool during the refueling outage on April 7 and 8, 1968. Eight blades were checked with go-no-go gages for dimensional variations and five of the eight by underwater TV for signs of visual wear. All blades inspected were found to be in acceptable condition. The blades examined and their locations in the core are exhibited below:

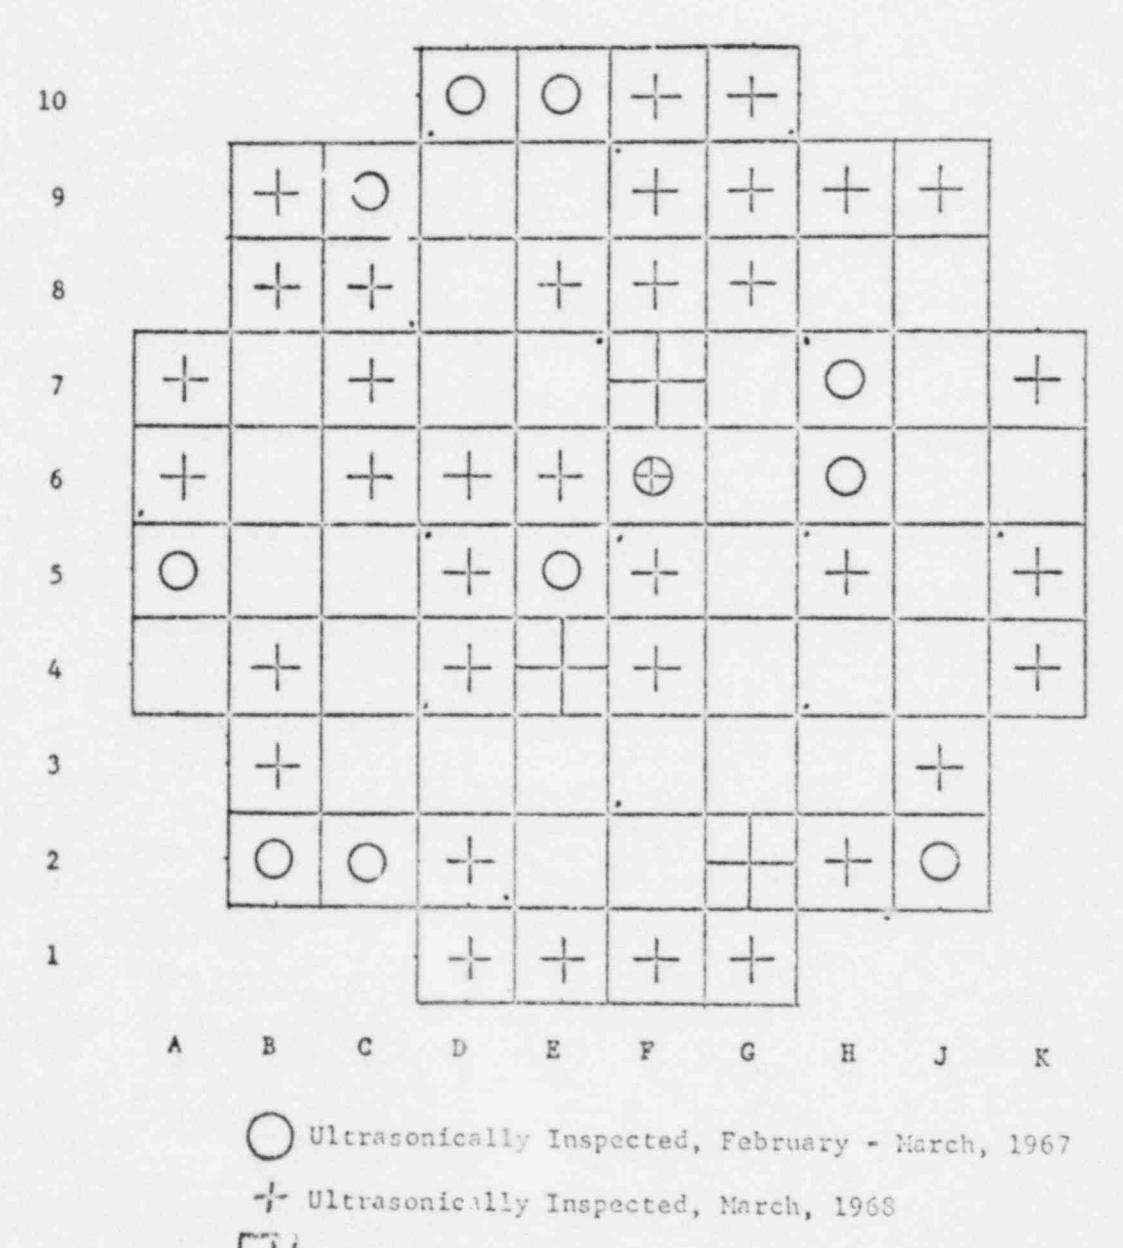
FIGURE 4

The 1968 primary system stainless steel piping weld inspection on Dresden Unit No. 1 was completed during the refueling, maintenance and inspection outage, February 3 through June 2, 1968. This intensified inspection duplicated the ultrasonic testing of welded areas performed in 1967 with an increase in percentage of large plate pipe welds inspected, and a more extensive use of the dye check technique.

The 6" stainless steel bypass loop in "B" secondary steam generator compartment was also replaced, although no indications of defects were found in this line. The replacement was made because of problems encountered previously with 304 stainless steel in the other three loops. The bypass was replaced with 304 L stainless steel and was radiographic and ultrasonically tested prior to and following installation.

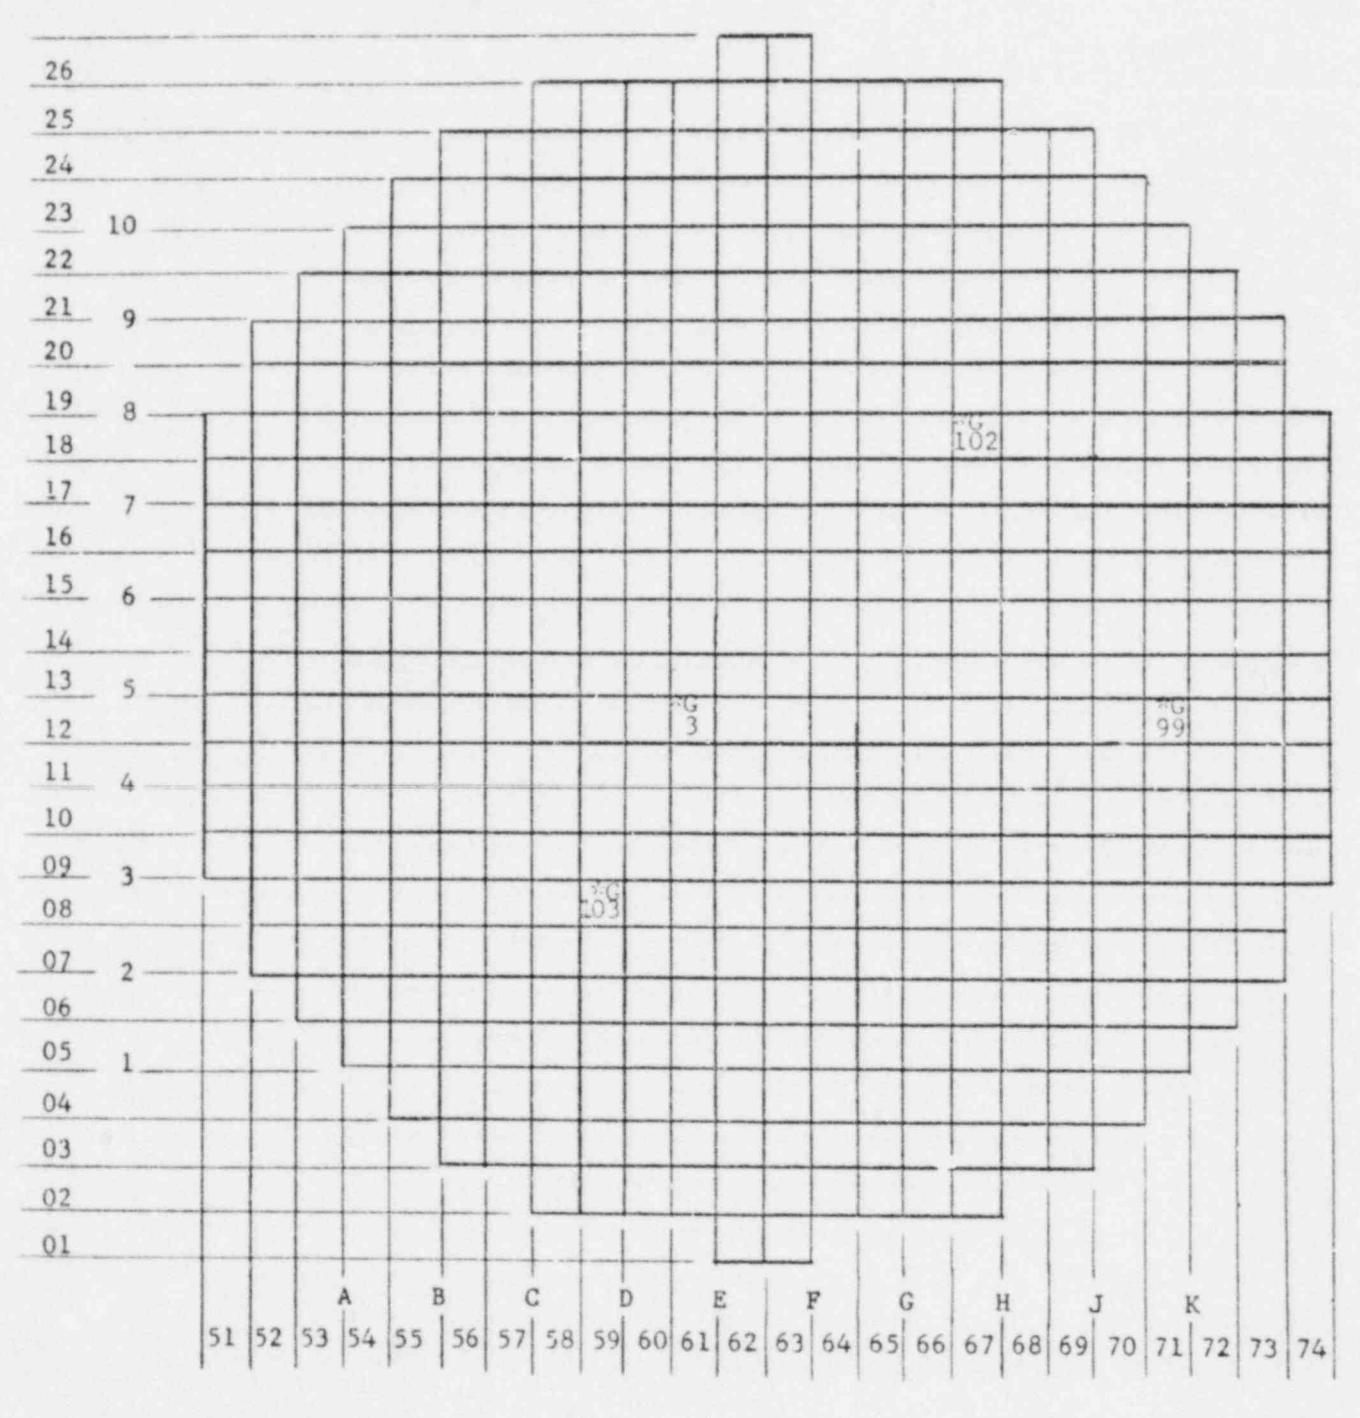
FIGURE 7

DEFECTIVE ASSEMBLY LOCATION (EOC 5)
