TOLEDO EDISON COMPANY DAVIS-BESSE NUCLEAR POWER STATION UNIT ONE SUPPLEMENTAL INFORMATION FOR LER NP-33-80-115

DATE OF EVENT: December 5, 1980

FACILITY: Davis-Besse Unit 1

IDENTIFICATION OF OCCURRENCE: Safety Features Actuation System (SFAS) Bistables Out of the Technical Specification Allowable Value

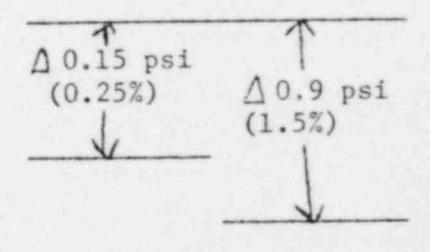
Description of Occurrence: On December 5, 1980 at 1730 hours during the performance of the SFAS Monthly Test, ST 5031.01 on SFAS Channel 3, the setpoint for the Borated Water Storage Tank (BWST) low level bistable (BA 312) was found to be out of tolerance. The bistable as found value was 0.552 V and the allowable value is less than or equal to 0.551 V.

Designation of Apparent Cause of Occurrence: The cause of these occurrences can be attributed to a component failure. The bistables are subject to instrument drift. The instrument drift was probably aggravated by the 120 VAC problem on the cabinet common.

BWST LEVEL (BA	312) (With 120 VAC	on Common)
	Level (inches)	Volts (1)
Full Range	600	2.00
As Found	57	0.552
Allowable Value (TS)	∠ 56.7	0.551
Trip Setpoint	∠ 55.0	0.547
Trip Setpoint	<u>2</u> 49.5	0.532
Allowable Value (TS)	2 48.3	0.529
Zero	0	0.4

Worst case drift 1.25% of full scale

Corrective Action: Upor finding the BWST level bistable BA 312 and the containment pressure bistable BA 309 out of calibration they were immediately recalibrated as per the test (ST 5030.01) procedure to within the Technical Specification limits.

To be sure that an AC voltage on common does not exist for an extended period of time the voltage between common and ground will be checked on a monthly basis per ST 5031.01, SFAS Monthly Test.
