PEACH BOTTOM-THE POWER OF EXCELLENCE

#### SUBJECT: Licensee Event Report Peach Bottom Atomic Power Station - Unit 2

This LER concerns a plant shutdown required by Technical Specifications due to a leaking RCIC check valve.

Reference:	Docket No. 50-277
Report Number:	2-89-030
Revision Number:	00
Event Date:	11/26/89
Report Date:	12/26/89
Facility:	Peach Bottom Atomic Power Station
	RD 1. Box 208, Delta, PA 17314

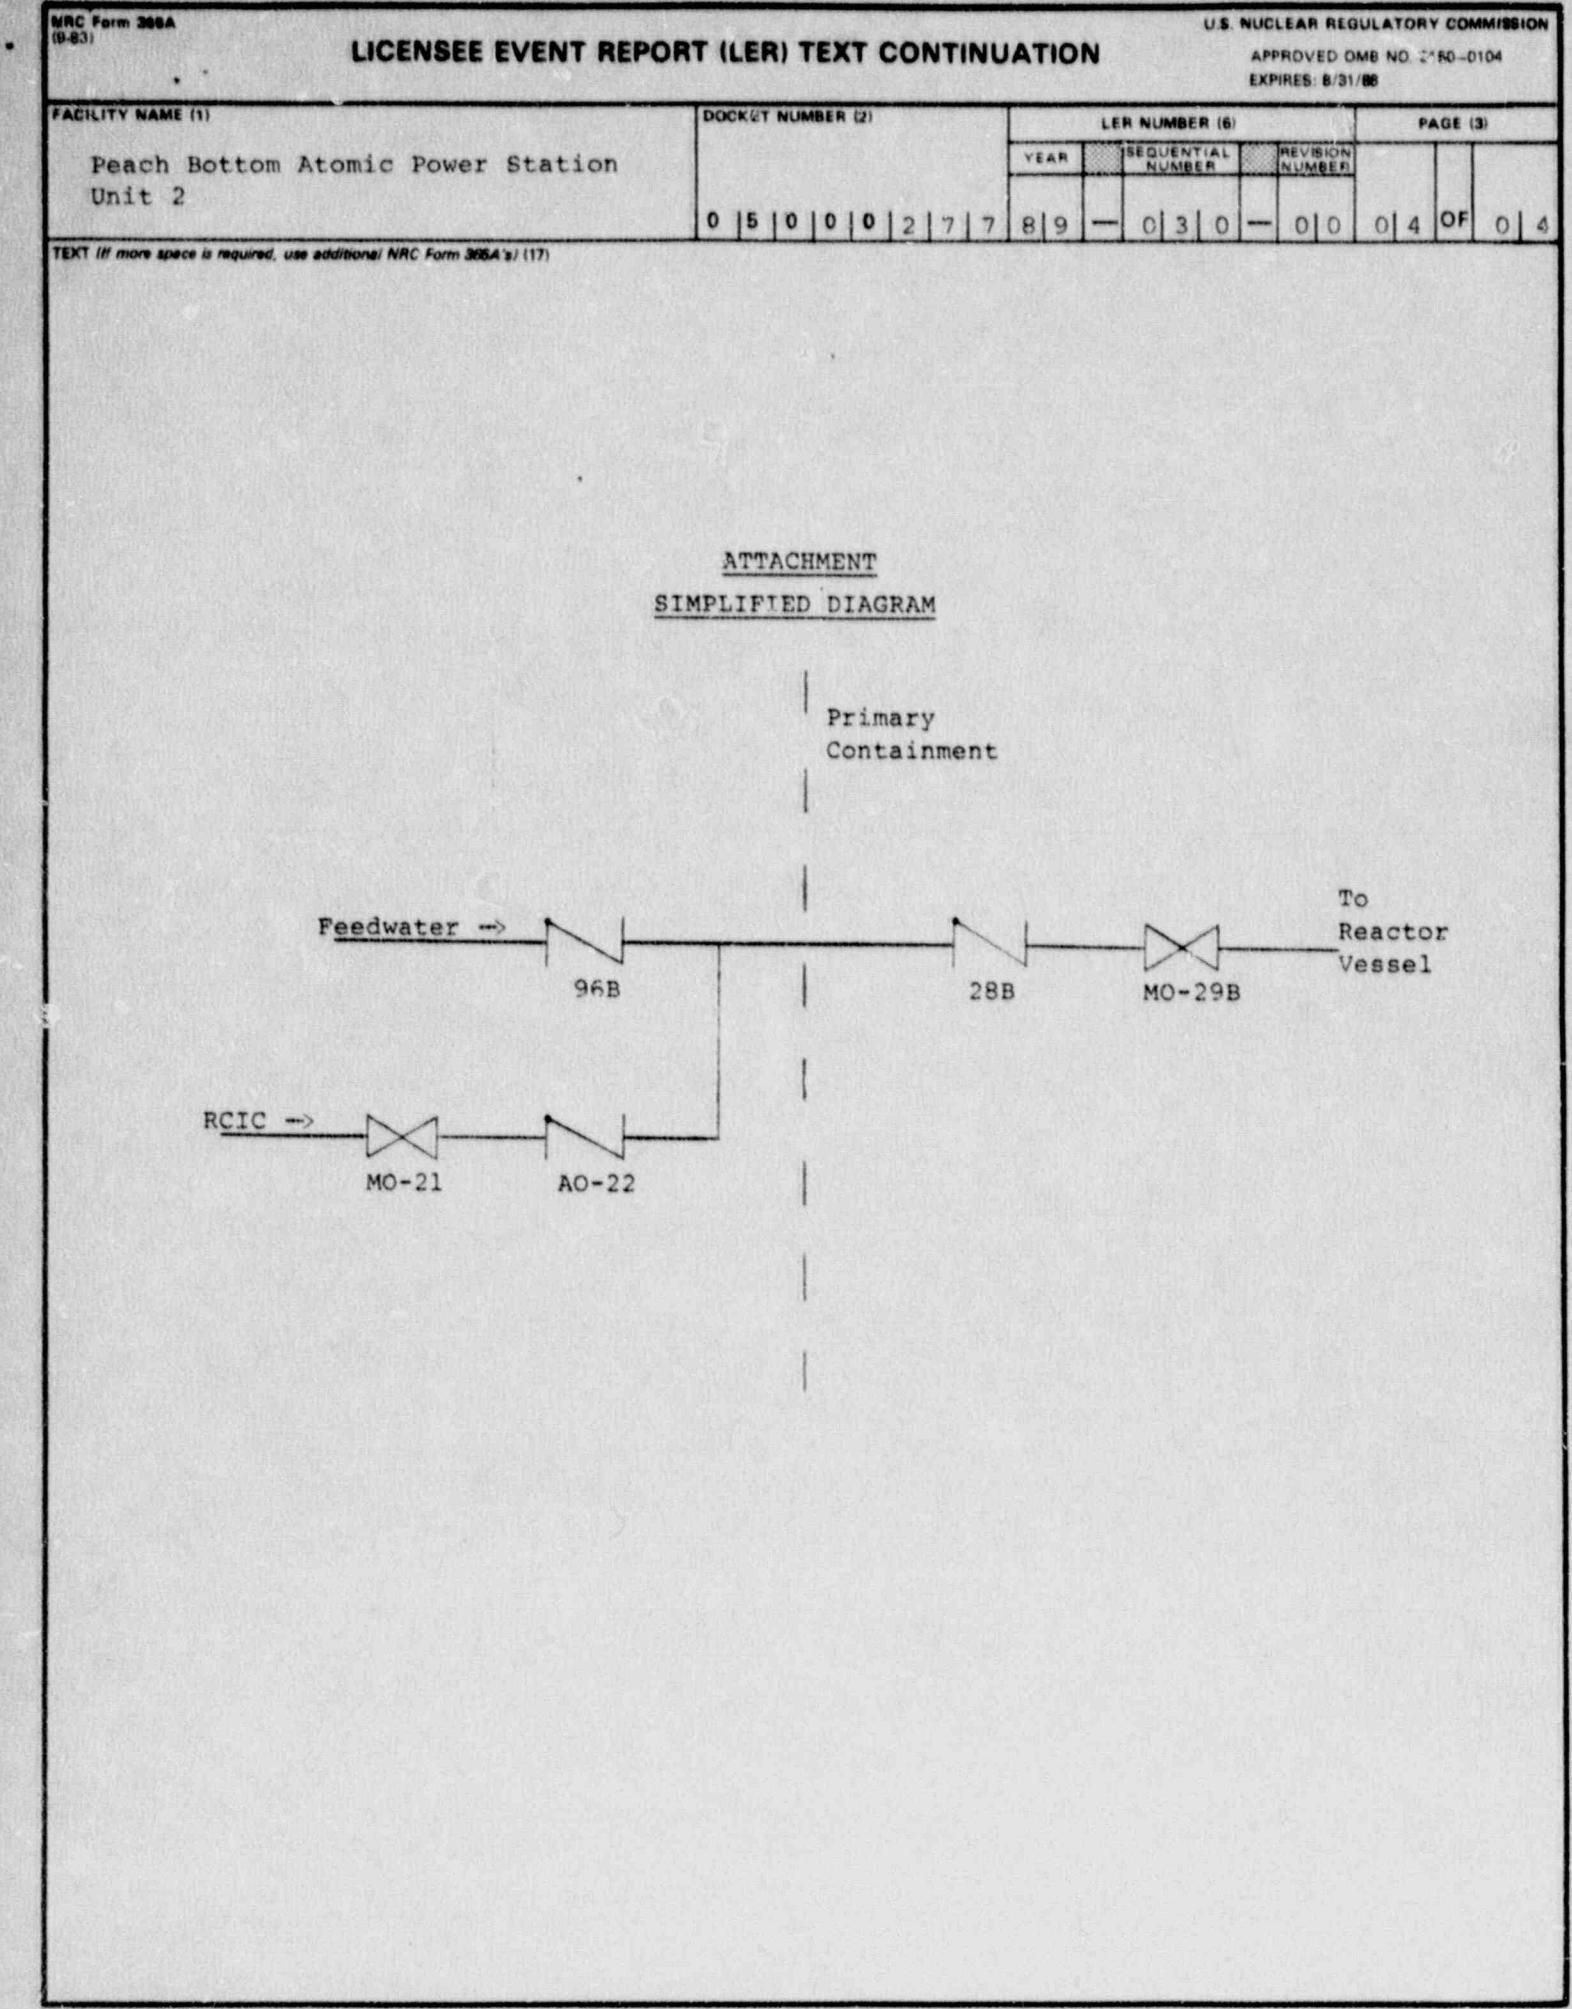
RCIC check valve A0-22 is on the RCIC injection line which connects into the "B" Feedwater (EIIS:SJ) line outside primary containment (see attached simplified diagram). Primary Containment Integrity as defined in Technical Specifications was not violated since Feedwater system check valve 28B and valve M0-29B, inside primary containment, remained operable throughout this event. Reactor shutdown was necessary in order to repair valve A0-22. The low reactor water level, which resulted in a
