REPORT OF INVESTIGATION

TITLE: SALEM NUCLEAR POWER STATION, Unit 1 Potential Tampering with No. 13 Steam Generator Wide Range Level Recorder

SUPPLEMENTAL: Docket No. 50-272/82-13

CASE NUMBER: I-82-079

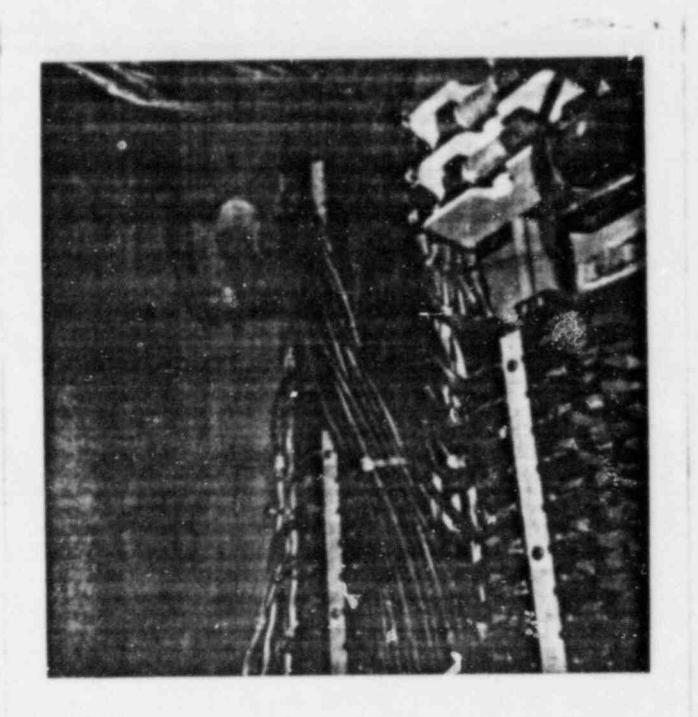
CABLE BUNDLE 1FW99-C-Ø

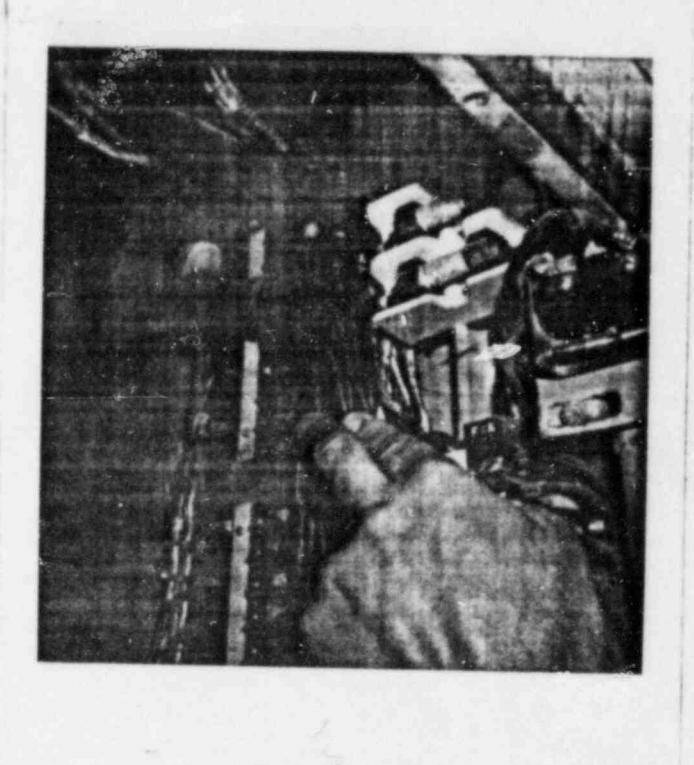
continued that at 3:45 p.m. on May 1, 1982, an I&C technician who was troubleshooting the problem in the hot shutdown panel found a piece of formed wire in the shape of a light bulb making contact with terminal points 9 and 12 on the terminal board which caused a short in one signal lead to the ground. Said there was no particular significance to the wire making contact with those terminal points since contact with any terminal points would have had the same result.

CABLE BUNDLE 1FW99-C-Ø AND TERMINAL POINTS 9 AND 12
